VRTC FIELD REPORT

Inspection of a 1999 Pontiac Grand Am

November 2004

VRTC-DCD4089 (EA03-021)
(Front Suspension Coil Spring Fracture)

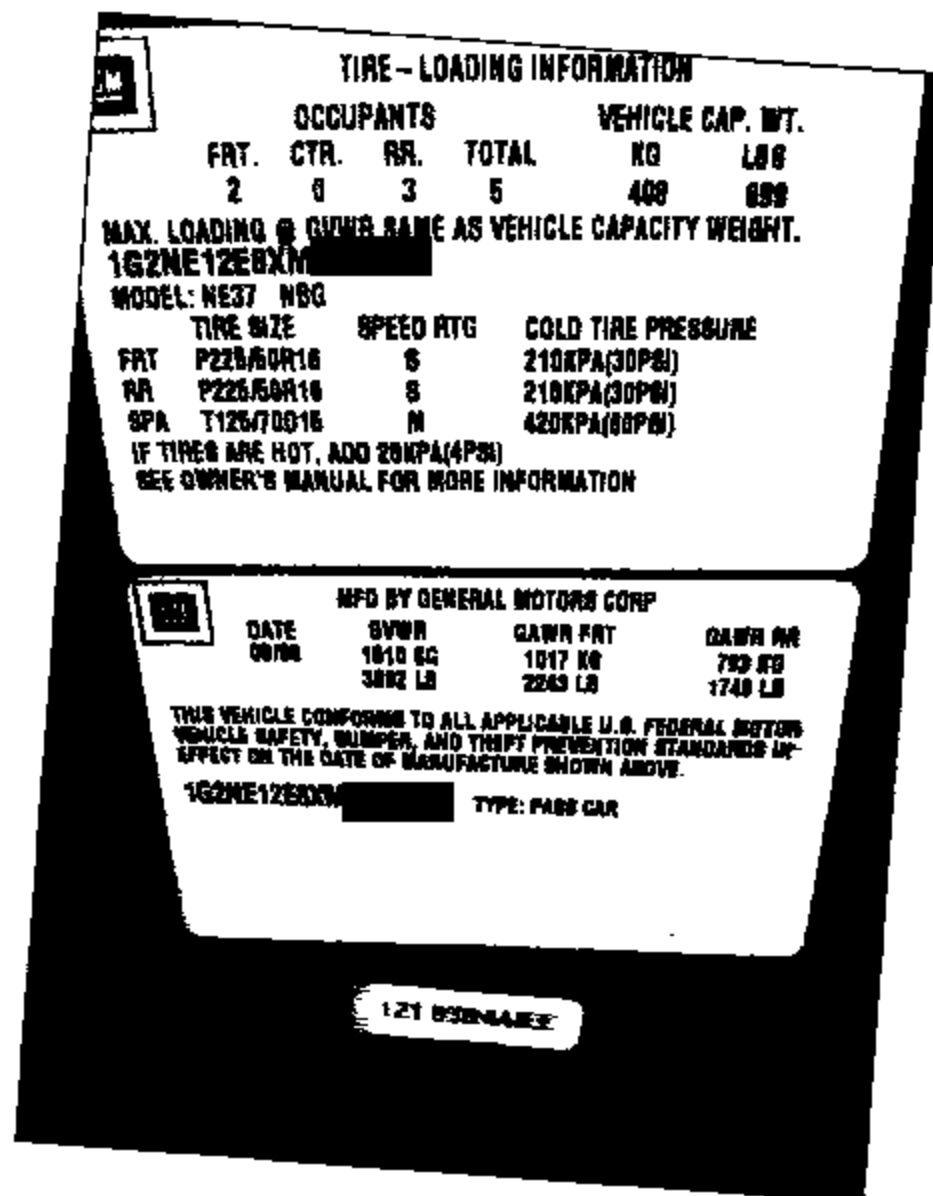
Figure 2 is a photograph of the FMVSS label of the subject vehicle. Clearly visible in this view are the vehicle identification number and the date of manufacture.

Figure 2 - FMVSS Door Label on the Subject Vehicle

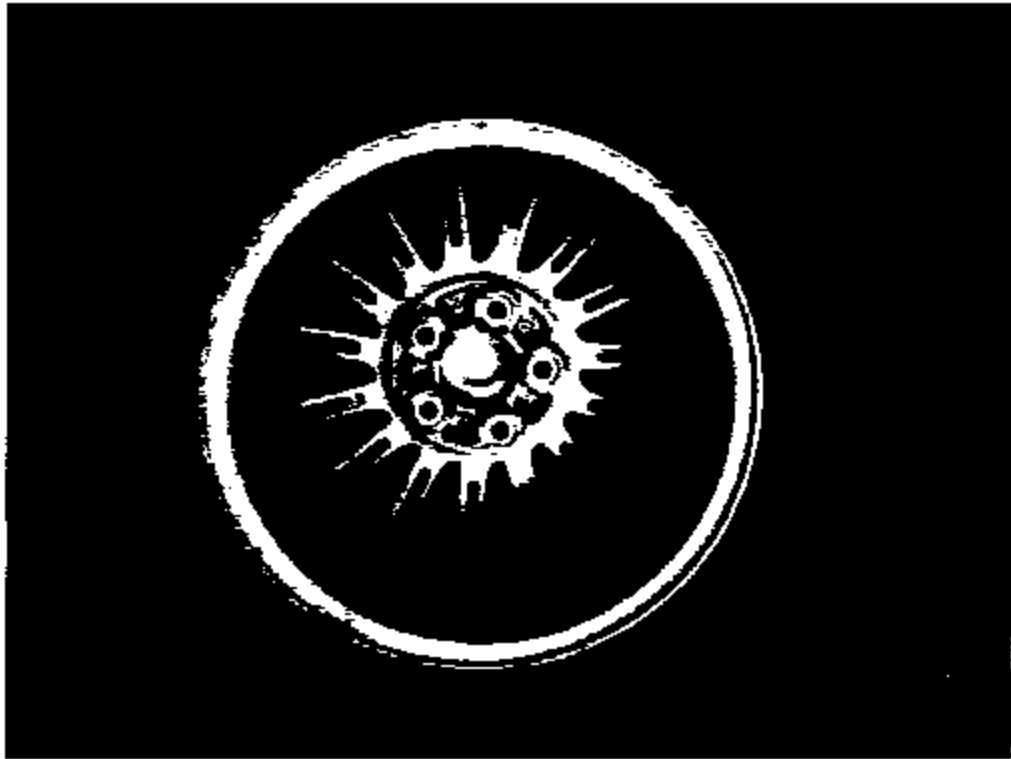
Figure 4 - Right Front Wheel of the Subject Vehicle

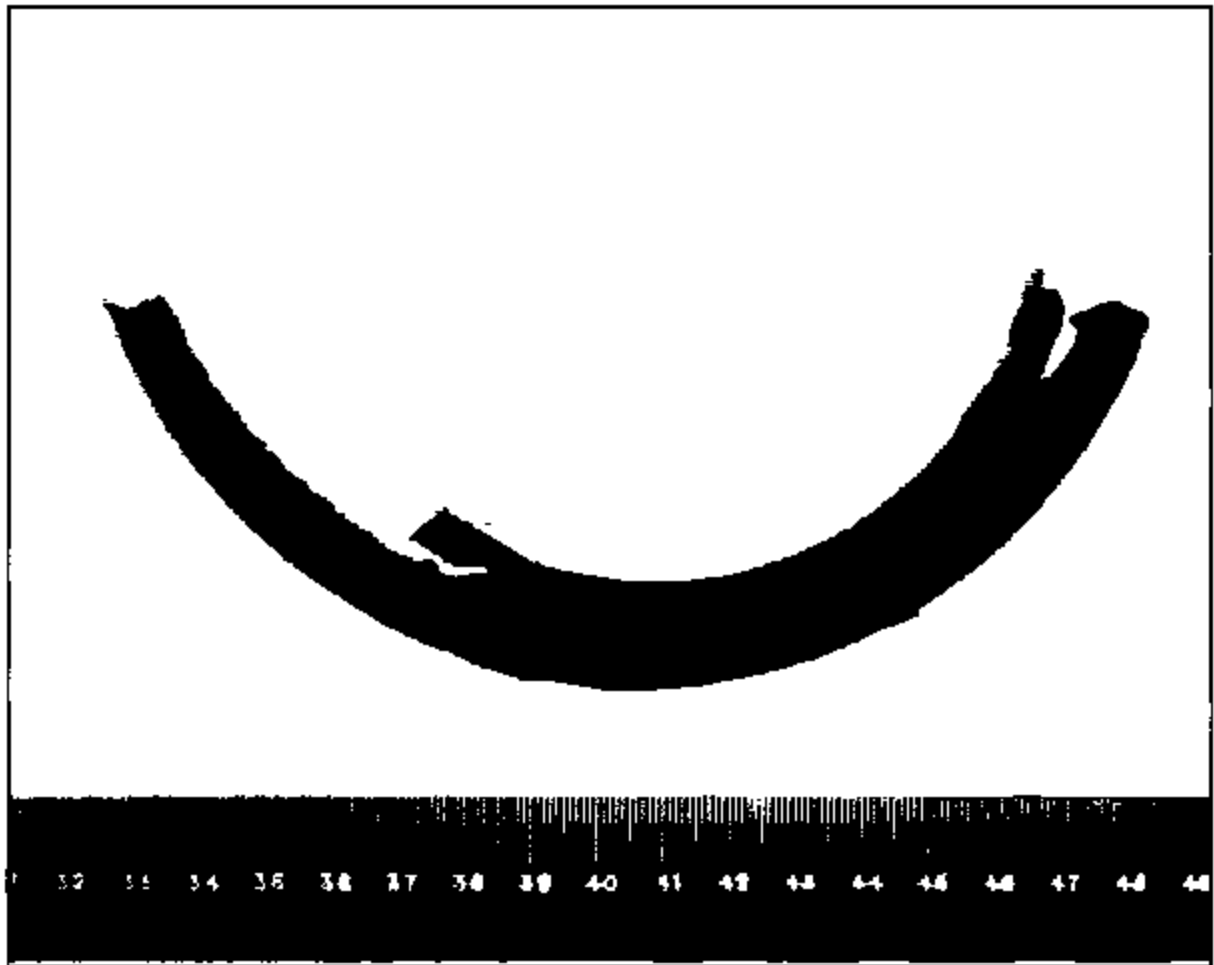
The owner gave the authors a piece of a broken coil spring that was allegedly found on the roadway behind the vehicle after the incident. Figure 5 is a photograph of this piece of the broken coil spring.

Figure 5 - Piece of Broken Spring Recovered From the Scene of the Incident

It is the opinion of the authors that the right-front suspension coil spring did indeed break in an unusual manner, and probably caused part of the broken spring to

contact the right-front tire. The tire was probably pierced by the broken spring, causing it to deflate rapidly. The combination of the broken spring and deflated tire caused the right-front of the vehicle to contact the roadway surface, which rendered the vehicle inoperative.
