Petition

**A Petition of Investigation
Office Of Defects Investigation C/O
National Highway Traffic Safety Administration
Room 5319 , NVS-215
400 7th Street SW
Washington , D C 20590**

For public safety and to perform a citizen's duty , I Robert Galanty hereby petition the National Highway Traffic Safety Administration for the following reasons pertaining to the 1992-1997 Chrysler LHS family of vehicles namely initiating with VIN number 2R3HD56F3TH306742 which exploded on July 2,1996 with 250 miles on the odometer (Note: This vehicle is believed as per Chrysler / U S Customs records to have been a Canadian gray Market vehicle) to conduct an investigation into the left and right fuel rail subject to Chrysler recall number 790 , ABS brakes subject to earlier recall number unknown at this time and the frame construction / allignment.

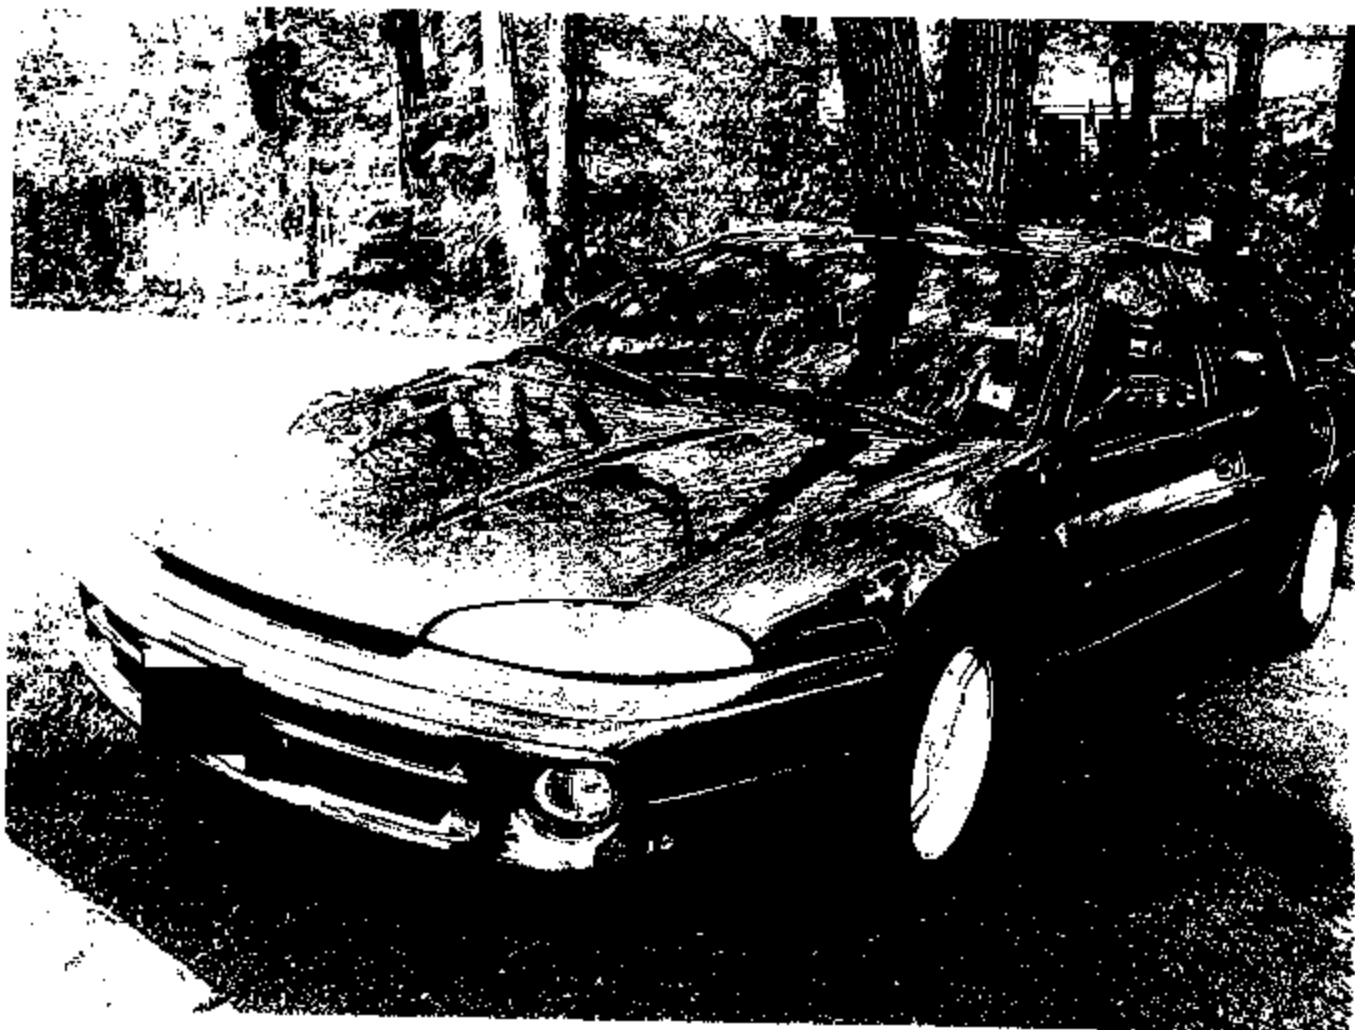
EXHIBIT 4 Notice in this photo, in contrast to Exhibit # 2, that the left rear wheel is lined up with the left side of the vehicle. Notice in particular that a part of the side wall of the rear tire can be seen in the entire "9-o'clock" to the "12-o'clock" position even though the camera was positioned closer to the vehicle's front in this photo than when the photo shown in Exhibit # 2 was taken.

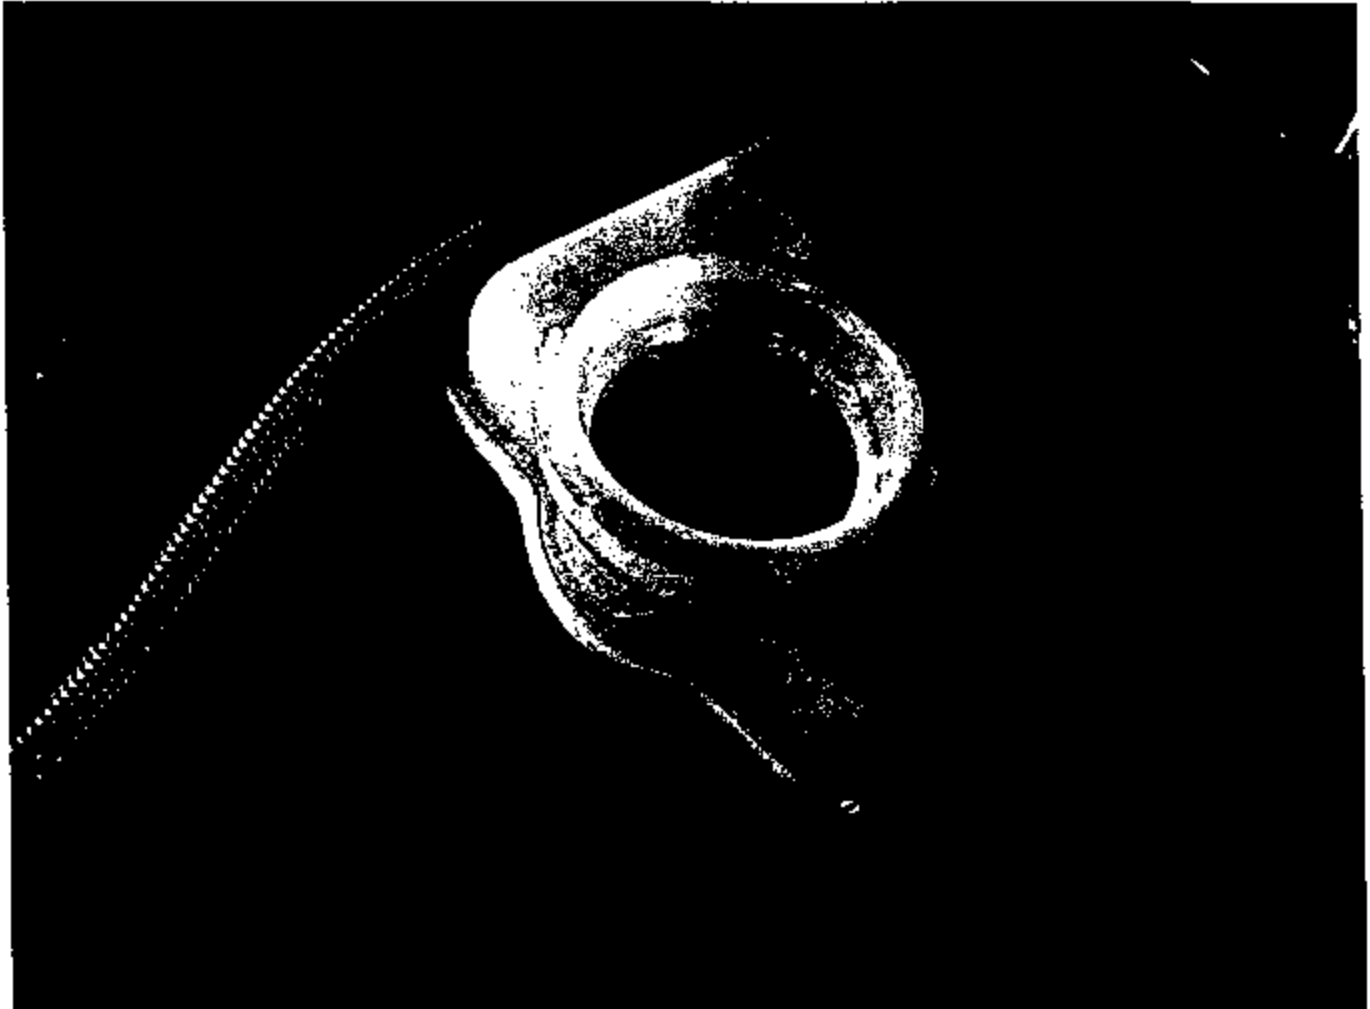
EXHIBIT 5. Chrysler Corporation has, for some reason, a problem with contamination of the brake fluid, as can be deduced from Chrysler's Service manual that addresses such problems. In its pure state, brake fluid is colorless.
