## ODI RESUME

Investigation: EA 04-035  
 Prompted By: PE04-061  
 Date Opened: 12/22/2004      Date Closed: 10/20/2005  
 Principal Investigator: Michael Lee  
 Subject: Front Turn Signal/DRL Failure

Manufacturer: General Motors Corp.  
 Products: 2003-2004 Saturn Ion Coupe  
 Population: 38,663

## SUMMARY REPORT

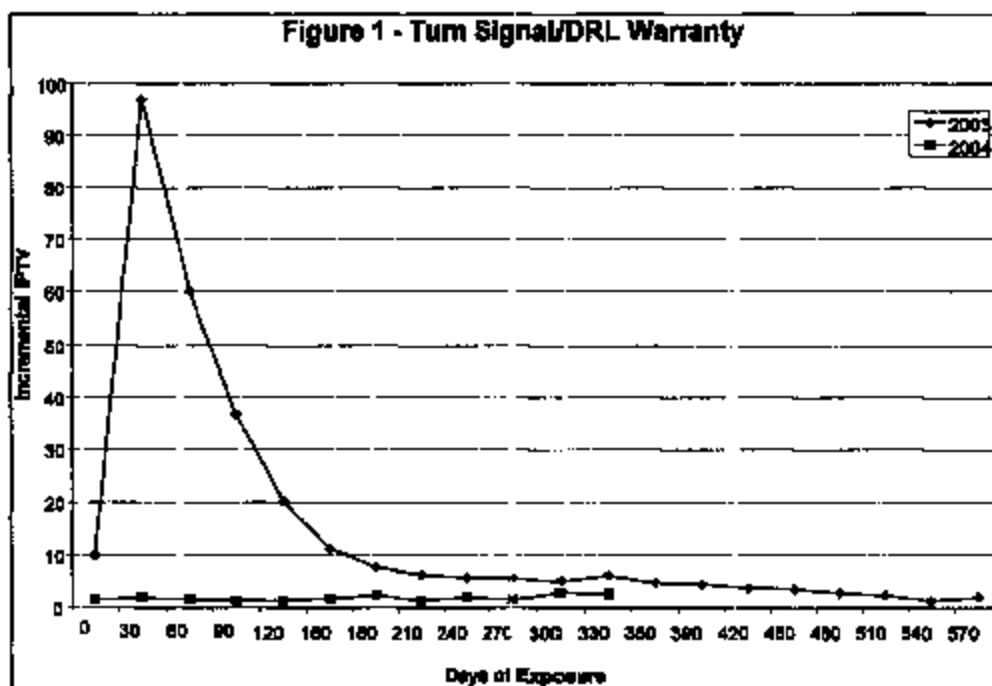
GM stated that early bulb failures in MY 2003 Ion coupes were addressed by improvements in design and manufacture of the bulb and socket. As shown in Figure 1, the MY 2003 incremental warranty rate, after 180 days exposure, is below 10 incidents per thousand vehicles (IPTV). The MY 2004 incremental warranty rate is below 3 IPTV. These are in the expected range for turn signal/DRL bulbs.

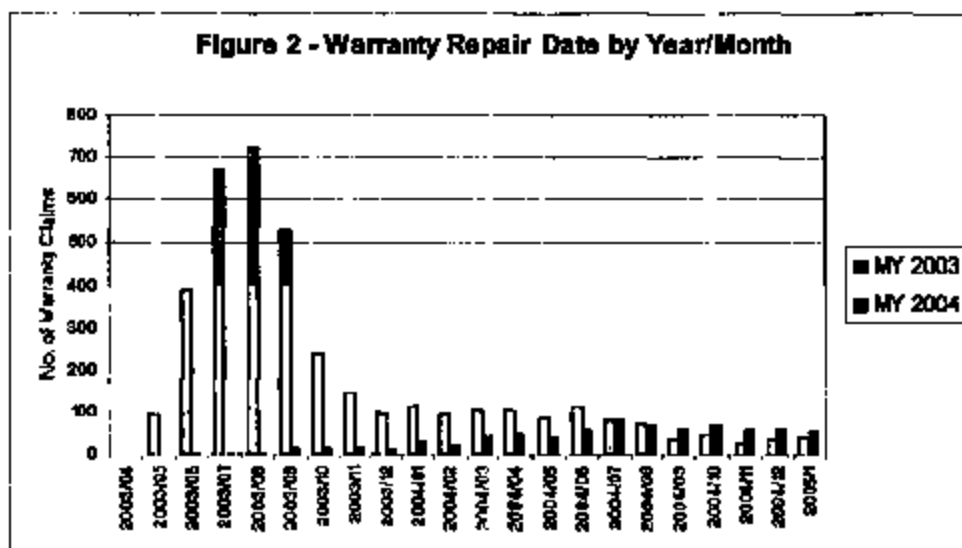
There were 4,604 warranty claims through January 2005, which may be related to the alleged defect in the subject vehicles. Most of the warranty claims were on MY 2003 vehicles and were early life failures as shown in Figure 2 (this trend is also seen in Figure 1).

It appears that significant bulb quality issues occurred during MY 2003 vehicle production. However, most of the failures due to these issues occurred in the first several months of use. After the significant initial surge in warranty claims, the claims declined drastically and have declined steadily since. The change of the lead wire material in August 2003, near the start of MY 2004 vehicle production, appears to have been effective in reducing failures of turn signal/DRL in MY 2004 vehicles. MY 2004 warranty claims do not indicate an increasing trend over time.
