Closing Report – EA04-005

Tailgate Support Cable Breakage in General Motors Model Years 1999-2004 Silverado and Sierra Vehicles and Model Years 2002-2004 Avalanche and Cadillac Escalade EXT Vehicles (designated C/K Models)

Reference Numbers: PE03-049, Campaign 04V-129

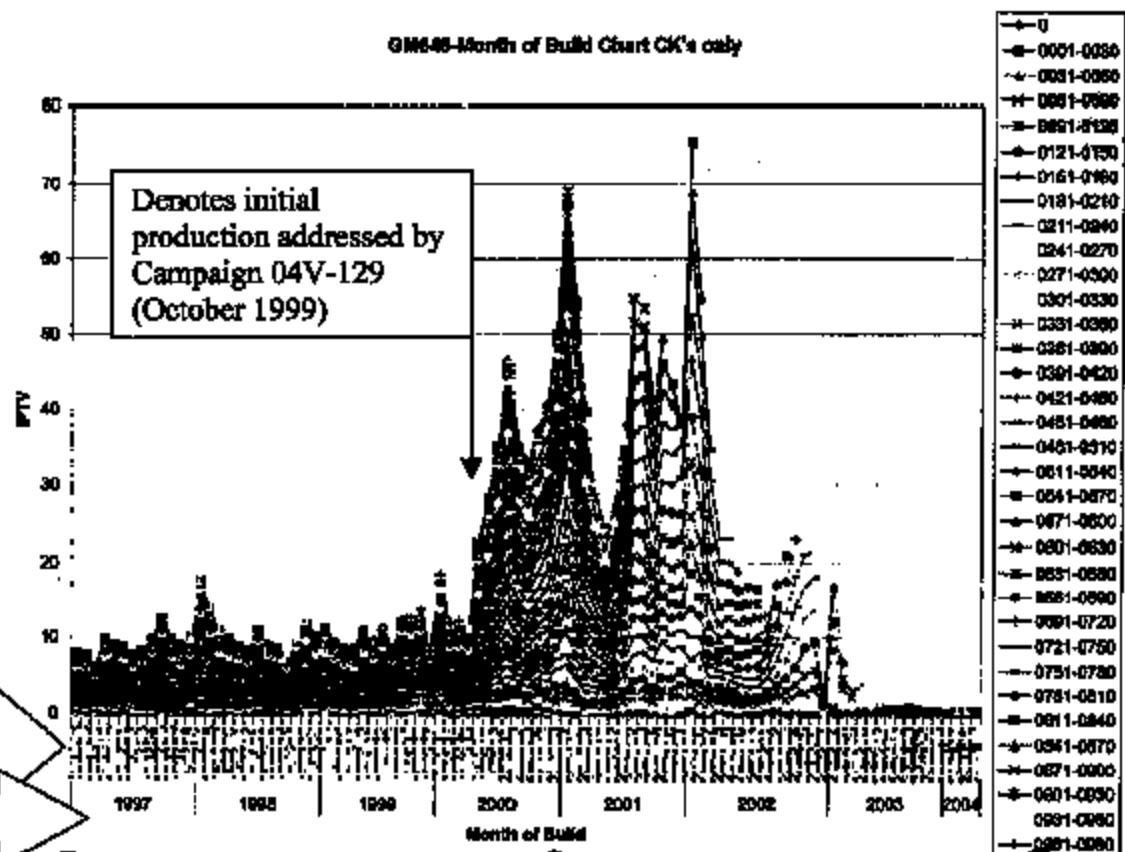
Chart 1 – Incident Rate (warranty claims per 1000 vehicles manufactured) for C/K models manufactured from August 1996 (model year 1997) through September 2003 (partial model year 2004).

The foregoing chart shows that the incident rate of broken (or incidents reported using similar descriptive words as identified above) tailgate support cables installed prior to October 1999 was significantly lower than the incident rate of breakage in tailgate cables installed during the following 2000-2002 model years of production.

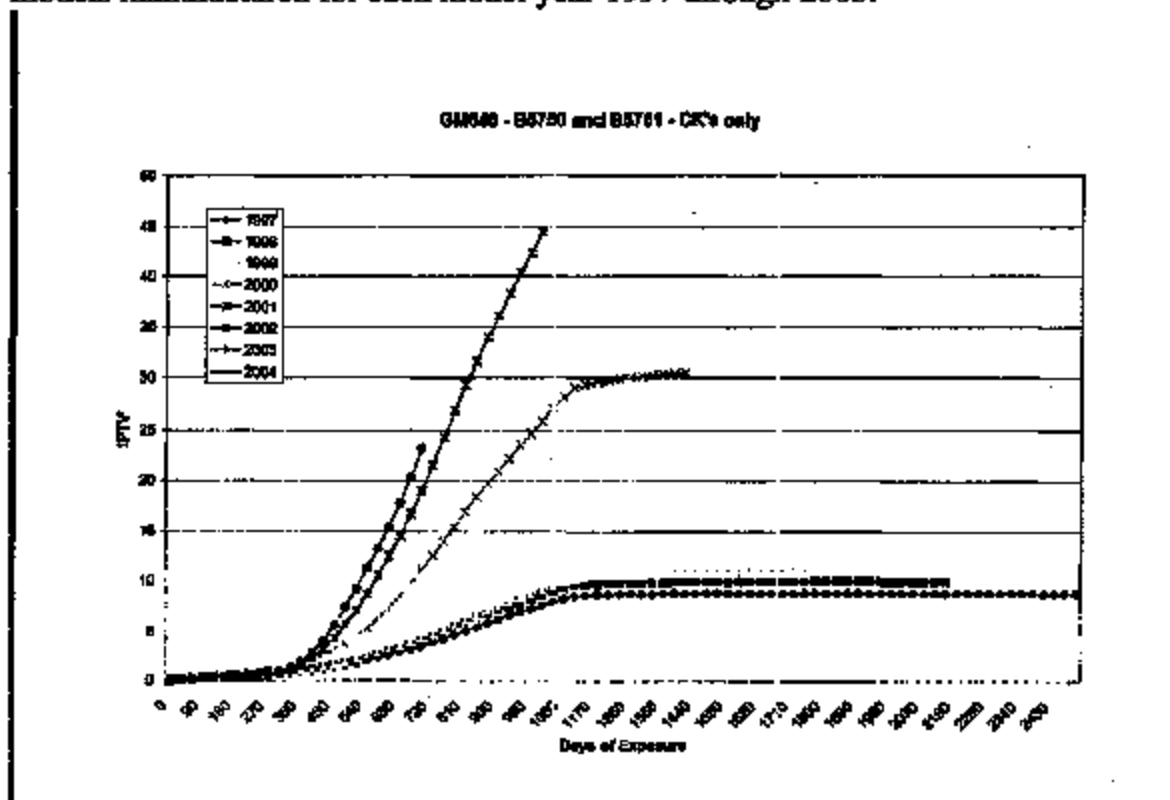
Chart 2 – Incident Rate (warranty claims per 1000 vehicles manufactured) for C/K models manufactured for each model year 1997 through 2003.

This summary indicates that the incident rate of warranty for broken tailgate support cables installed in 2000-2002 model year C/K vehicles is significantly greater than the incident rate for 1997-1999 model year C/K vehicles. The apparent "flattening" of the incident rate after approximately 1080 days of product exposure (approximately three years) is due to the end of warranty coverage and is not an indication that the rate of tailgate breakage has abated or decreased.

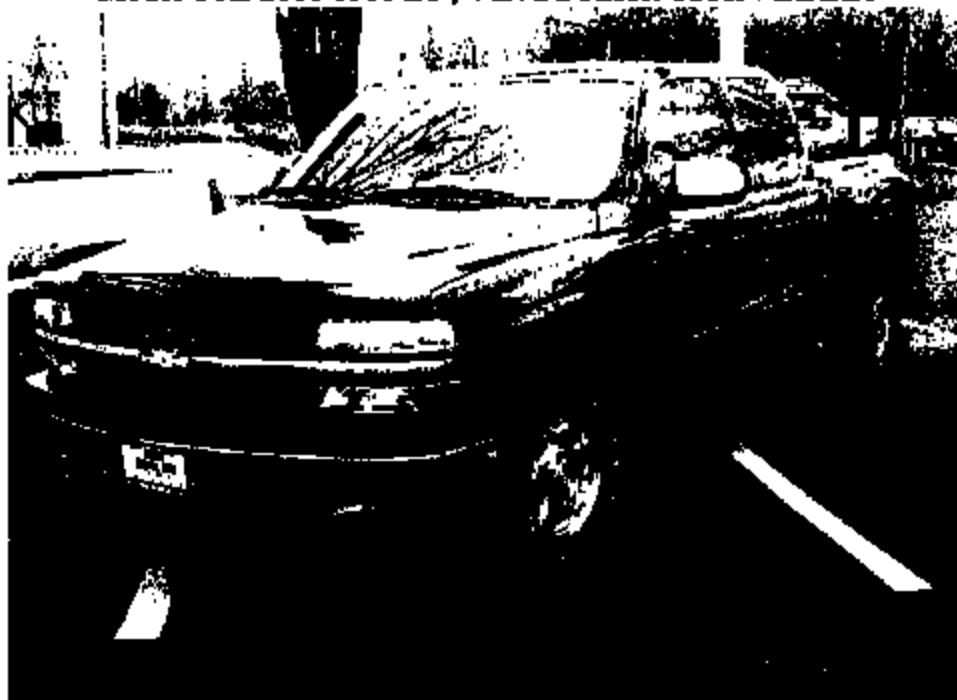
Model Year 2001 1500 LT, VIN 2GCEK19T211XXXXXX

The tailgate is shown in the open (lowered) unloaded position supported by the tailgate support cables. Note the right side (far) cable appears to be slack while the left side (close) cable is taut.

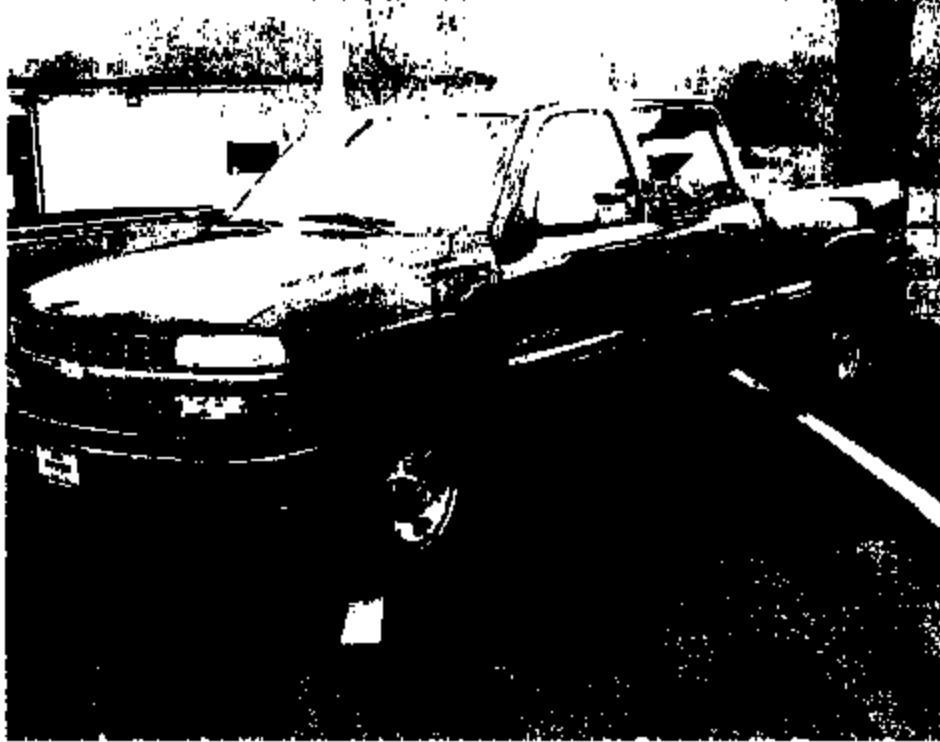
Model Year 2002 1500 HD LS, VIN 1GCGK13U42FXXXXXX

The tailgate is shown in the open (lowered) unloaded position supported by the tailgate support cables. A minor distortion can be seen in the left cable at the point where the cable flexes when the tailgate is closed. This distortion may provide an indication that the interior cable is damaged.

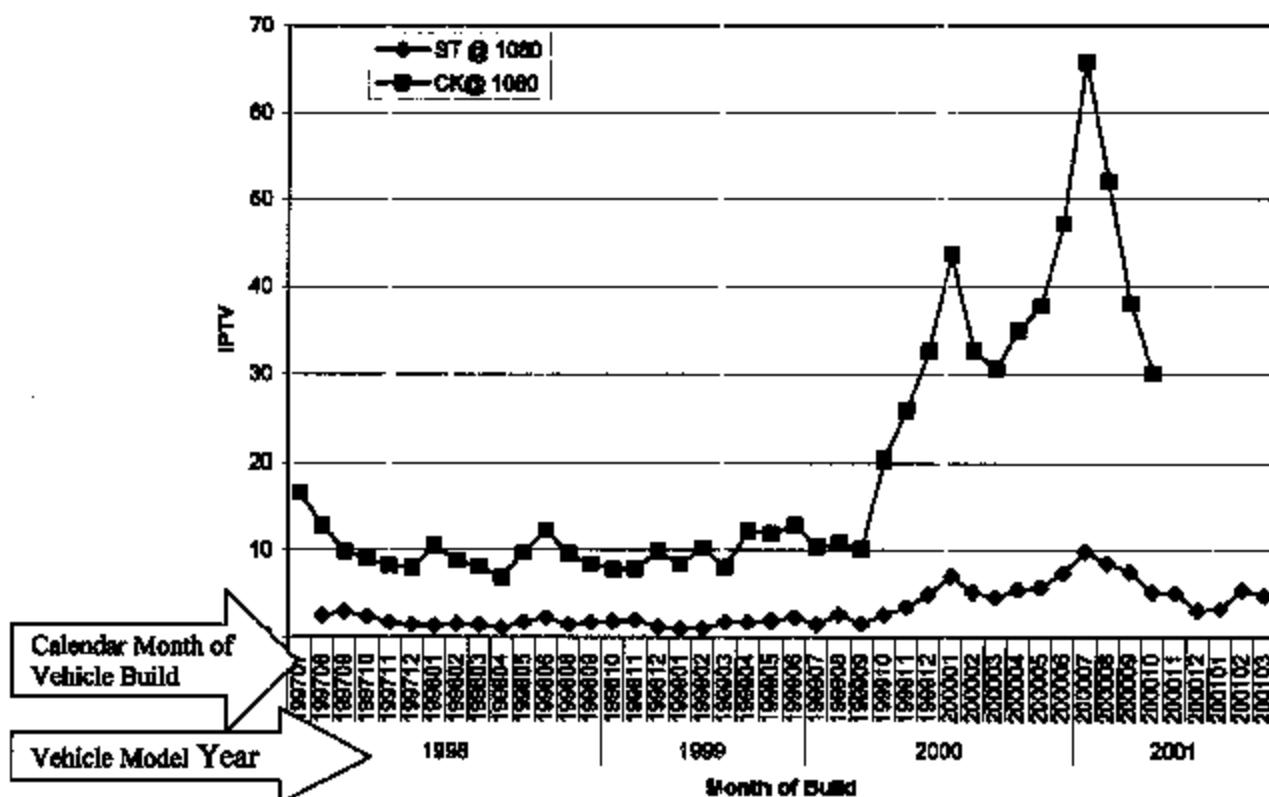
ST vs CK Warranty @ 1000 Days of Exposure
B5750 Tailgate Cable-Right-Replace, B5751 Tailgate Cable-Left-Replace

Prior to the 2000 model year, the warranty rate for the S/T models was approximately 2-3 incidents per 1000 vehicles manufactured and increased to approximately 5-10 incidents per 1000 vehicles during or after model year 2000. Prior to the 2000 model year, the warranty rate for the C/K models is approximately 8-12 incidents per 1000 vehicles manufactured and increased to approximately 10-65 incidents per 1000 vehicles manufactured during or after model year 2000.

Although tailgate support cable breakage has occurred at modest levels in the S/T models, the breakage of tailgate support cables appears to occur at a significantly higher rate and exhibits a significant "departure from norm" in vehicles manufactured in or after model year 2000.
