ODI RESUME

Investigation: EA04-006
Prompted By: Preliminary Evaluation (PE) 03-044
Date Opened: 02/23/2004 Date Closed: 02/10/2005
Principal Investigator: Scott Yon
Subject: Accelerator Pedal Sensor (ETC)

Manufacturer: Ford Motor Company
Products: MY 2002 - 2003 F Series And Excursion W/7.3L Diesel and PAP
Population: 98,636

SUMMARY REPORT - ENGINEERING ANALYSIS 04-006**DATE OPENED:** February 23, 2004**DATE CLOSED:** February 10, 2005**SUBJECT:** Failure of the accelerator pedal sensor for the throttle control system.

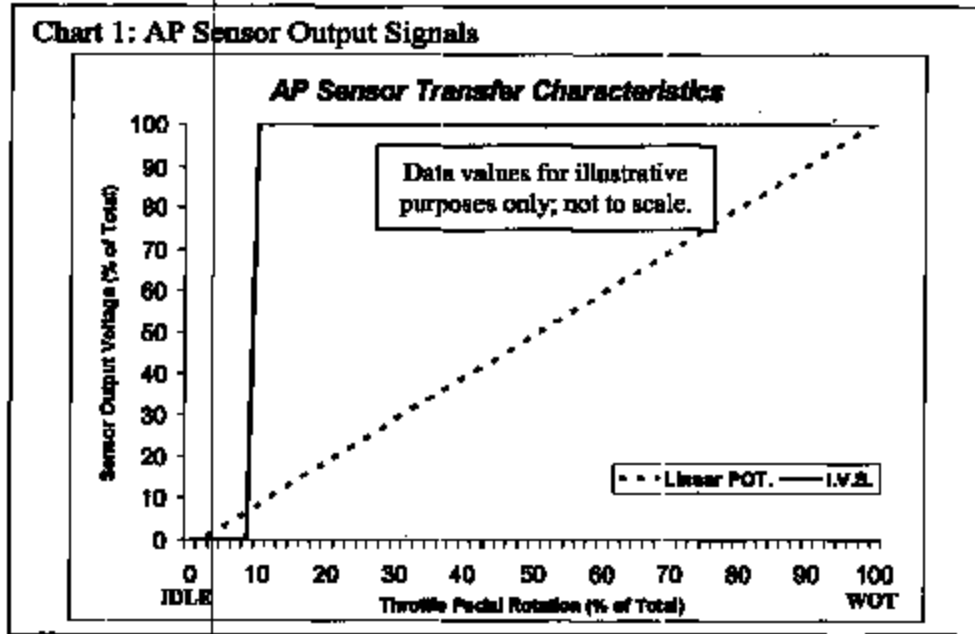
The transfer characteristics of the AP sensor's two output signals are shown in Chart 1. The ECU monitors the proportional signal to establish throttle pedal position. The IVS sensor produces a digital output that changes from a low to high state near the idle position. The ECU compares the two signals in relation to one another. If the signals are implausible, the throttle returns to the idle state and a Diagnostic Trouble Code (DTC) is set in ECU memory. Ford asserts that this functionality is required for compliance with FMVSS 124, the Federal standard for throttle control systems.

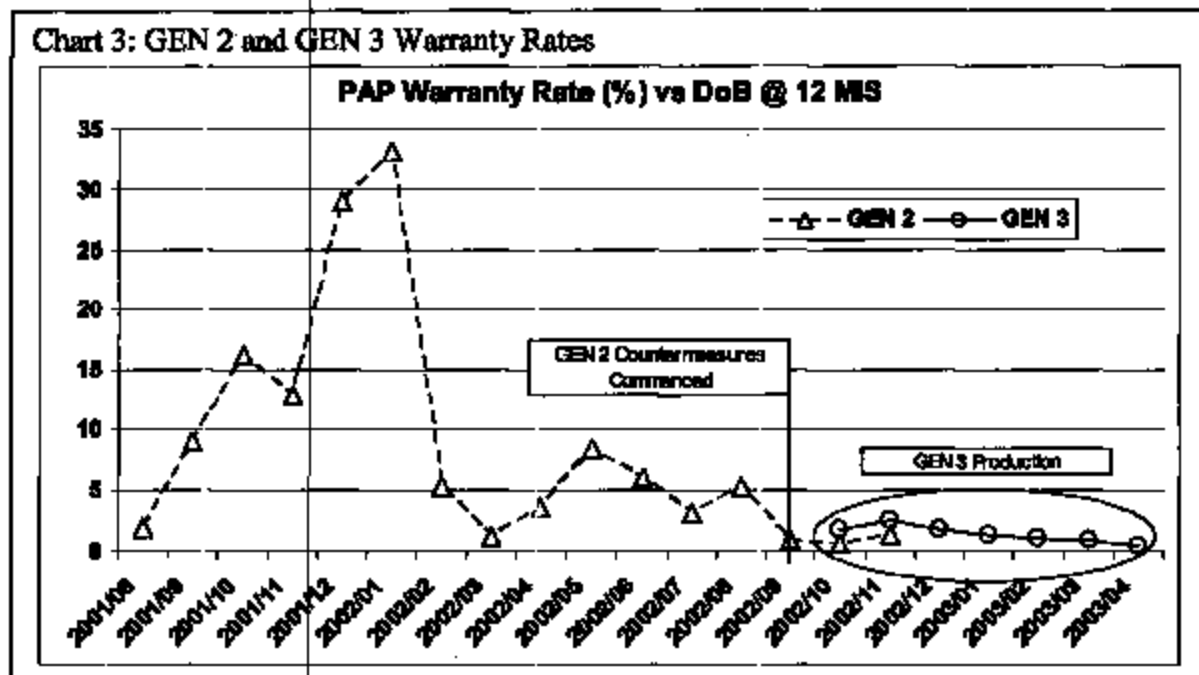
Ford's IR responses contained 58,000 subject vehicle warranty claim records, of which approximately 46,000 records were related to FSA 03B03 repairs. ODI analyzed the remaining 12,000 claims to assess AP warranty performance, noting that average time to failure was about 10 months at about 20,000 miles. Chart 3 below shows warranty rate versus month of vehicle production at one year in service, and identifies the month Ford began implementing sensor countermeasures for the GEN 2 AP⁹. Warranty data for the GEN 3 AP sensor was used by ODI for peer comparison, as shown in chart 3¹⁰. Ford warranty claims
