ENGINEERING ANALYSIS CLOSING REPORT

**SUBJECT: Malfunction of Electric Powered Door Locks
In Model Year 2001 Kia Optima Vehicles**

EA No.: 04-030

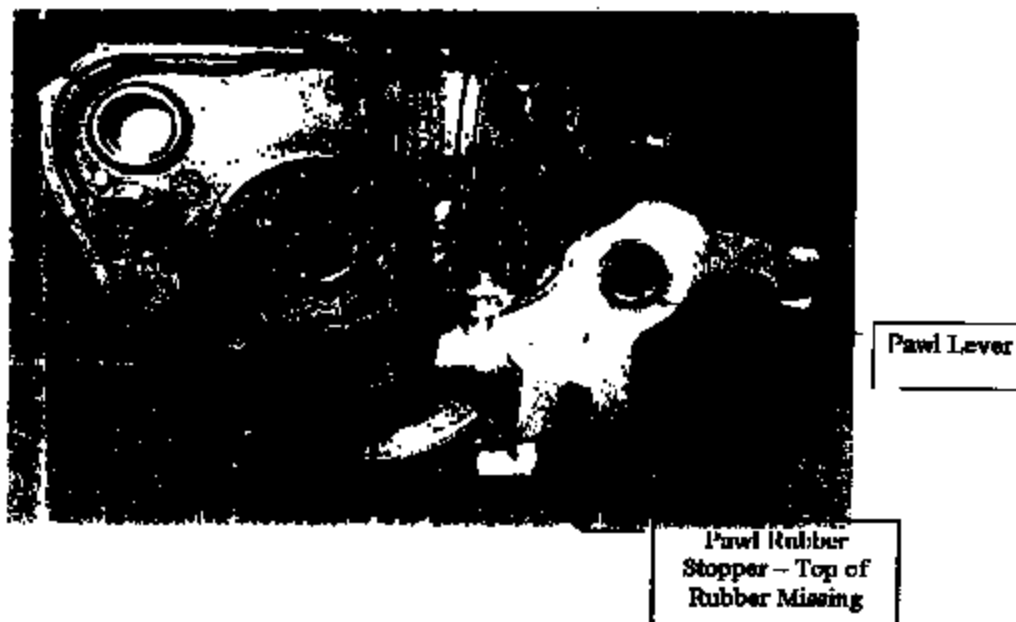
Figure 5 shows close-up details of the door latch assembly. Figure 6 illustrates the close-up details of an internal view of the latch assembly, noting the latch pawl lever and the rubber pawl stopper. In the latter illustration, the top of the pawl stopper is missing, allowing the pawl lever to be mispositioned and, therefore the lock actuator switch contact point will also be mispositioned.

Figure 6. Close-up Internal View of Optima Latch Assembly (shown with damaged rubber pawl stopper) (Source: KMC)

Kia states that the root cause of malfunction of the subject door lock is deterioration due to time and use of the rubber pawl stopper in the latch, as the stopper fails to maintain proper strength and flexibility of the rubber material from which it is fabricated. This mechanical failure is cited as the root cause of malfunction of the subject lock mechanism. When the pawl stopper deteriorates or sustains a certain amount of permanent compression, it may fail to properly position the door latch pawl lever and the location of the contact point in the lock actuator lock switch becomes unstable.

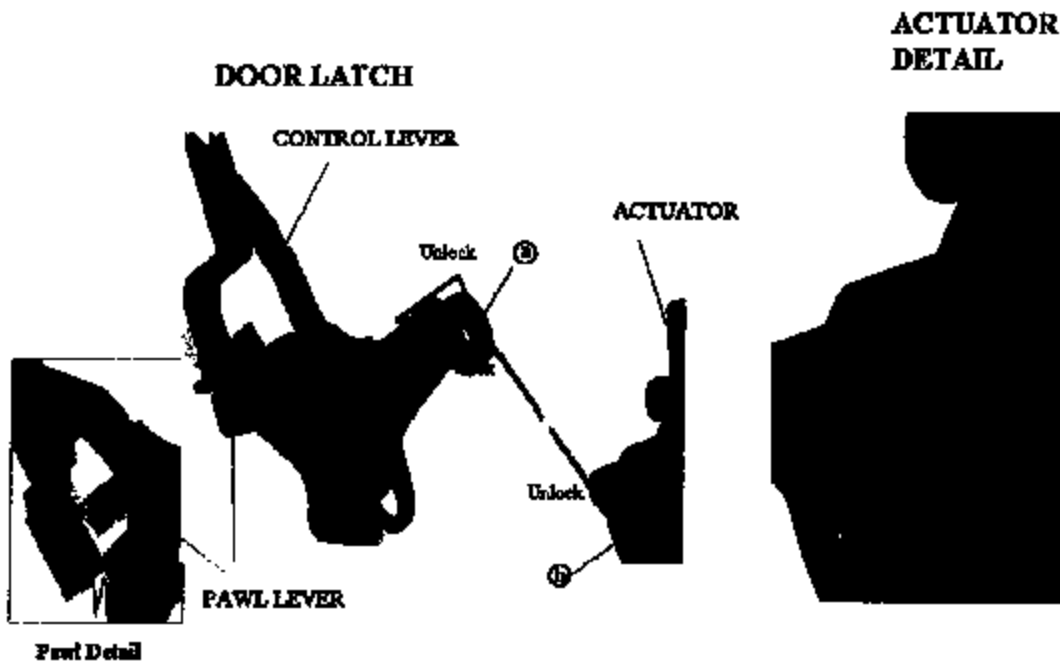
In Figure 7, the door latch pawl is out of its proper position due to deterioration of the rubber pawl stopper. The control lever can not move the pawl lever and the door lock plate cannot move into its proper position. This causes the door lock actuator switch to be positioned in the operational borderline between "lock" and "unlock." In this unstable condition, the actuator switch can send a "lock" signal to the ETACS, which then sends a "lock" signal to all four doors. According to Kia's analysis, this sequence of events describes the type of malfunction that is the subject of this investigation.

Figure 7. Details of Door Latch Components and Lock Actuator (Source: KMC)

As described by Kia, deterioration of the rubber pawl stopper allows the door latch pawl lever to interfere with the control lever, mispositioning the actuator switch in the functional borderline between “lock” and “unlock.” In this unstable position the actuator switch can send a “lock” message to the actuator, locking all passenger doors with the auto-lock function. A subsequent attempt to unlock the system will then unlock the doors, but it can also return the actuator switch to an unstable position, due to the deteriorated condition of the pawl stopper. If the actuator switch then reads that the lever is in the “lock” position, after approximately one second the switch will send that signal to the actuator, and the ETACS will then re-lock all four doors.

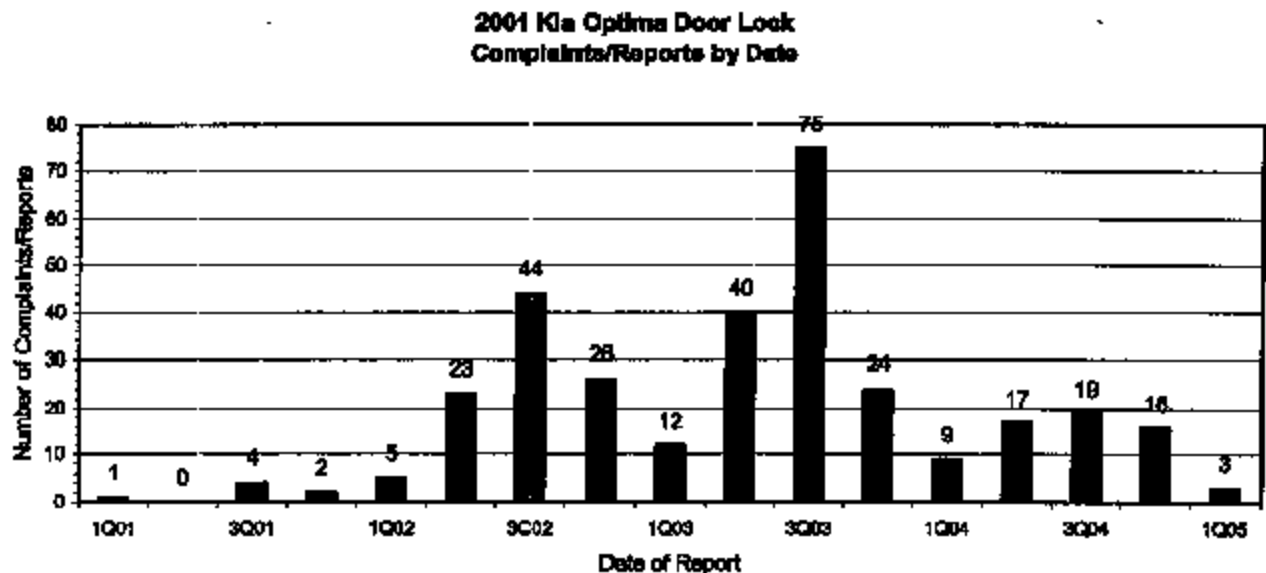
The consumer complaints and field reports received by ODI and submitted to Kia were evaluated for evidence of any type of associated trend. The numbers of incident reports were plotted against incident dates, and the results are shown in Figure 8. The graphic shows that the door lock malfunctions did not begin to occur in significant numbers until after the end of production of the subject vehicles. The numbers of incidents continued in significant numbers, reaching a peak during the third quarter of calendar year 2003. There is no consistent rate of increase in the number of incident reports through the end of calendar year 2004, and there was no spike in the number of consumer complaints following the opening of ODI's investigation.

Figure 8. Self-Locking Incidents by Date of Report

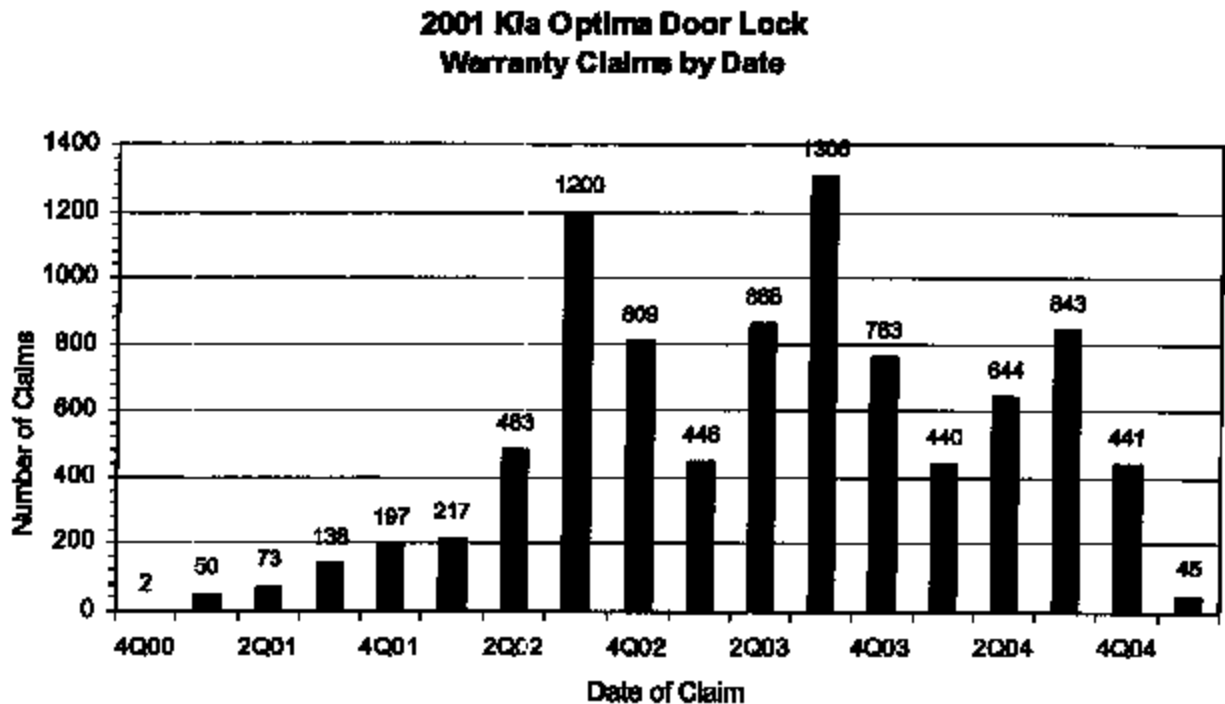
The numbers of warranty claims were also plotted versus the date of claim to evaluate the existence of any detectable trend. Similar to the incident reports from consumer and field reports, the warranty claims peaked in the third quarter of calendar year 2003. A graphic of these data is shown in Figure 9.

Figure 9. Warranty Claims by Date of Claim
