DP04-006

Attachment #Q6

Safety Recall: Ignition Switch Key Interlock

(Supersedes 03-088, dated January 8, 2004)

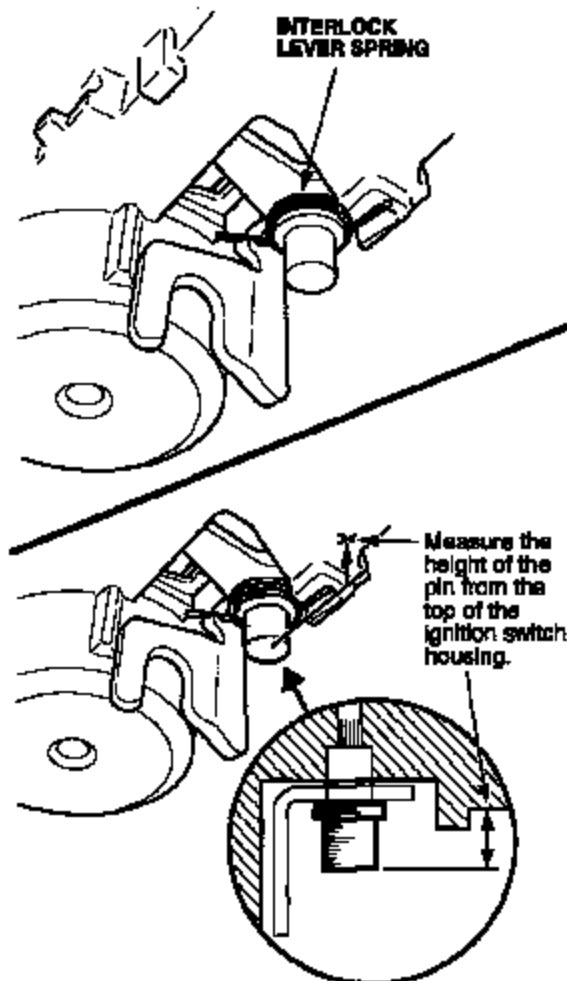
5. Note the position of the interlock lever spring; you'll need to install the new spring the same way. Also, measure the installed height of the interlock lever pin with vernier calipers. This measurement will be used in both repair procedures.

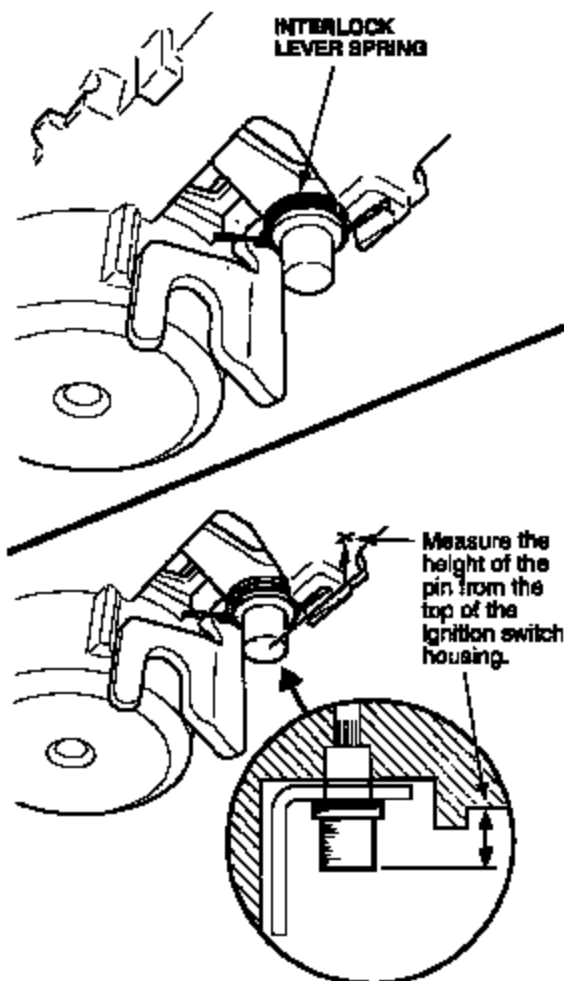
5. Note the position of the interlock lever spring; you'll need to install the new spring the same way. Also, measure the installed height of the interlock lever pin with vernier calipers. This measurement will be used in both repair procedures.
