Applies To: See VEHICLES AFFECTED

April 30, 2004

Safety Recall: Ignition Switch Key Interlock

(Supersedes 03-088, dated January 8, 2004)

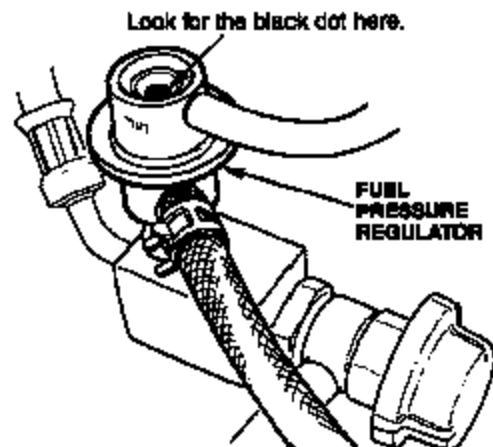
During the '00 model year, the factory changed the fuel pressure regulator and the PCM in '00 Accord V6 4-door models (from VIN YA[redacted] and 2-door models (from VIN YA[redacted] to improve engine starting after hot soak. The new fuel pressure regulator is set to a range of **48 to 54 psi** instead of **41 to 48 psi**, and is marked with a black dot so it's easy to identify. The new PCM mounts with three bolts instead of two.

The PCM and fuel pressure regulator must be matched to each other; otherwise, performance drops over time and the MIL eventually comes on. When ordering a replacement PCM, make sure you're ordering the unit that's matched to the fuel pressure regulator installed in the vehicle.

To keep things straight, check the fuel pressure regulator for a black dot. If you see a black dot, order PCM P/N 37820-P8C-A55, H/C 6828479. If you don't see a black dot, then order P/N 37820-P8C-A53, H/C 6358469.

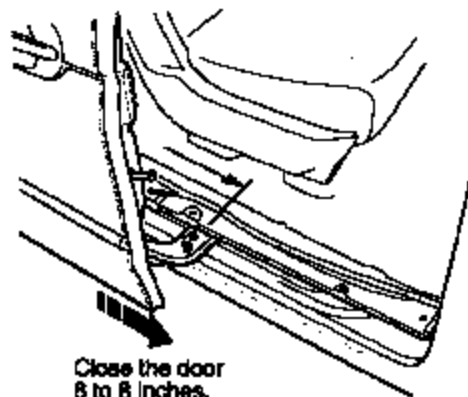
If an object gets accidentally wedged between the power sliding door and the vehicle body while the door is opening, it puts an abnormal amount of outward pressure on the door. This can force the lower roller past the lower roller plate, causing the door to come off its track.

5. Remove the stop spring mounting bolt. Remove and discard the stop spring.
