**PE04-078**

**FORD**

**BOOK 2 OF 12**

**ATTACHMENT F**

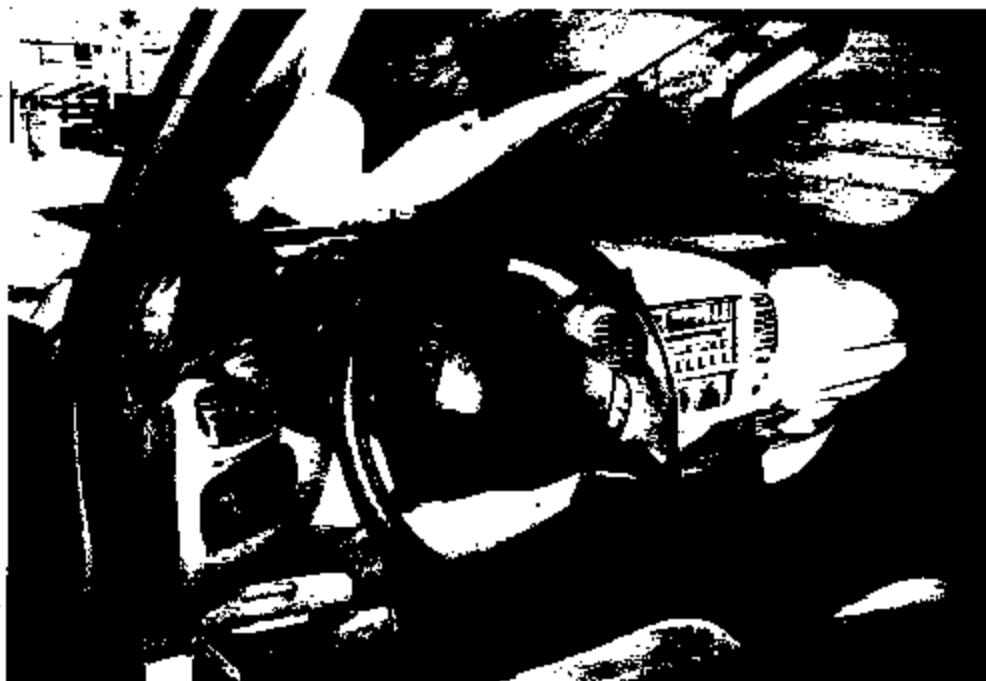
5. We observed primarily the intact, and attached, steering column.
6. We observed an only mildly burned vehicle dash. Ninety percent (90%) of the vehicle dash was intact and attached. The only section of the vehicle dash that was burned was that immediately above the steering column on the top face on the top portion of the left side face. This burn within the vehicle dash was distinctively upper level, consistent with a fire traveling from the engine compartment into the interior, and not vice versa.

12. Overview of the burn experienced by the vehicle dash.
