**PE04-078**  
**FORD**  
**1/28/2005**  
**BOOK 3 OF 12**  
**ATTACHMENT F**  
**PART 1 OF 6**

**B. PHOTOGRAPHS**

# Interscience, Inc.

Re: Our Project No: L0500-02  
Insured: [REDACTED]  
Claim No: [REDACTED]  
Date of Loss: April 27, 2004  
Date of Notification: May 4, 2004  
Date of Inspection: May 11, 2004

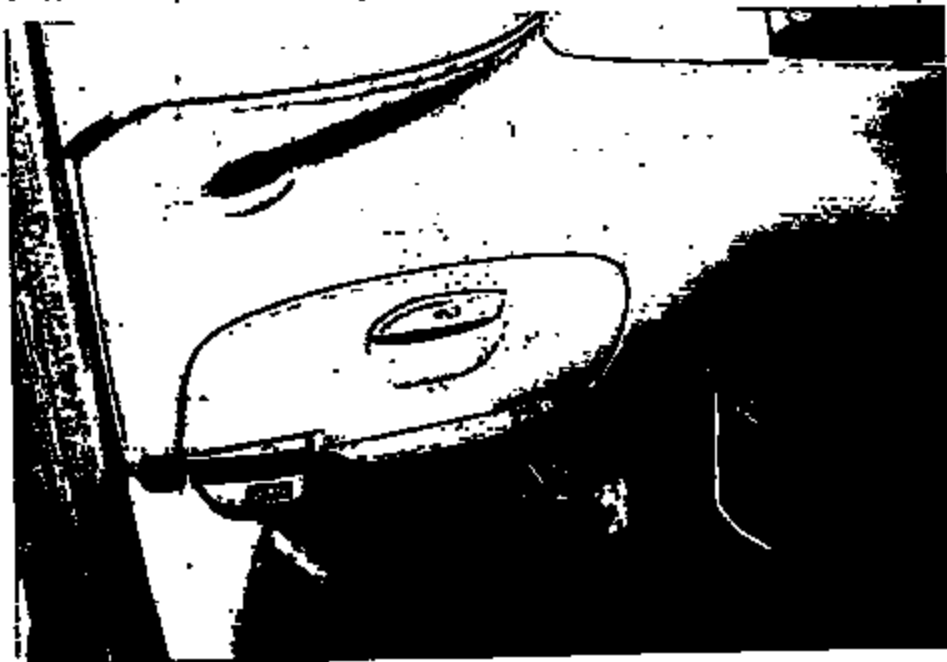
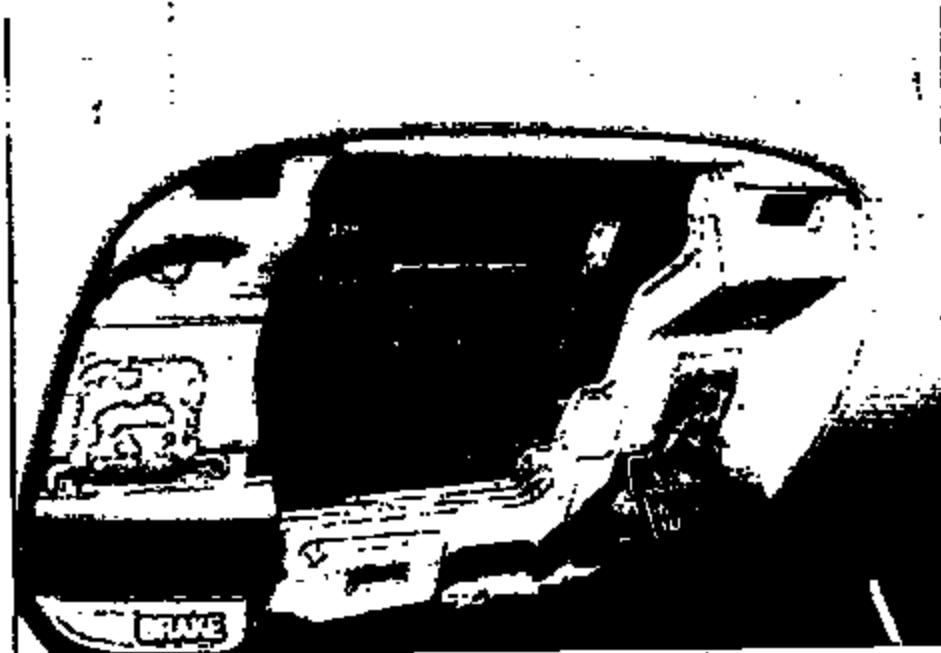
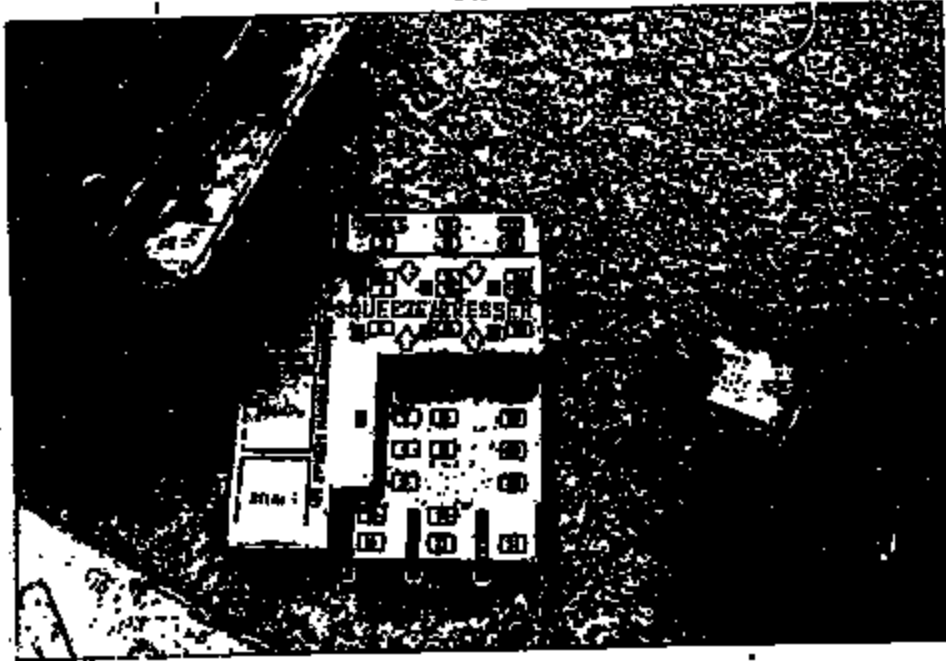
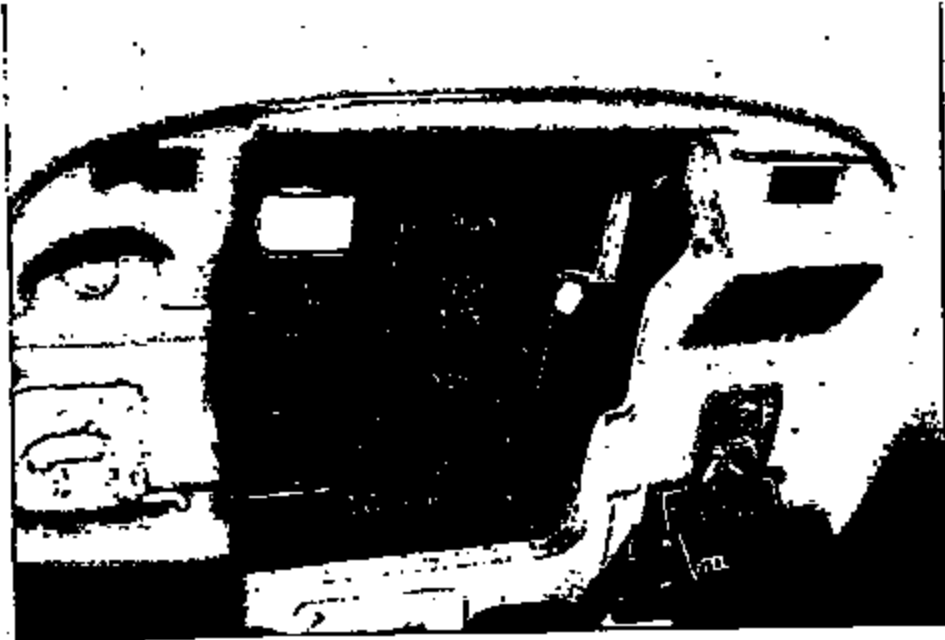
The interior fuse panel was examined and five fuses were observed to have been blown. The fuse diagram was not available for identifying the circuits served by the fuses.

52-55. Views of the interior fuse panel of the vehicle.
