**PE04-078**

**FORD**

**BOOK 5 OF 12**

**Fire Cause Examination on a 2000 Ford F150  
Pickup Truck at Hixson Ford Dealership  
in Monroe, Louisiana**

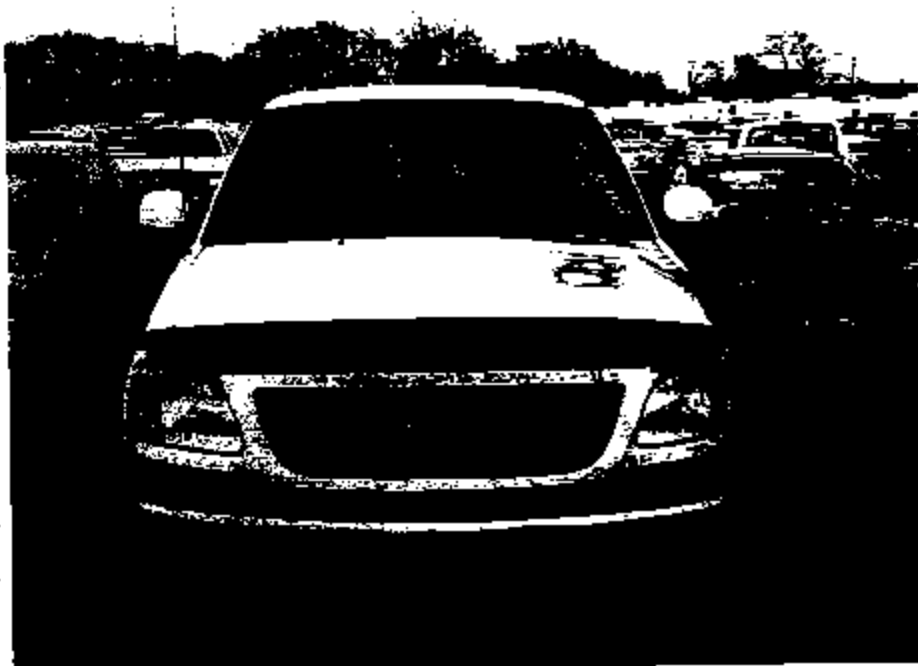
**Photograph 1: Front of the Ford F-150**

The F-150 had sustained heavy fire damage to the driver's side rear of the hood. The driver's side wiper assembly was partially consumed and there was a heavy accumulation of soot to the exterior surface of the driver's side windshield. The combustible light assemblies, grill, and bumper covering were all intact. Texas license plate [REDACTED] was affixed to the front of the vehicle (Photograph 1).

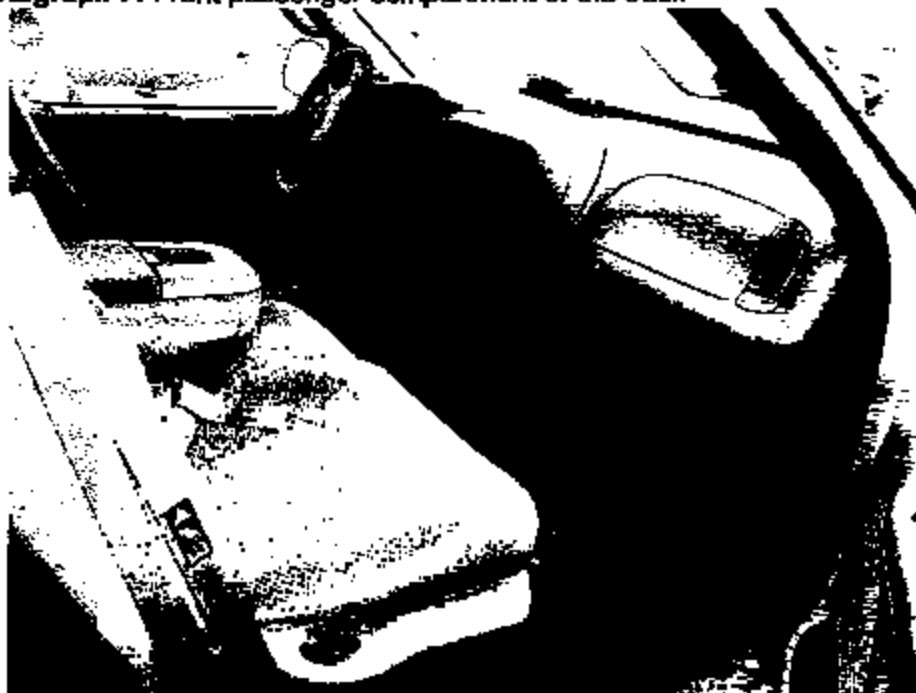
**Photograph 7: Front passenger compartment of the truck**

There appeared to be no fire or smoke damage to the front passenger's side of the passenger compartment. The dash and all of its components were intact as were the combustible seating and flooring materials. There was no soot accumulation on the seating surfaces (Photograph 7).

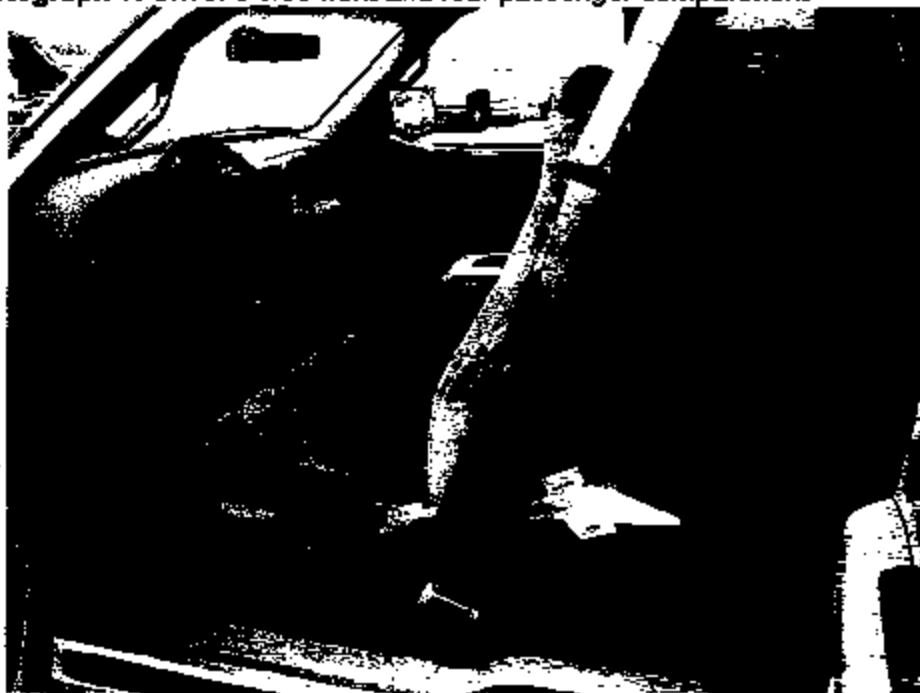
Photograph 9: Driver's side front and rear passenger compartment

The rear seating area on the driver's side, in the passenger compartment, was found in the same condition as the passenger's side. The front driver's side compartment was also intact and undamaged by the fire (Photograph 9).
