PE04-078

FORD

BOOK 5 OF 12

ATTACHMENT F

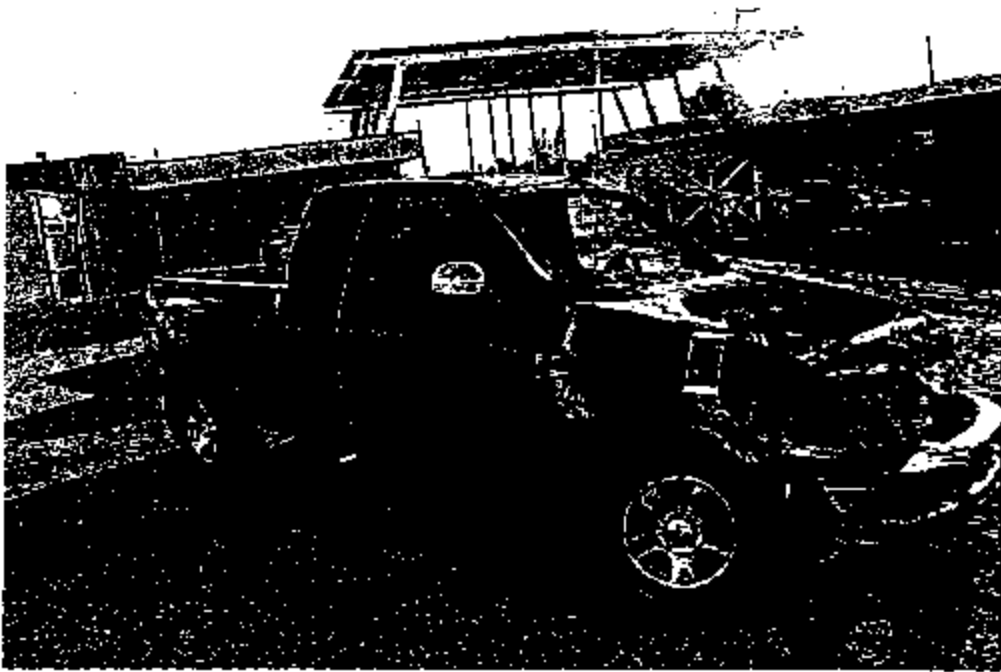
#1 - Right front 3/4 view

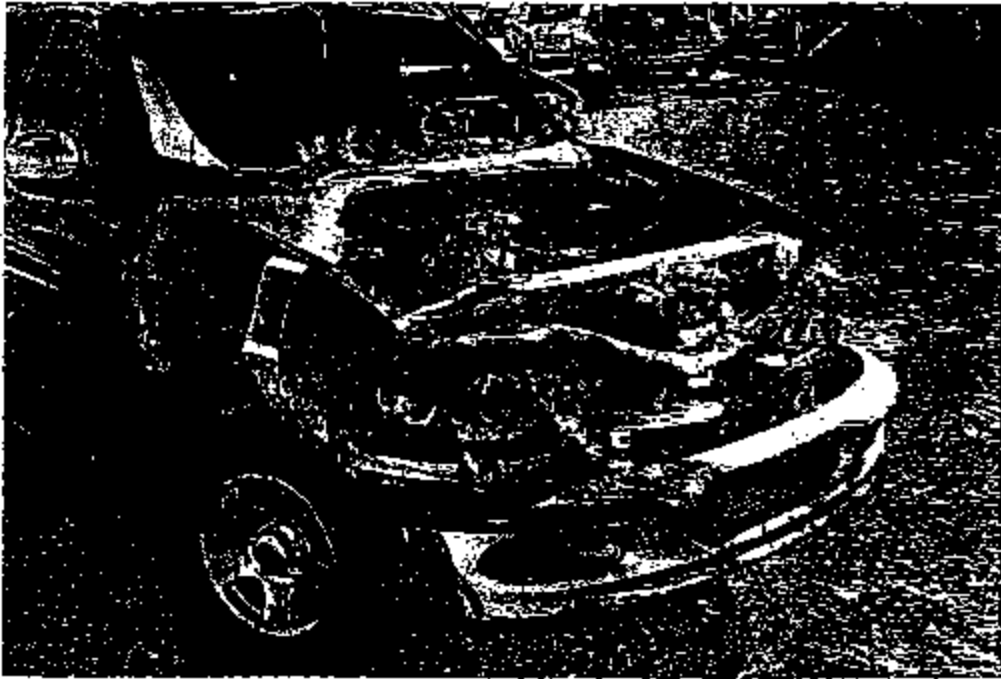
#2 - Severe fire damages sustained at the front of the vehicle

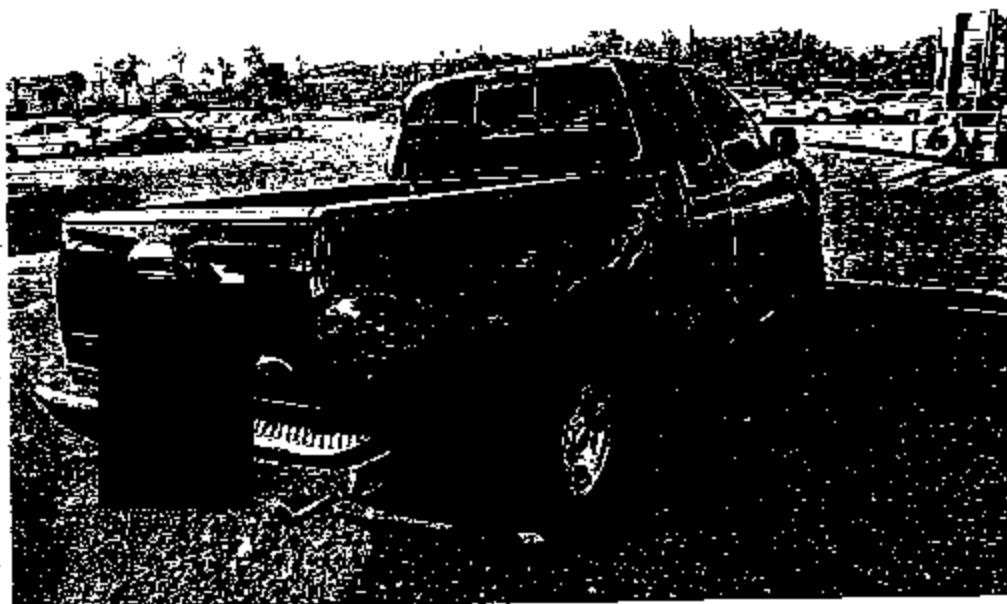
#3 - Right rear 3/4 view

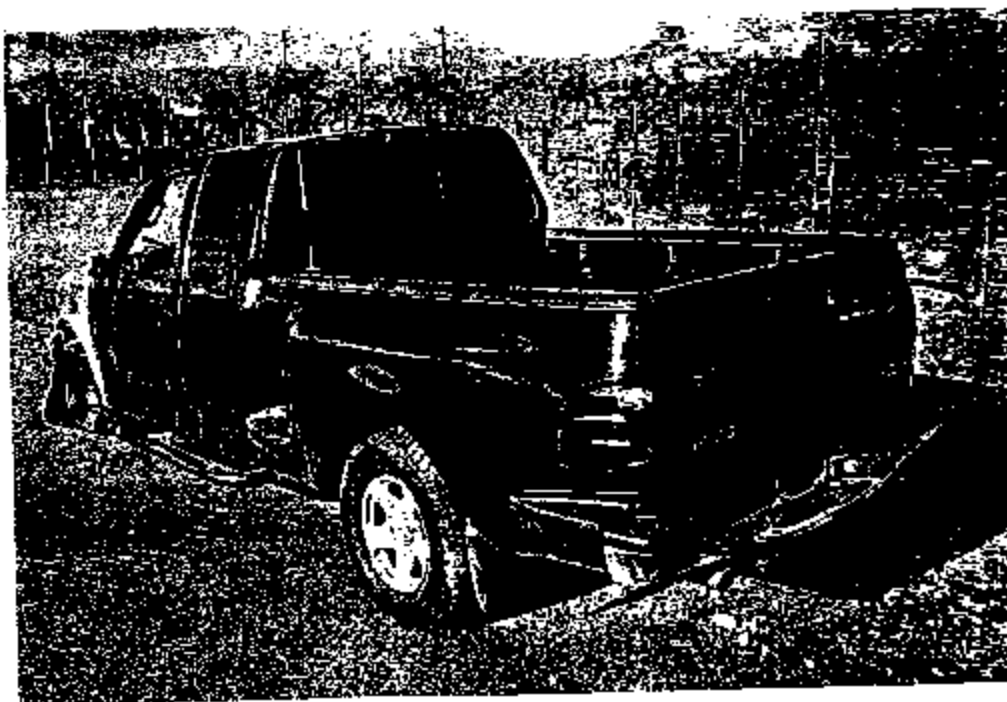
#4 - Left rear 3/4 view

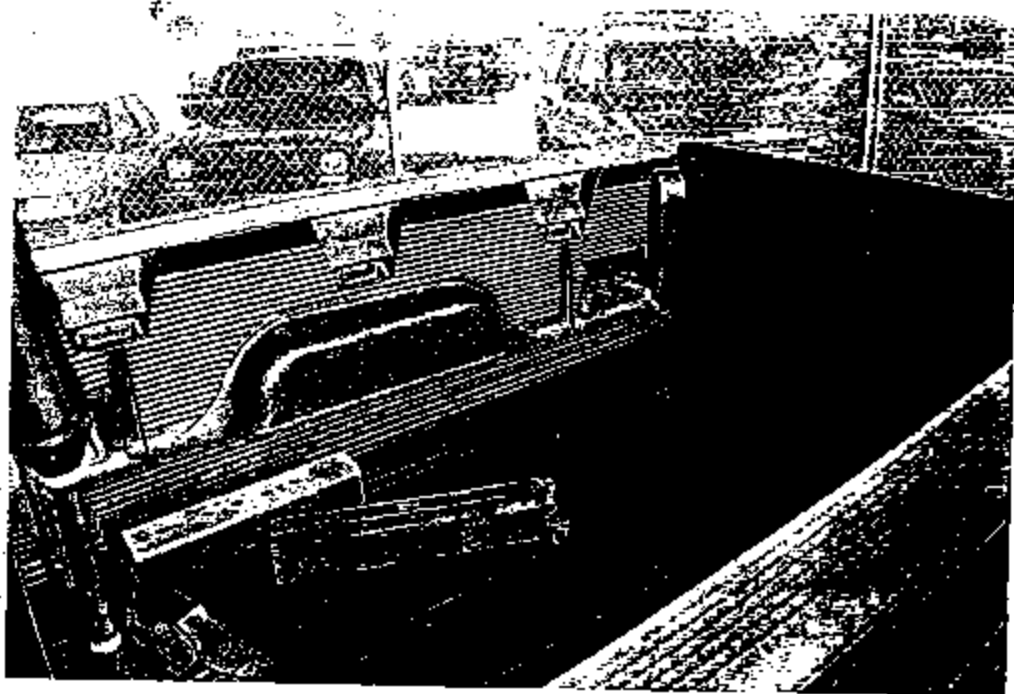
#5 - No damage evident to the bed

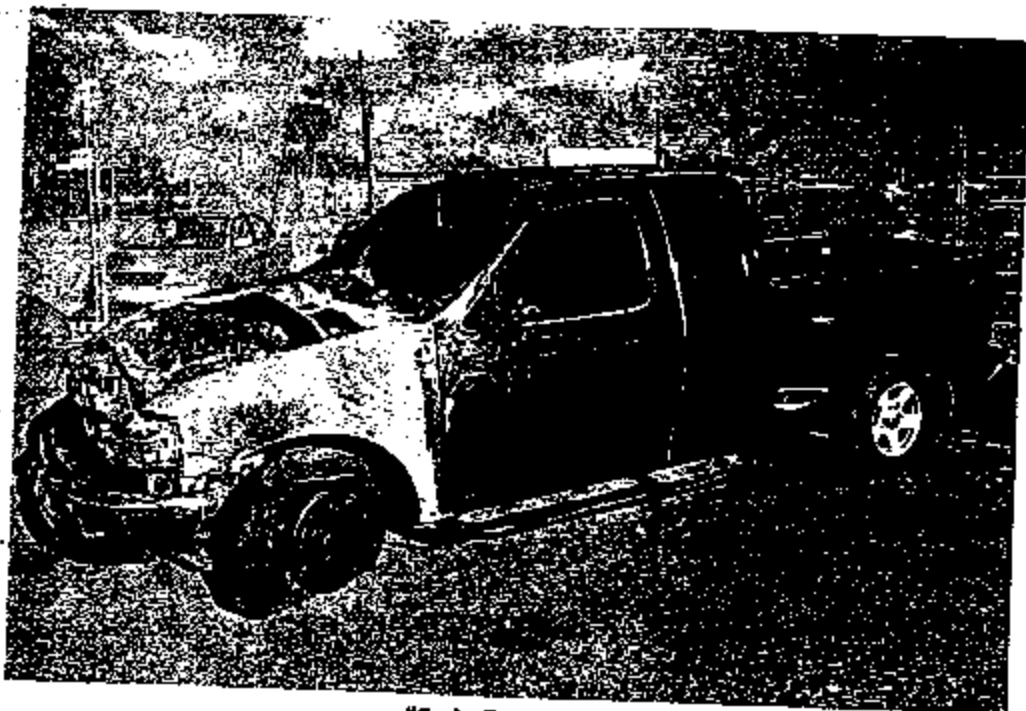
#6 - Left side view

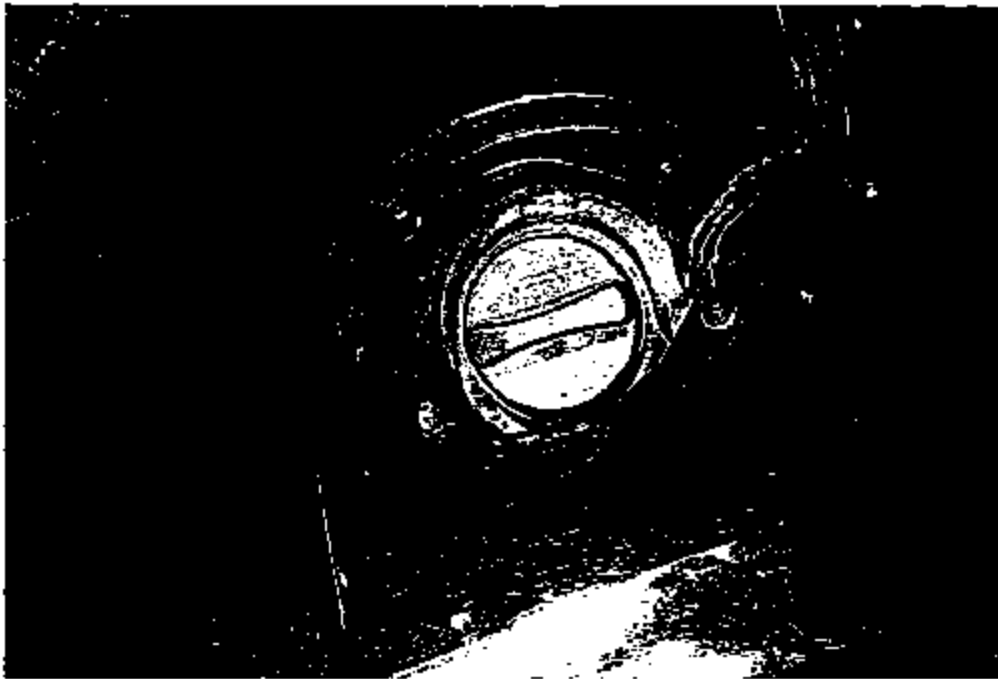
#8 - The fuel cap was properly secured and in its proper place

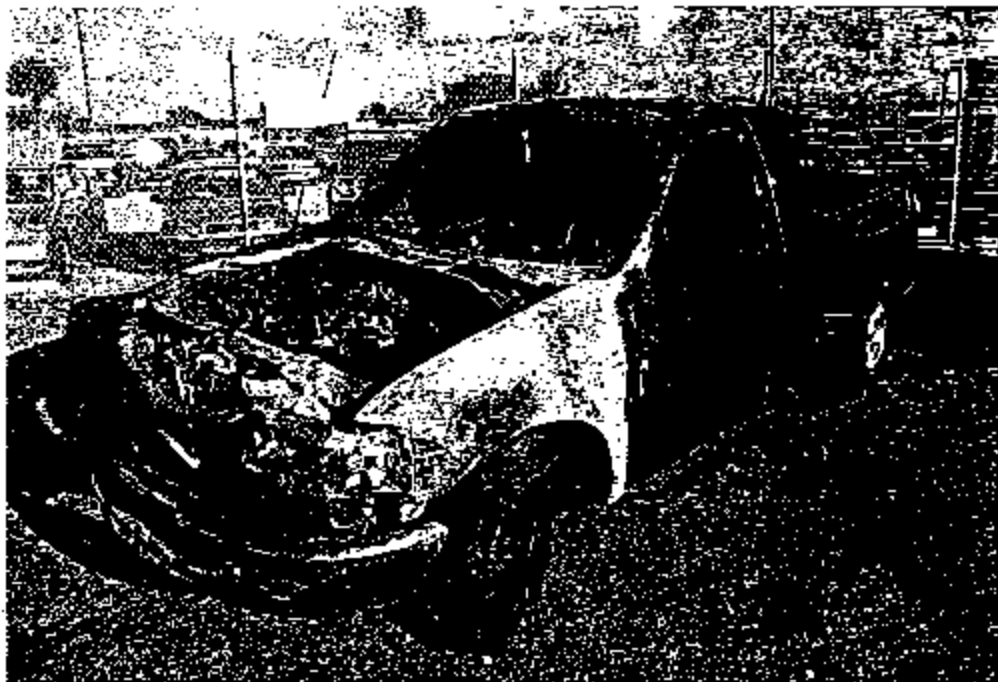
#9 - Left front 3/4 view

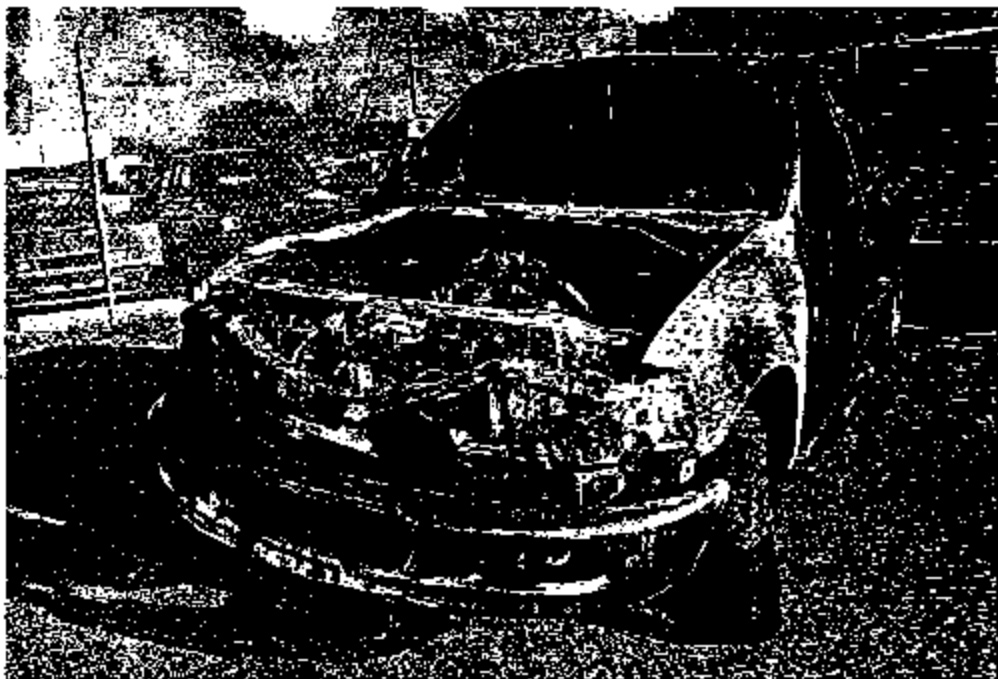
#10 - Front end

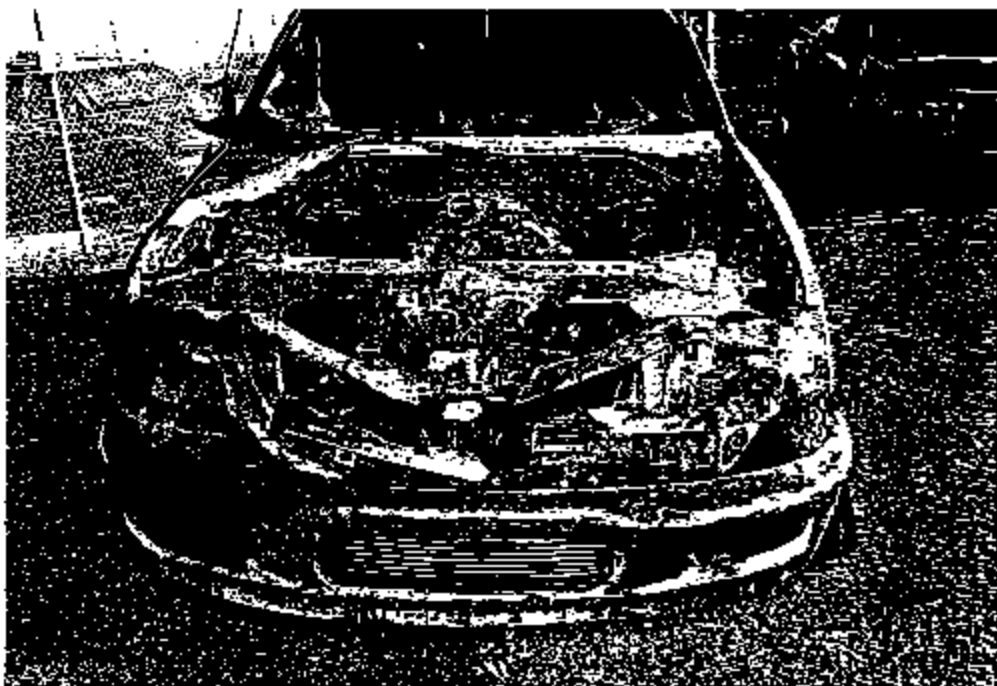
#11 - The radiator and A/C condenser had either melted or been consumed

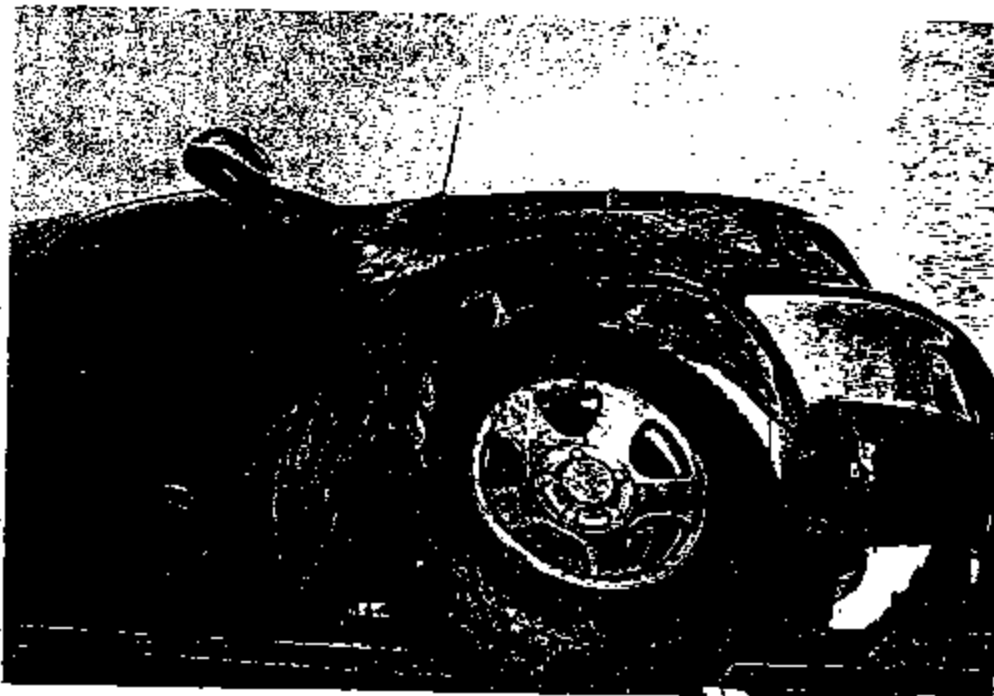
#13 - Moderate fire damage sustained at the right front area

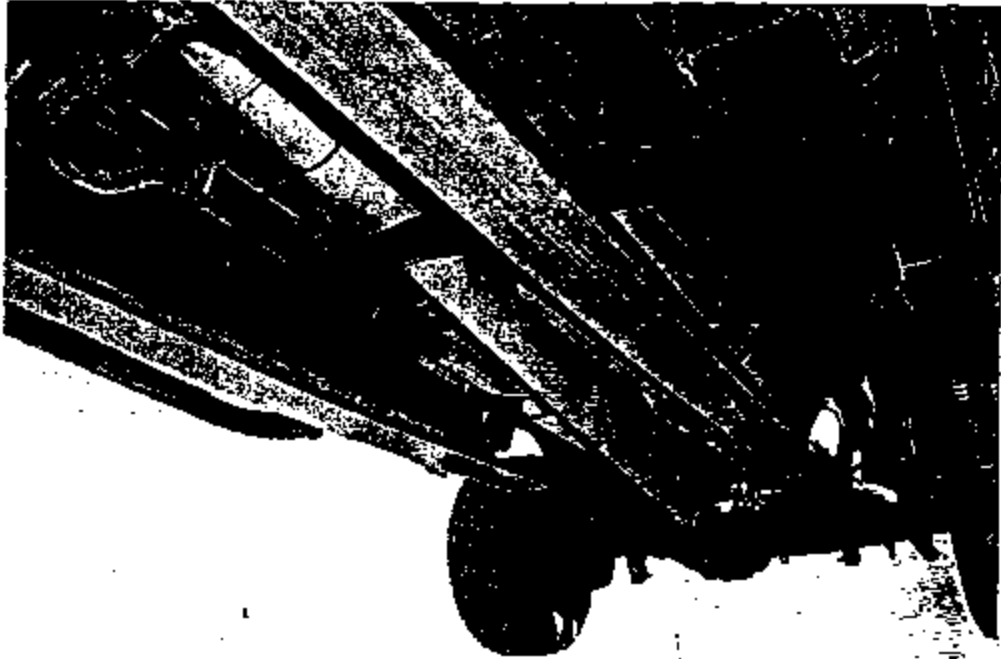
#17 - No fire damage sustained at the underbody

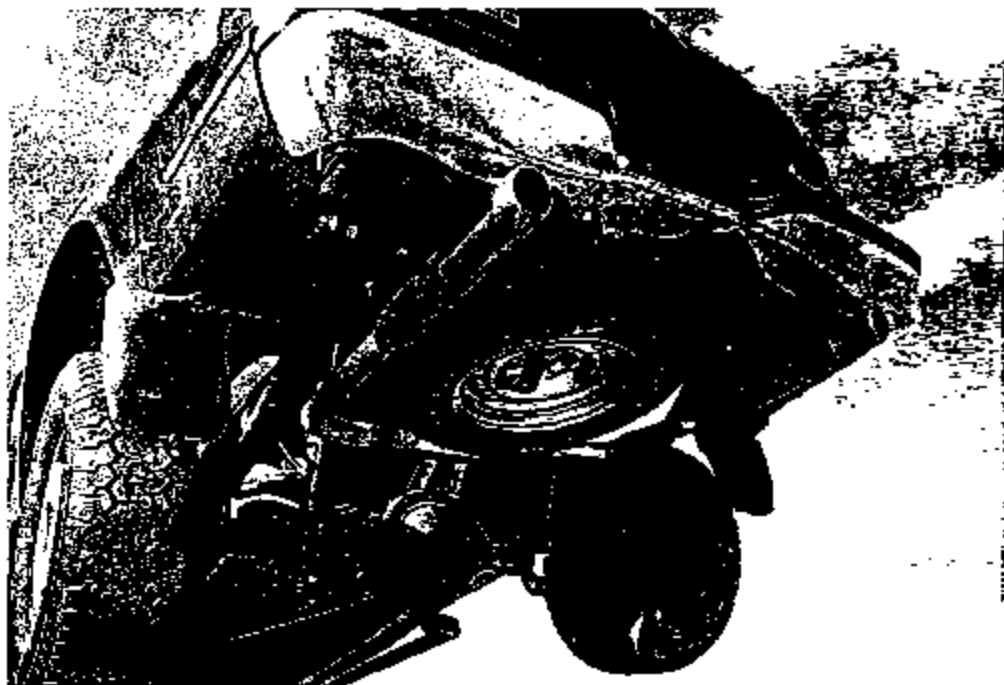
#19 - No damage evident at the rear of the undercarriage

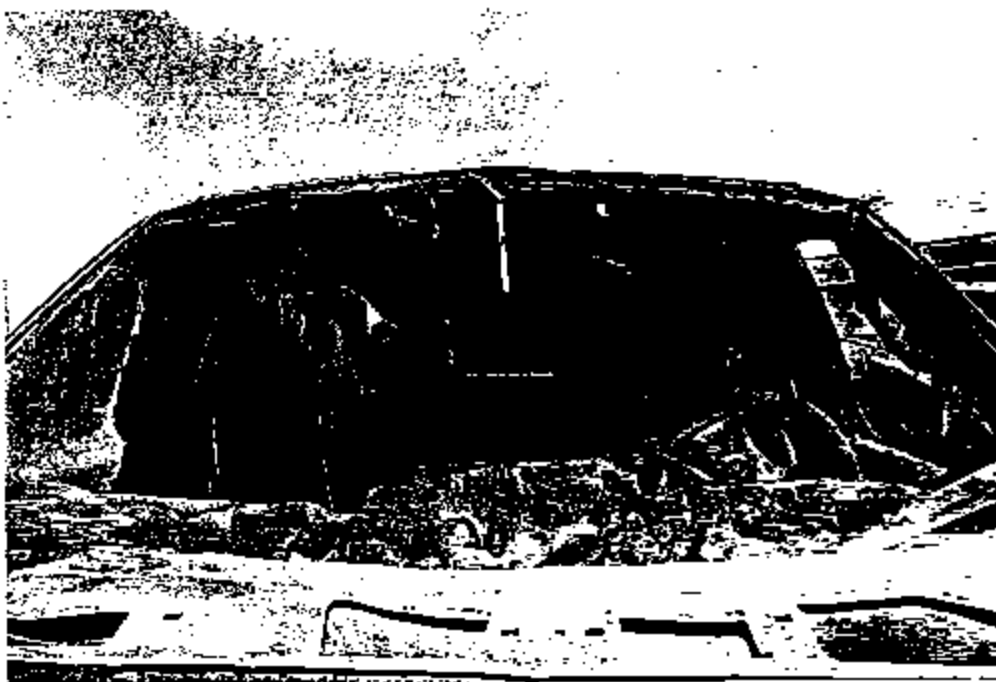
#38 - The passenger compartment as viewed over the cowf area

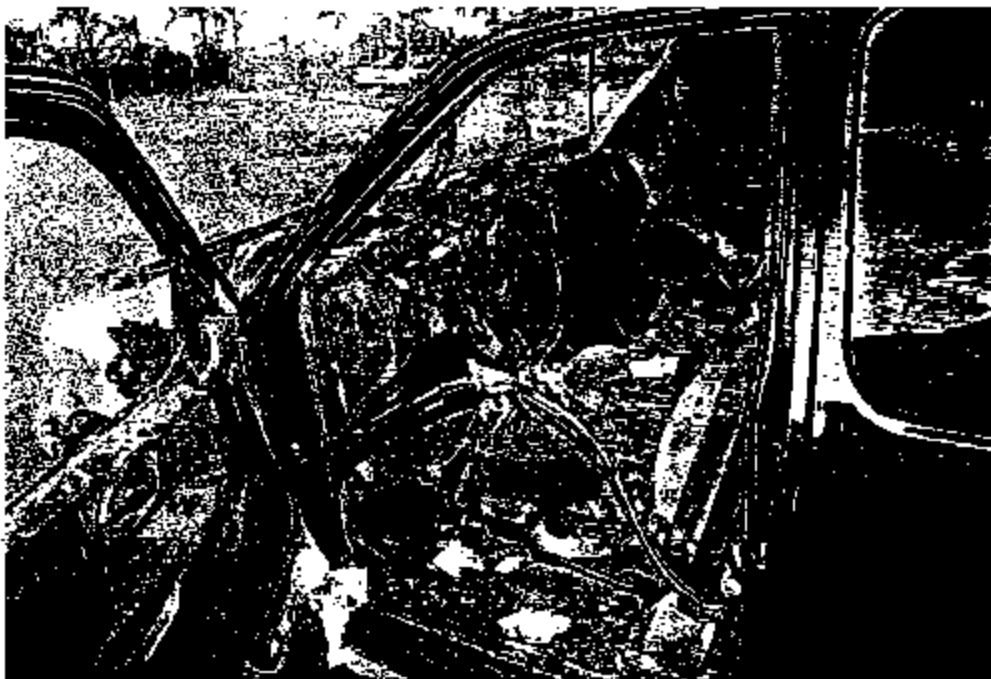
#40 - The passenger compartment as viewed through the driver's door opening

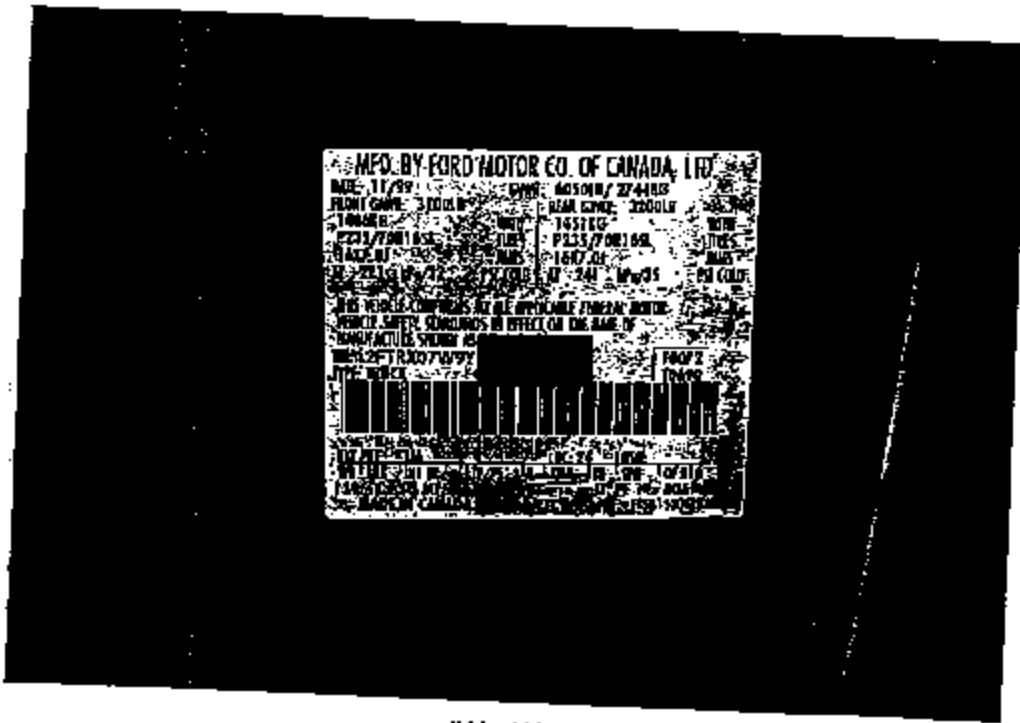
#41 - V.I.N.
