PE04-078

FORD

ARBITRATIONS & INSPECTIONS

The purpose of this assignment was to determine the origin and cause of a fire in the below referenced 2001 Ford Expedition, hereafter referred to as the subject vehicle, that reportedly occurred shortly after the vehicle had been parked.

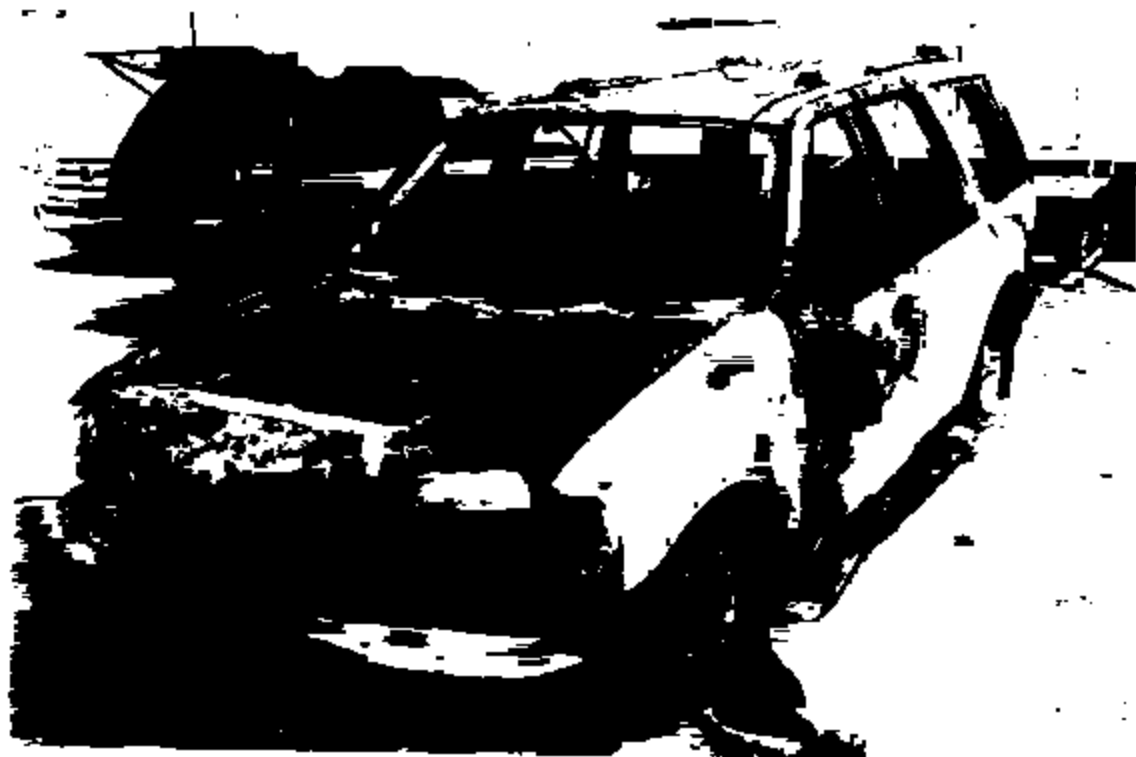
#1 - Left front 3/4 view

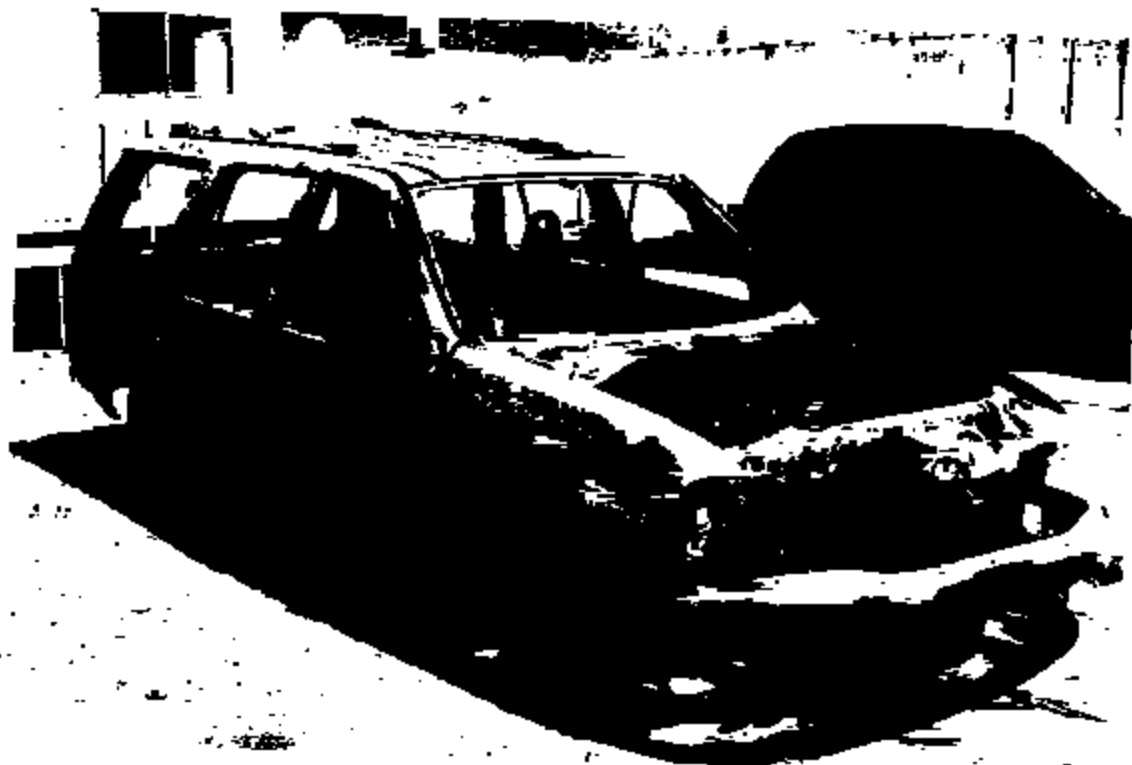
#3 - Right front 3/4 view

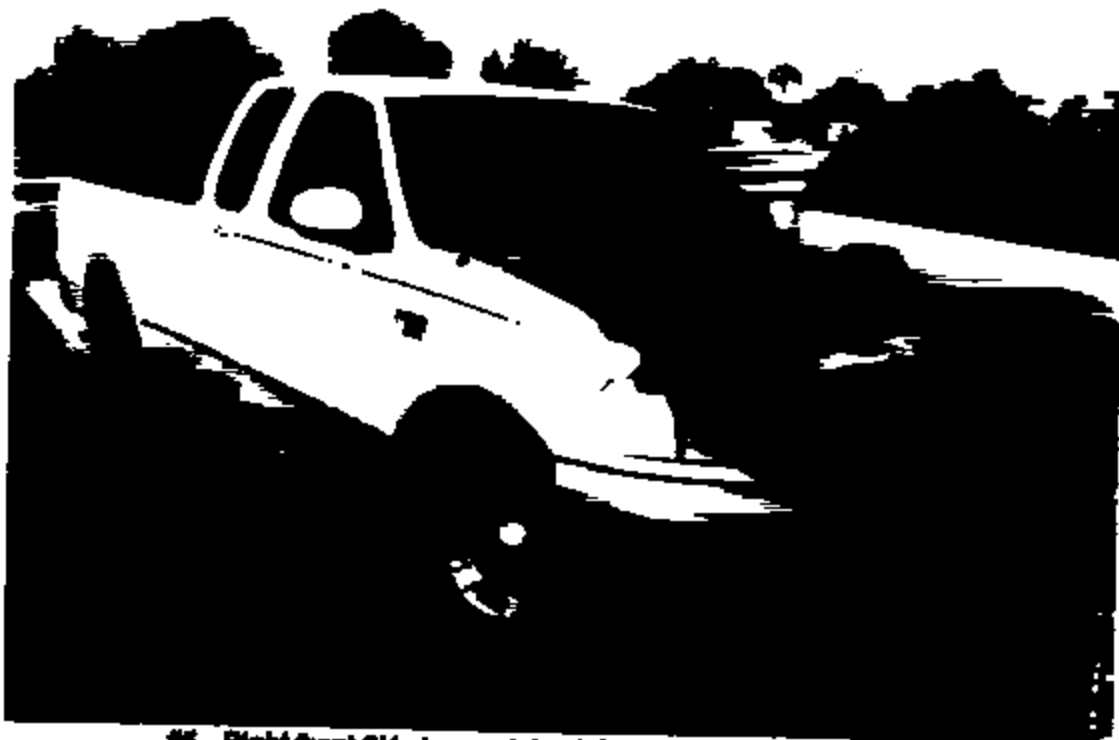
#5 - Right front 3/4 view - minimal damage on right side
