PE04-078

ATTACHMENT F

3.0 EXAMINATION OF VEHICLE

4.0 CONCLUSIONS

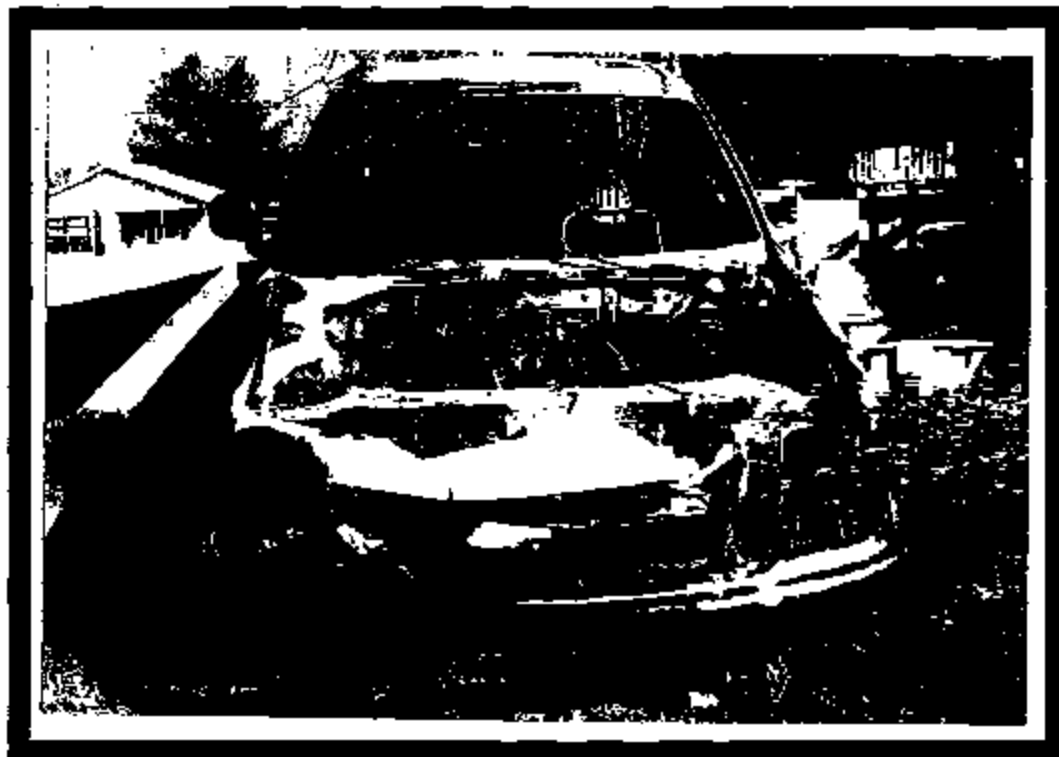
Photograph: #2 Transportation Technology : 21004

Note: Front view of fire damaged vehicle.
