PE04-078

FORD

The purpose of this assignment was to determine the origin and cause of a fire in the below referenced 2000 Ford F150 pickup truck, hereafter referred to as the subject truck, that had been parked for approximately 20 minutes prior to the fire's occurrence.

The purpose of this assignment was to determine the origin and cause of a fire in the below referenced 2000 Ford F150 pickup truck, hereafter referred to as the subject truck, that reportedly occurred while it was parked.

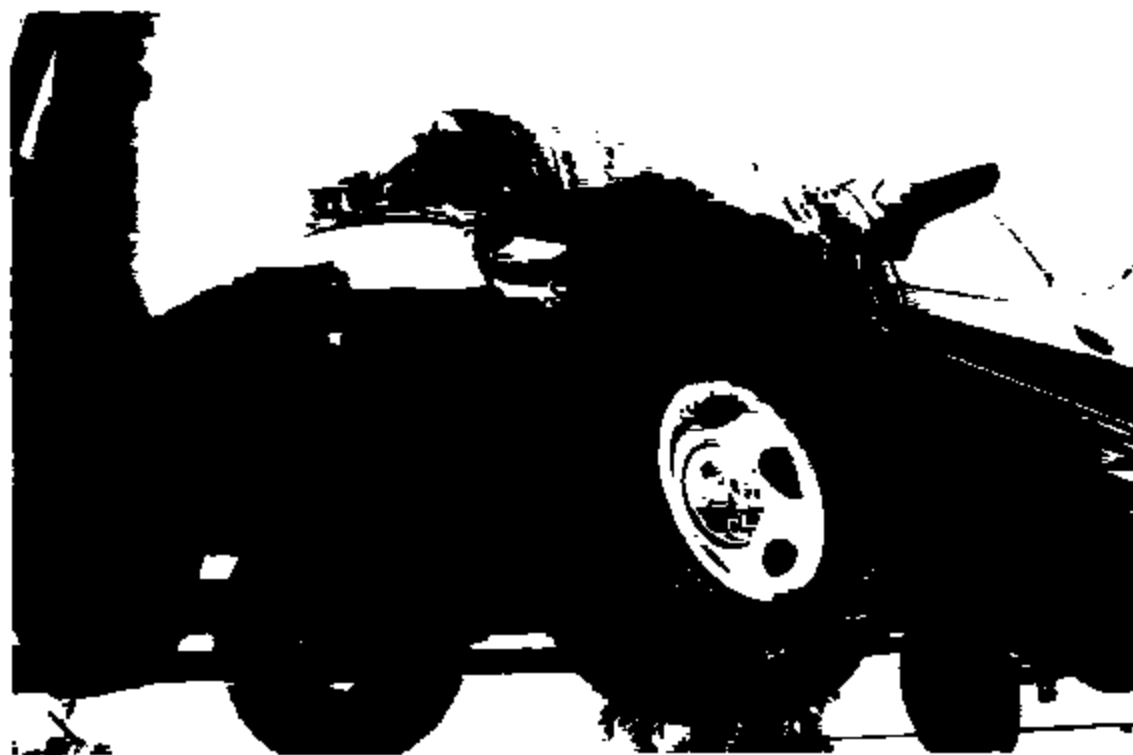
#2 - The left front fender was fire scorched

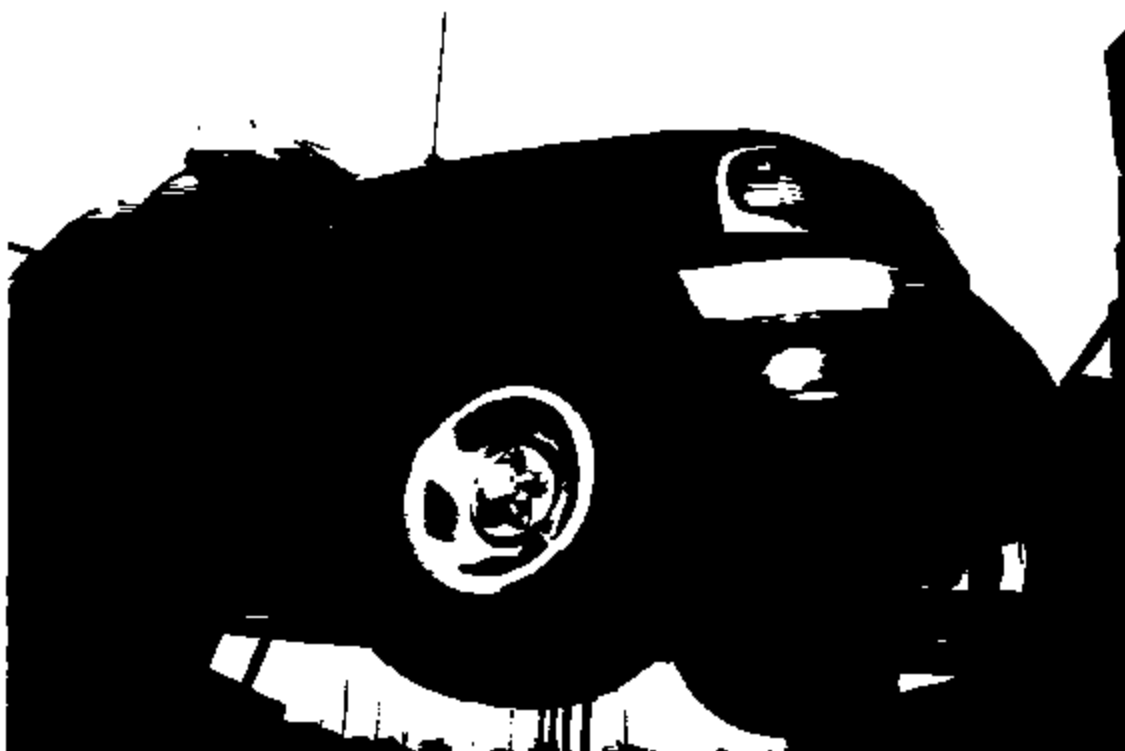
#10 - No fire damages evident at the right front corner

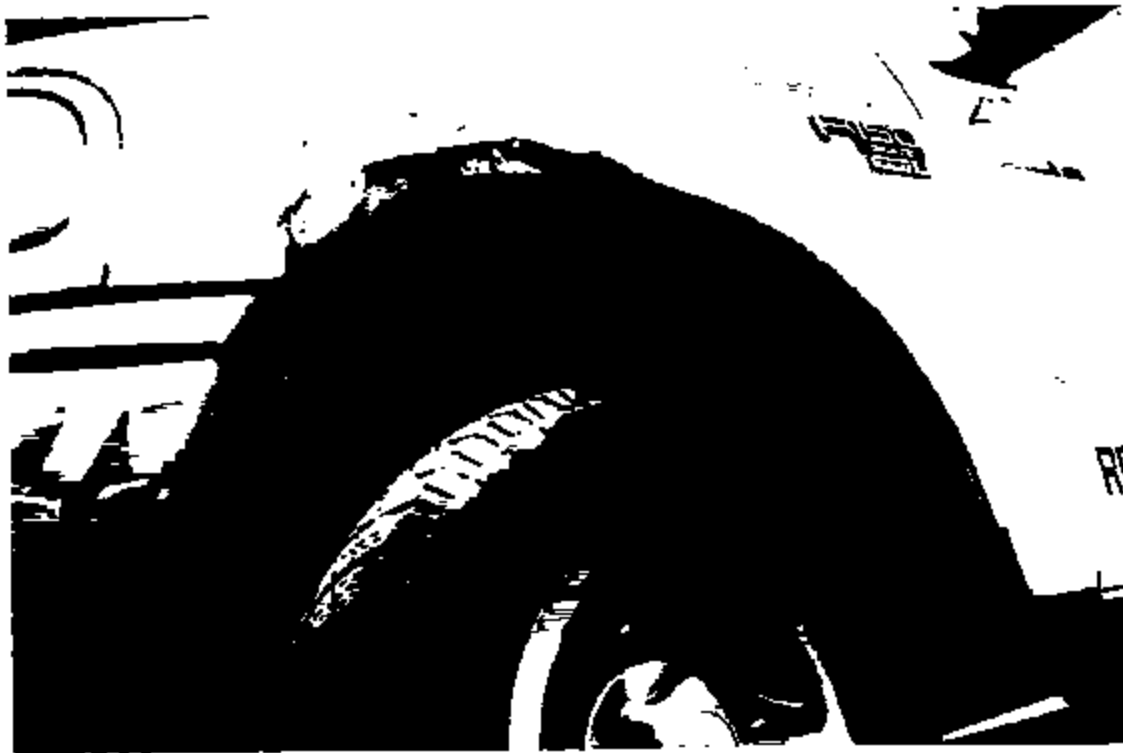
#19 - The left inner fender panel had melted
