RQ04-011
FORD
APRIL 26, 2005
REQUEST 8
PART 2 OF 4
BOOKS 30 OF 43

GLOBAL BUCKLES WARRANTIES

SEAT BELT BUCKLE INSPECTION AND/OR REPLACEMENT PROCEDURE

Subject: 2001 Expedition/Navigator Front Seat Belt Replaced After Recall

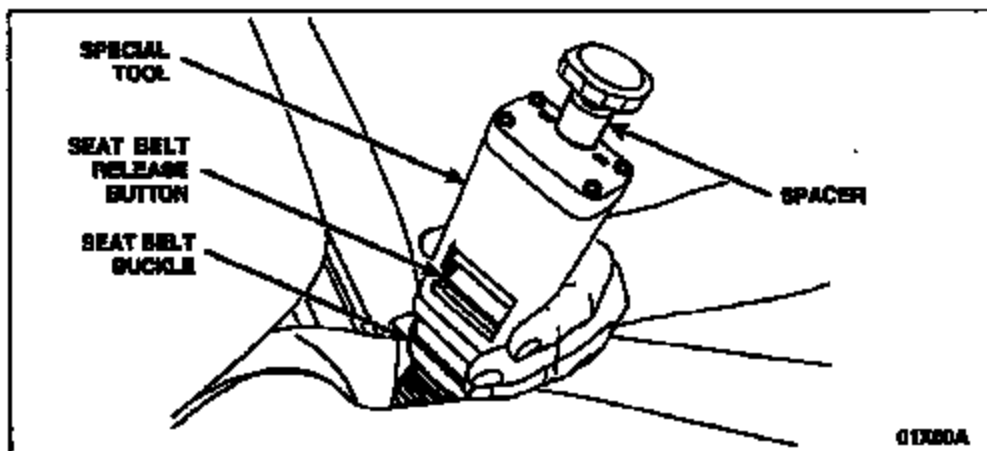
**FIGURE 1**

⚠ WARNING: FAILURE TO USE THE SPECIAL TOOL AS INSTRUCTED IN THIS INSPECTION CAN ALLOW A FAULTY BUCKLE TO PASS THE INSPECTION. MAKE SURE TO USE THE TOOL EXACTLY AS INSTRUCTED IN THE INSPECTION PROCEDURE.

⚠ Press and release the red seat belt release button located on the driver side seat belt buckle. Then, install the special tool onto the driver side seat belt buckle and hold it in place. See Figure 1.

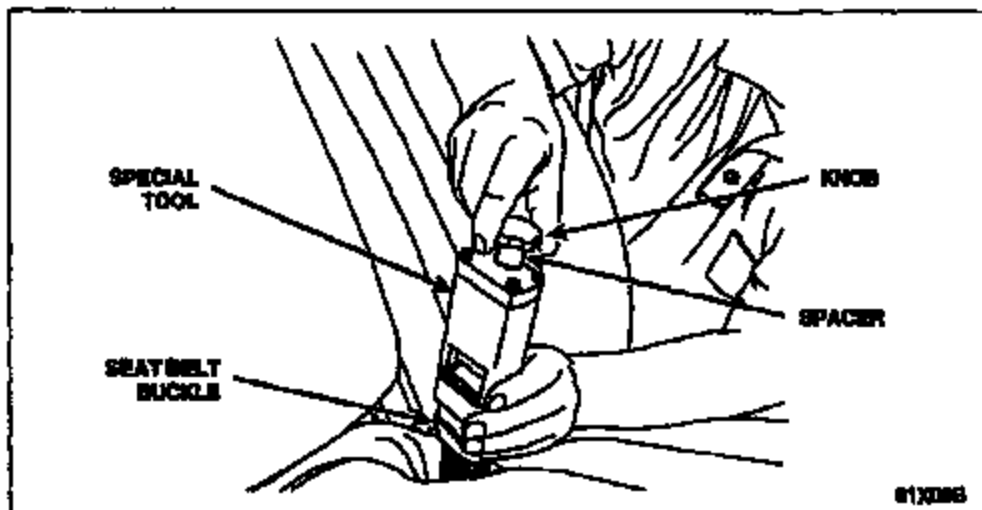
FIGURE 2

2. **WARNING: MAKE SURE YOU TURN THE KNOB ON THE SPECIAL TOOL SLOWLY IN THIS STEP. FAILURE TO DO SO MAY RESULT IN A FAULTY BUCKLE PASSING INSPECTION.**

While holding the special tool in place, turn the knob on the special tool until it bottoms out. If resistance is felt while turning the knob on the special tool, it may require lubrication. Lubricate the threads on the knob shaft with Lubri-Plate® (130-AA) white grease or similar white lithium grease. See Figure 2.

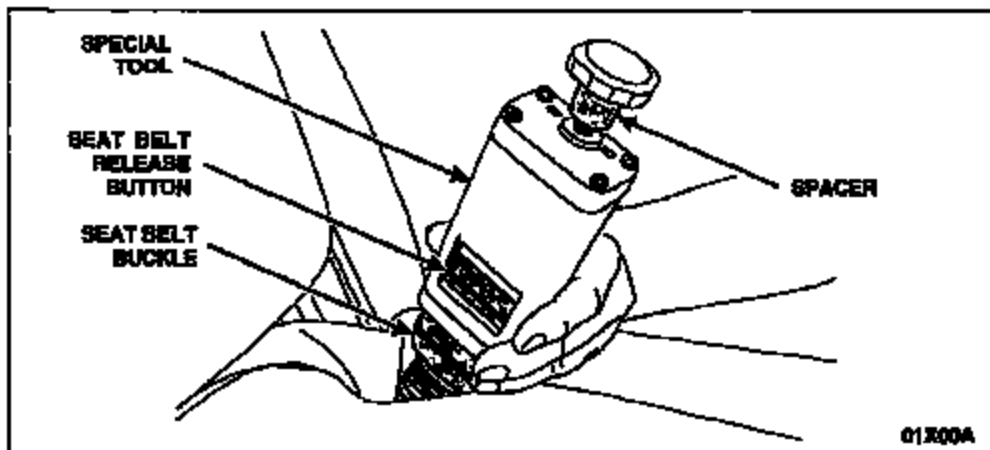
FIGURE 1

WARNING: CYCLE THE GAUGE COMPLETELY FOR EACH TEST. FAILURE TO FULLY CYCLE THE GAUGE BY LEAVING IT IN THE FULLY EXTENDED POSITION (ROTATED CLOCKWISE TO THE STOP) AND MANUALLY INSERTING THE TOOL INTO THE BUCKLE CAN RESULT IN ACCEPTING BAD BUCKLES AS GOOD BUCKLES. FOLLOW THESE INSTRUCTIONS TO PREVENT ACCEPTING ANY BAD BUCKLES AS GOOD.

Press and release the red seat belt release button located on the driver side seat belt buckle. Then, install the special tool onto the driver side seat belt buckle and hold it in place. See Figure 1.

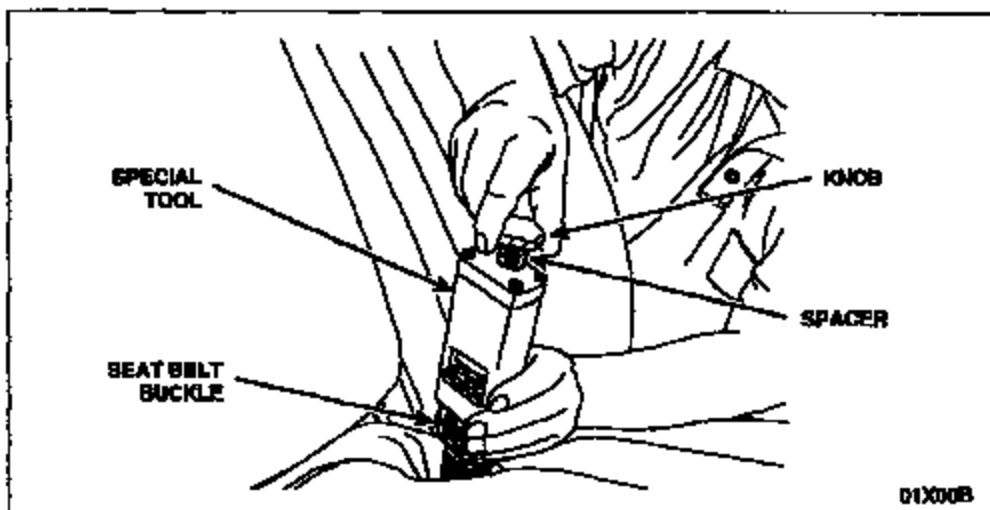
FIGURE 2

2. **WARNING: MAKE SURE YOU TURN THE KNOB ON THE SPECIAL TOOL SLOWLY IN THIS STEP. FAILURE TO DO SO MAY RESULT IN A FAULTY BUCKLE PASSING INSPECTION.**

While holding the special tool in place, turn the knob on the special tool until it bottoms out. If resistance is felt while turning the knob on the special tool, it may require lubrication. Lubricate the threads on the knob shaft with Lubriplate® (130-AA) white grease or similar white lithium grease. See Figure 2.

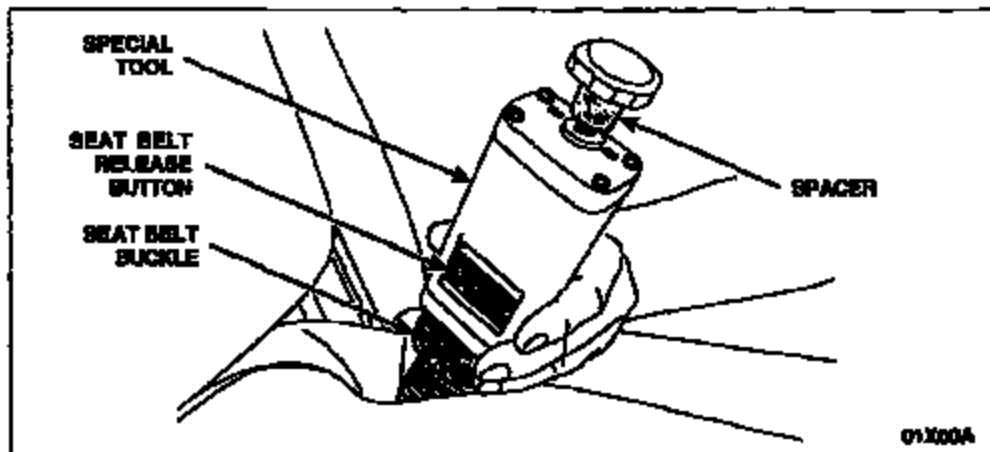
FIGURE 1

⚠ WARNING: CYCLE THE GAUGE COMPLETELY FOR EACH TEST. FAILURE TO FULLY CYCLE THE GAUGE BY LEAVING IT IN THE FULLY EXTENDED POSITION (ROTATED CLOCKWISE TO THE STOP) AND MANUALLY INSERTING THE TOOL INTO THE BUCKLE CAN RESULT IN ACCEPTING BAD BUCKLES AS GOOD BUCKLES. FOLLOW THESE INSTRUCTIONS TO PREVENT ACCEPTING ANY BAD BUCKLES AS GOOD.

⚠ Press and release the red seat belt release button located on the driver side seat belt buckle. Then, install the special tool onto the driver side seat belt buckle and hold it in place. See Figure 1.

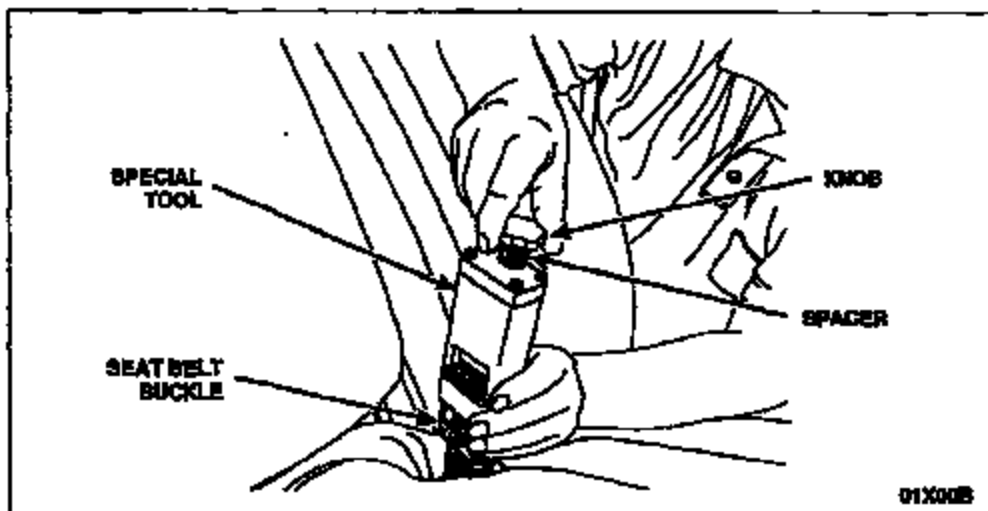
FIGURE 2

2. **WARNING: MAKE SURE YOU TURN THE KNOB ON THE SPECIAL TOOL SLOWLY IN THIS STEP. FAILURE TO DO SO MAY RESULT IN A FAULTY BUCKLE PASSING INSPECTION.**

While holding the special tool in place, turn the knob on the special tool until it bottoms out. If resistance is felt while turning the knob on the special tool, it may require lubrication. Lubricate the threads on the knob shaft with Lubriplate® (130-AA) white grease or similar white lithium grease. See Figure 2.

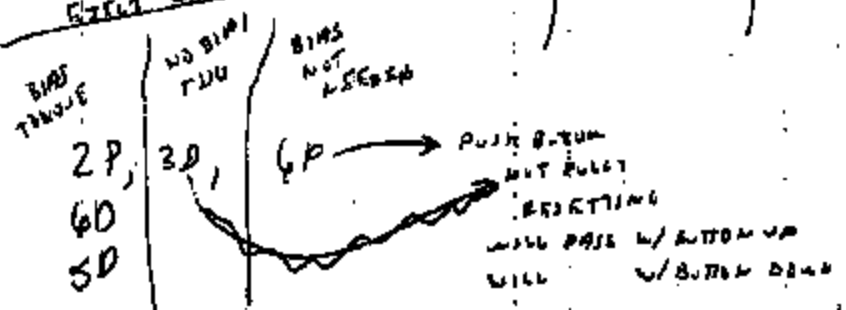
EXIT GAGE TONGUE

6D = LINE WITH PERMUTATION TONGUE

6P = CYCLE BUTTON ONCE TO CONDITION
BULKY, TONGUE THEN PASS

5D = EJECTS MIN TONGUE 1 OUT OF
4 + 1/35. EJECTS PRIMARY W/ BULKY
W/ LATCH MISSING
