# DAIMLERCHRYSLER

Reference: NVS-212mjl; EA04-013

This document contains DaimlerChrysler Corporation's ("DCC") response to the referenced inquiry regarding airbag clockspring in certain 1998 – 2000 model year DCC minivans ("the subject vehicles"). In reaching our analysis and conclusions, and by providing the information contained herein, DCC is not waiving its claim to attorney work product and attorney-client privileged communications.

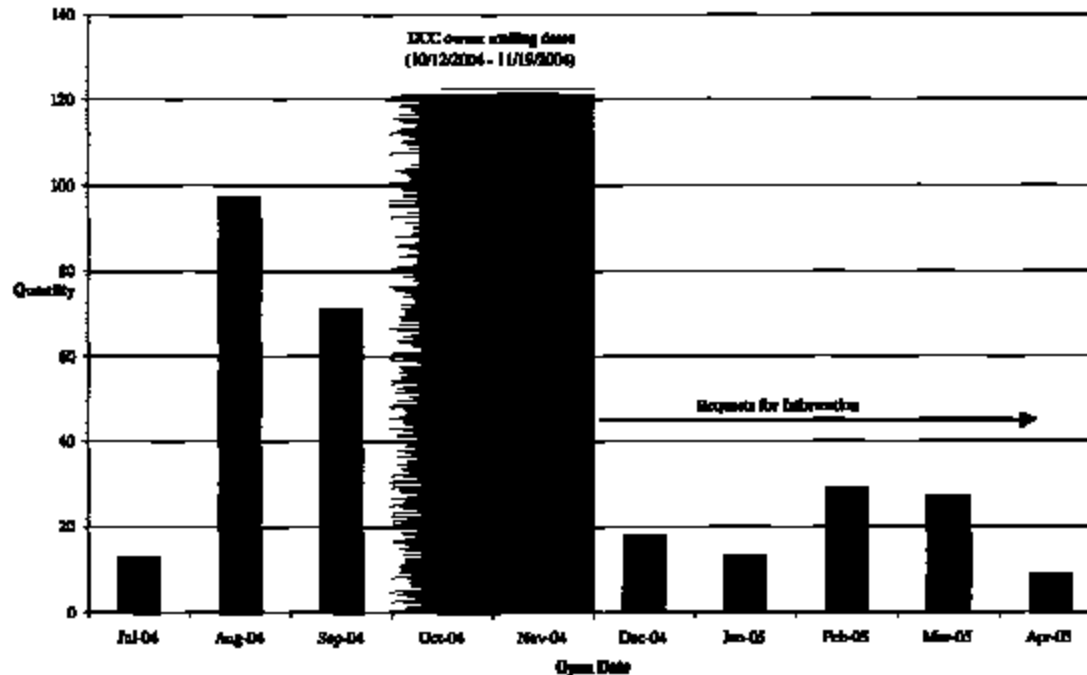
EA04-13 3rd Response CAIRS & Field Report Open Dates

It should also be noted that over 75% of these new complaints were received by DCC prior to consumer notification of Safety Recall D17/Lifetime Extended Warranty. DCC conducted a detailed review of the small number of customer complaints received since the consumer notification of Safety Recall D17/Lifetime Extended Warranty and concluded that all of the complaints are customers stating that the airbag light is illuminated on their vehicle and inquiring if their vehicle is covered under the recall/lifetime extended warranty. The customers are being informed that their vehicle is covered by the recall/lifetime extended warranty and requested to schedule an appointment with an authorized DCC service center to have the recall performed. This data clearly shows that Safety Recall D17/Lifetime Extended Warranty is an adequate and effective remedy and has fully addressed any consumer concern. DCC initiated the customer mailing notifying the vehicle owners of Safety Recall D17/Lifetime Extended Warranty on October 12, 2004. DCC concluded the recall/lifetime extended warranty mailing on November 19, 2004.
