Subject: **FINAL REPORT - VRTC-DCD4072 "Investigation of  
Electronic Throttle Control on 2001-2003 Ford F-Supern  
Duty and Excursion (EA04-006)"**

# **Investigation of Electronic Throttle Control on 2001-2003 Ford F-Super Duty and Excursion**

FINAL REPORT  
NOVEMBER 2004

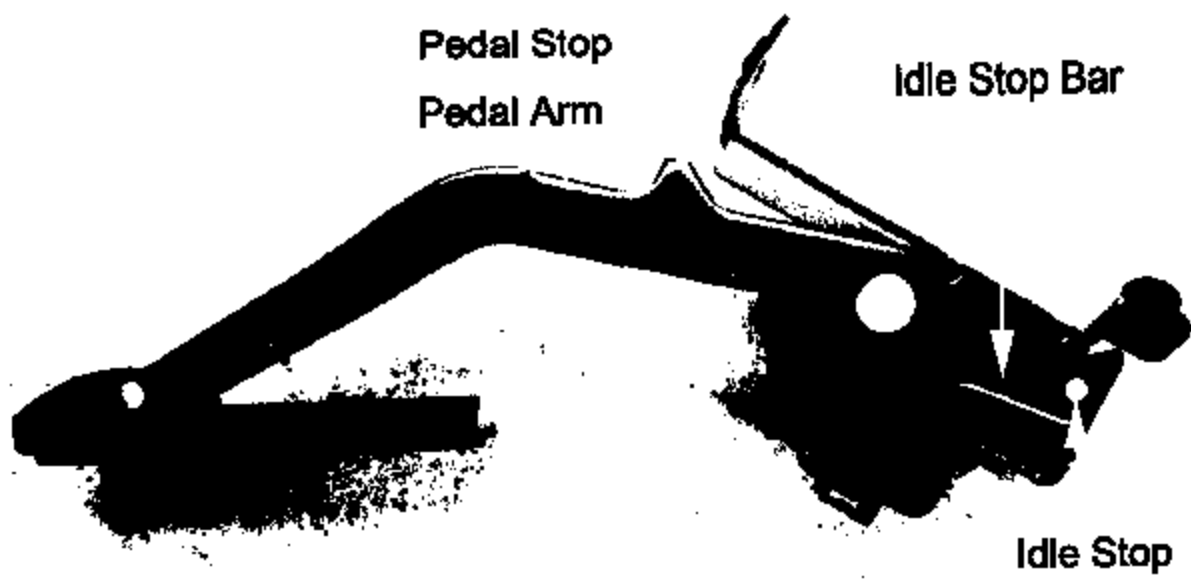
**Figure 4**  
**"BA" Pedal Assembly**

Two additional accelerator pedal assemblies were purchased from an authorized Ford dealership. The boxes in which they were shipped both showed the same part number (1C34-9F836-BA) as the one that was previously purchased. However, the label carrying the part number that was affixed to the pedal assembly carried a BB suffix, rather than the BA suffix listed on the earlier parts. Ford informed ODI that all current orders for replacement parts should be filled with the "BB" pedal. The "BB" pedal assembly incorporated a full-throttle stop bar that contacted the back of the existing idle stop at WOT before the pedal arm contacted the original pedal stop. Eleven pedal assemblies were measured to determine the clearance between the pedal arm and the original pedal stop when the new full-throttle stop bar was engaged. Clearance on these 11 pedals ranged from 0.060 inch and 0.082 inch. Figure 4 shows a "BA" pedal assembly. Figure 5 shows a "BB" pedal assembly.

4. The gradual reduction of the force required during the tests to cause the APS output voltage to exceed 4.5 volts suggests that repeated high force applications on the "BA" accelerator pedal by consumers may cause permanent deformation of the accelerator pedal assembly. Over time, this may result in forces much lower than 100 lb being required to reach the 4.5-volt threshold for the APS output.

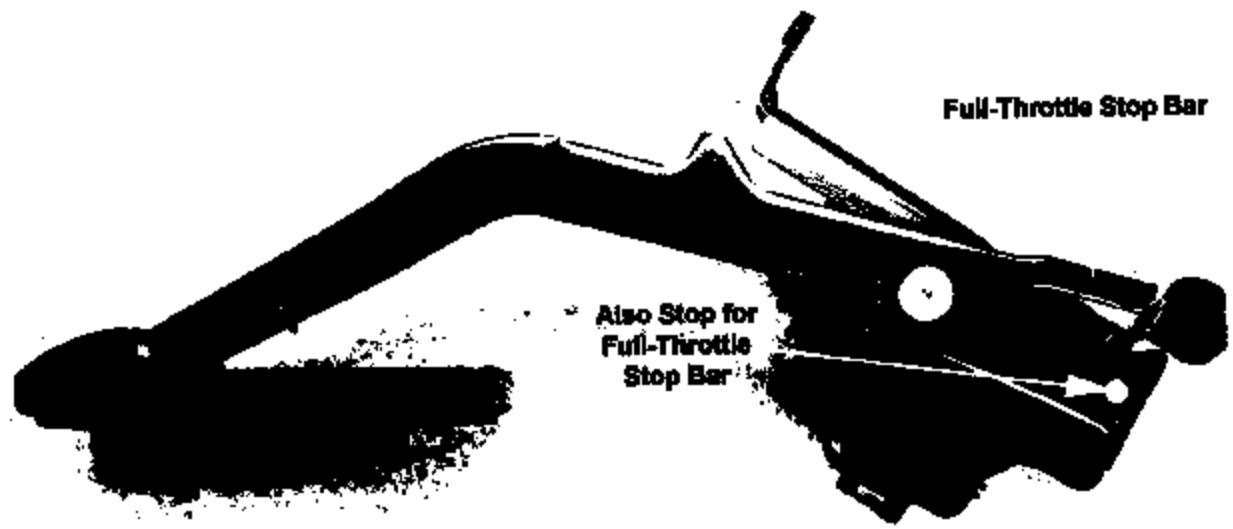
**Figure 5**  
**"BB" Pedal Assembly**

The new "BB" pedal assembly was installed in the test truck and pedal applications up to 135 lb were performed. There was no appreciable permanent change in the zero-force idle voltage or the minimum-force full-voltage during these tests. The full throttle voltage only increased by 140 mv between 12 and 135 lb of pedal force and never exceeded 4.01 volts.

3. Compared to the original "BA" pedal, the replacement "BB" pedal, incorporating a new full-throttle stop bar, performs better at higher pedal forces. The APS output voltage did not exceed 4.0 volts when 100 lb of force was applied to the accelerator pedal in any of the replacement "BB" pedals that were installed during the field survey.

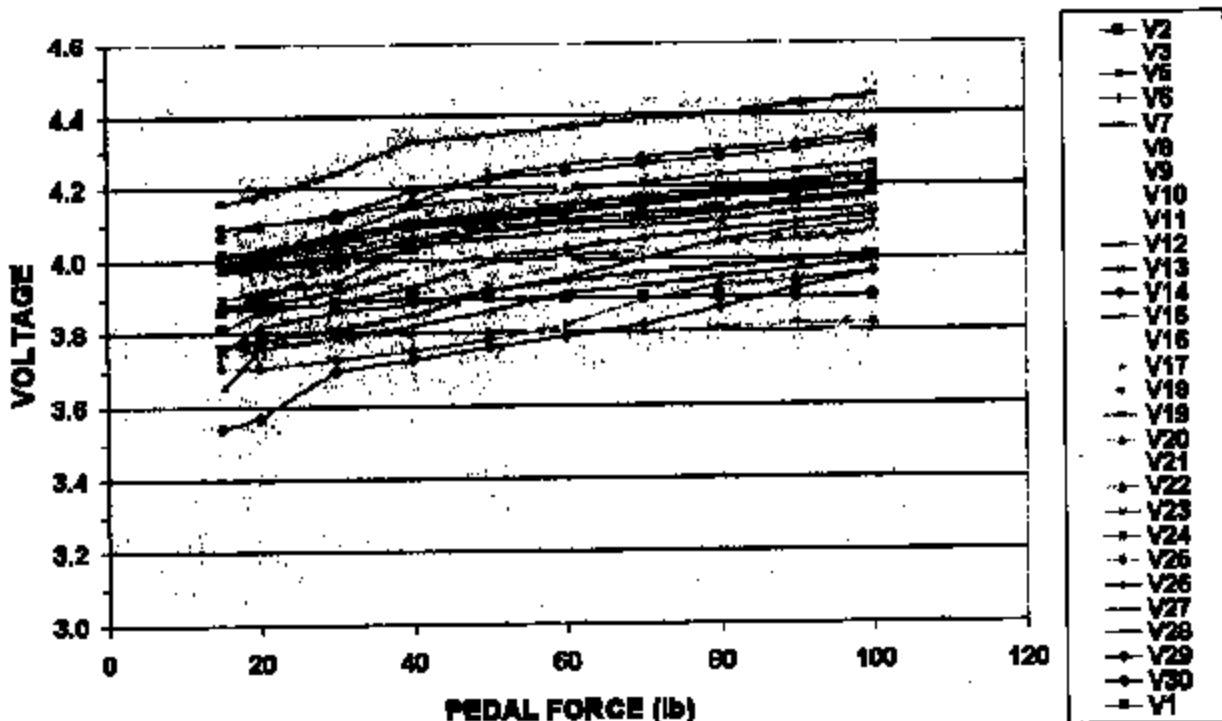
Figure 7 – As-Found APS Output Voltages  
 Note: Data recorder malfunction for V4

A summary of the inspections is shown in Table 1. Graphical representations of the APS output voltages for the As-Found and Replacement pedal assemblies are shown in Figures 7 and 8 respectively.

None of the 30 subject vehicles inspected in the field during this program exhibited the anomaly at pedal forces up to 100 lb. On the 30 vehicles inspected, the APS output voltage varied from 3.81 volts to 4.44 volts at a pedal force of 100 lb. After the pedal assemblies were replaced on 19 of these vehicles, the maximum APS output voltage was less than 4.0 volts at the same pedal force. The application of 100 lb of force on the accelerator pedal during field testing for this program required a concentrated effort and "hand" bracing against the steering wheel for leverage.

2. The inspection of 30 in-use subject vehicles subjected the accelerator pedal to a force (100 lb) more than eight times the force required to achieve and hold the accelerator pedal in the WOT position. None of the inspected vehicles demonstrated the anomaly at this force level although the APS output voltage for some of these vehicles was close to the 4.5-volt limit.
