ODI RESUME

Investigation: EA 05-007
 Prompted By:
 Date Opened: 04/14/2005 Date Closed: 04/11/2006
 Principal Investigator: Tom Bowman
 Subject: Tailgate Support Cables

Closing Report – EA05-007

Tailgate Support Cable Breakage in General Motors Model Years 1998-2000 C/K Silverado and Sierra Vehicles (GMT-400 and GMT-800 Vehicle Platforms)

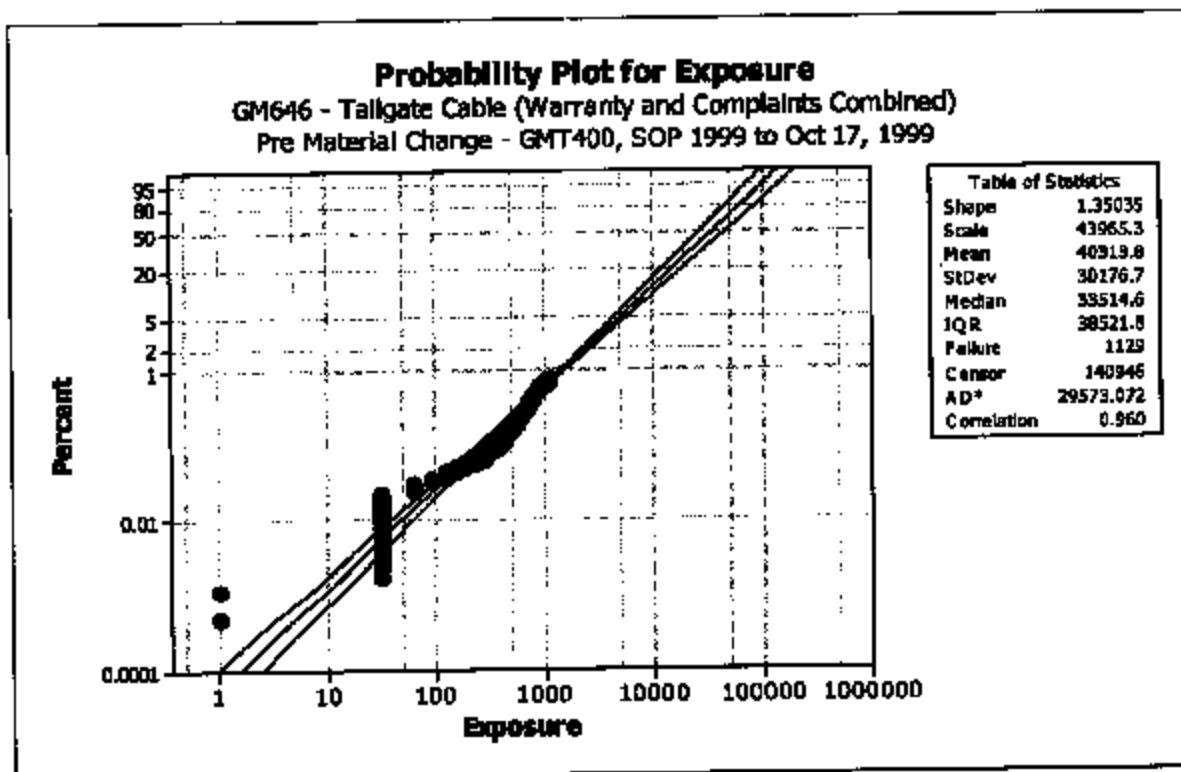
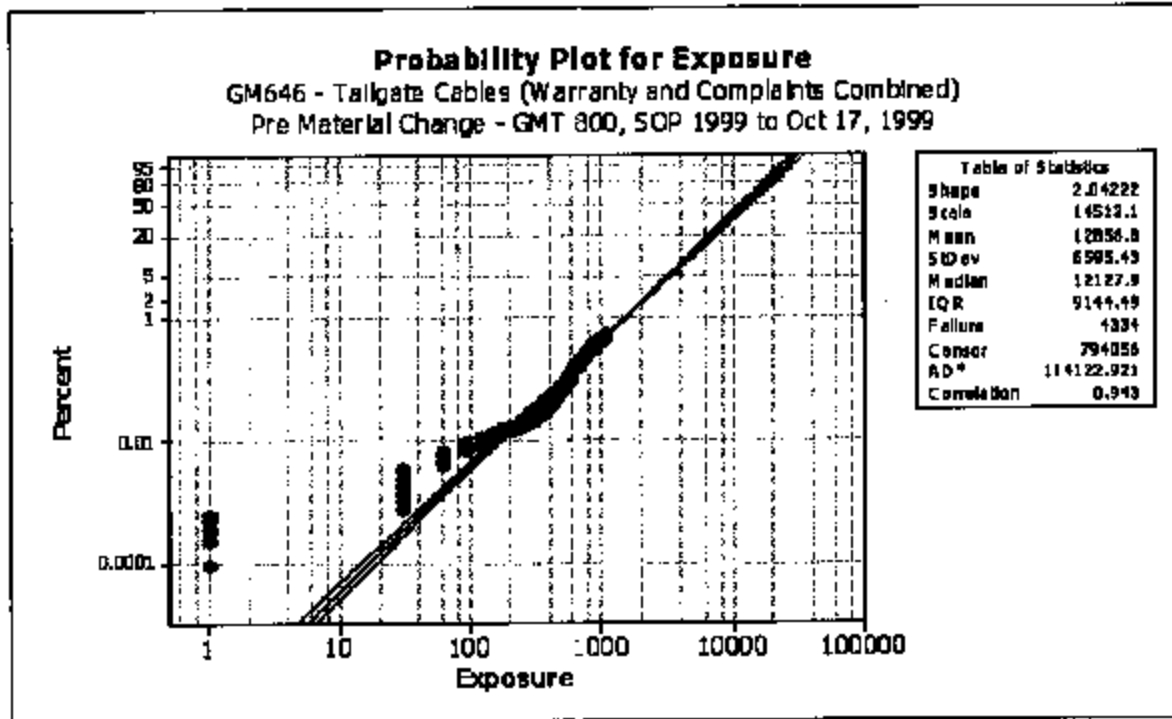
Weibull Plots of Tailgate Support Cable Failures on GMT-400 and GMT-800 for Vehicles Built Prior to October 17, 1999

Exposure (x-axis) is measured in days of service. The shape parameter (beta) indicates the whether the failure rate is increasing (beta < 1), constant (beta = 1), or decreasing (beta > 1).

The analysis indicates that the tailgate cable failure rate is increasing for both the GMT-400 (beta = 1.35) and GMT-800 (beta = 2.04), but that the failure rate for the GMT-800 is increasing at a faster rate.
