U.S. Department
of Transportation
**National Highway
Traffic Safety
Administration**

ODI RESUME

Investigation: EA 05-015
 Prompted By: PE05-033
 Date Opened: 10/13/2005 Date Closed: 12/06/2006
 Principal Investigator: Cynthia Glass
 Subject: Windshield Leak Causes Electric Failures

Manufacturer: Ford Motor Company
 Products: 1999-2001 Ford Expedition
 Population: 653,471

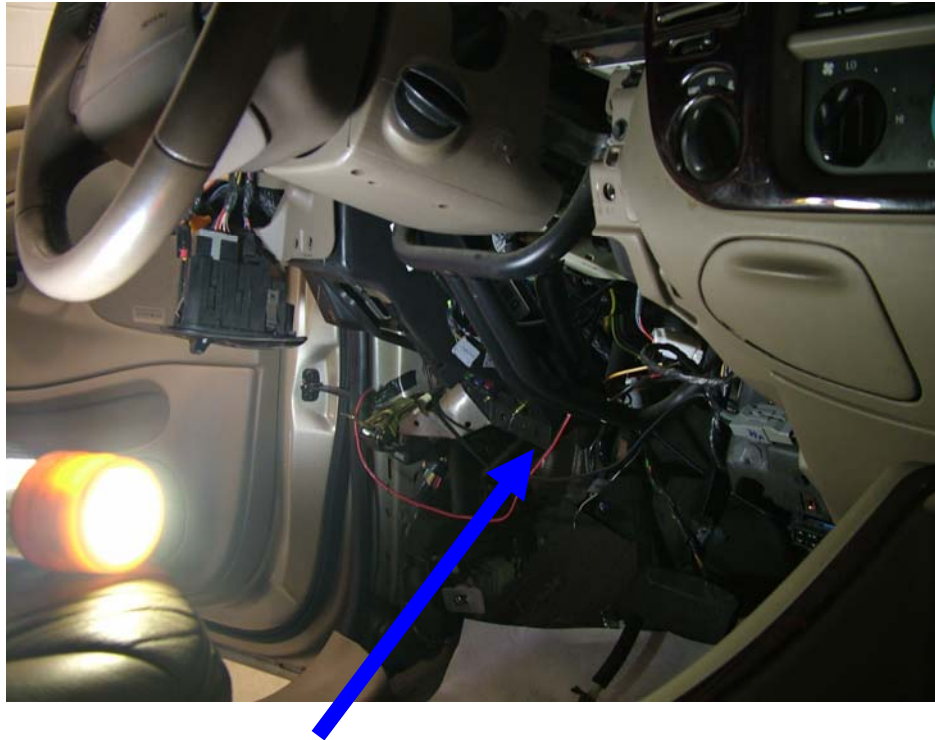
Figure 1: Location of the GEM and Fuse Box

The GEM and fuse box are located in the interior of the vehicle, below the front windshield and in front of the drivers seating position. The GEM is a "black box design" ¹ located behind the instrument panel, in the area forward of the driver's left knee. The fuses are encased in a plastic box located underneath the steering column and instrument panel. Figure 1 shows the general location of the GEM and the fuse box in the vehicle. Figure 2 shows the layout and function of various fuses in the fuse box.

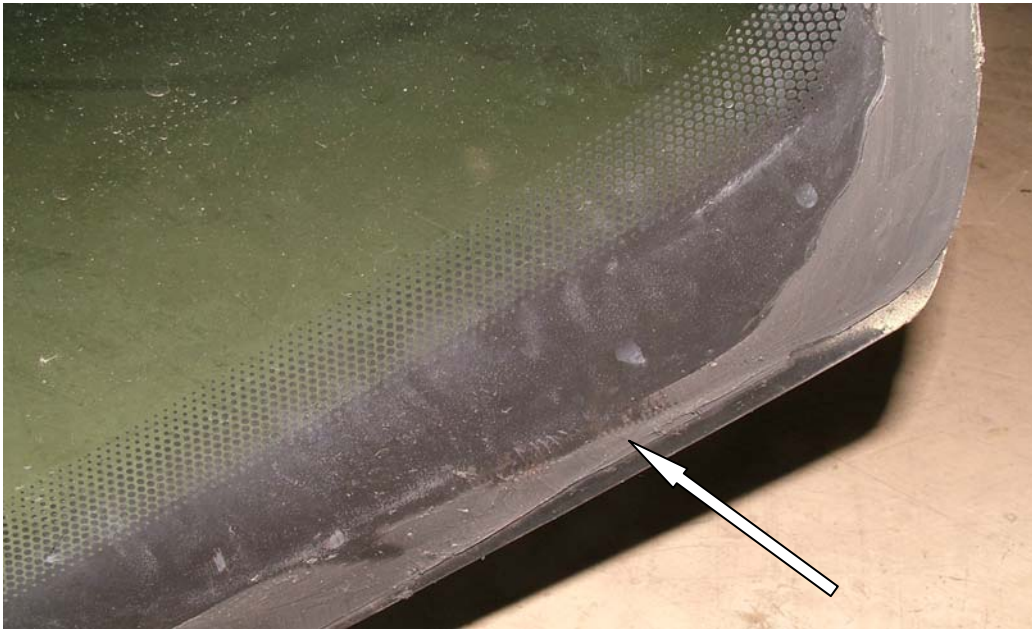
Figure 7: Insufficient Sealant

VRTC conducted an ultrasonic leak test along the periphery of the windshield. The leak test indicated a leak along the driver’s side A-pillar at the bottom and across the top of the windshield. The driver’s side A-pillar lacked sufficient sealant along the bottom of the windshield. See Figure 7. The width of the sealant should be 30mm (1.2inches) along the

entire periphery of the windshield. It was also observed that the molding across the top of the windshield was misaligned. See Figure 8. These conditions created a potential opening for water to enter into the vehicle and the GEM and/or the fuse box. The GEM and fuse box in this vehicle were found to have significant contamination and/or corrosion due to water intrusion.

- There were gaps along the periphery of the windshield because the windshield glass was not properly sealed. There was insufficient sealant along the bottom of the glass, and the molding was misaligned across the top of the windshield.
- Initial inspection of the fuse box and GEM showed that both contained notable contamination and/or corrosion due to water intrusion.
- Testing in the water-soak booth was unable to show evidence of windshield wiper or head light malfunction, failure or intermittent operation.
- Testing in the water-soak booth was unable to show evidence of water intrusion into the vehicle, fuse box or GEM.
