U.S. Department
of Transportation
**National Highway
Traffic Safety
Administration**

Investigation: EA 05-017
 Prompted By: PE04-080
 Date Opened: 10/28/2005 Date Closed: 04/30/2007
 Principal Investigator: Peter Kivett
 Subject: Hummer H2 Steering Knuckle Failures

ENGINEERING ANALYSIS CLOSING REPORT

SUBJECT: STEERING KNUCKLE FAILURES

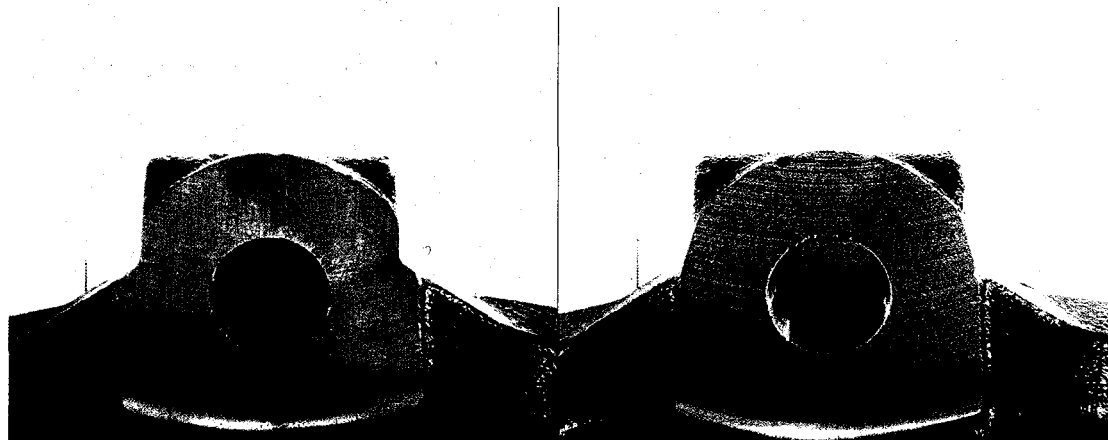
Figure 2

As indicated above, GM redesigned the steering knuckle boss (see Figure 2), removed the old knuckle from production and/or sale, and began installing the redesigned knuckle on June 9, 2003. Assembly line torque applied to secure the ball joint stud to the knuckle was also increased from 100 to 110 Nm. GM made a subsequent change to the torque specifications in June 2005, changing it to 50 Nm + ¼ turn, which helps ensure proper draw-in of the stud and a tight joint. GM also increased the tire pressure from 35 to 44 psi. This change, allegedly based on fuel economy improvements, also diminishes friction at the road/tire interface and reduces stress on the steering system.

Figure 2, below, depicts both the MY 2003 (used until June 2003) and the post-June 2003 steering knuckles used on the H2. The MY 2003 knuckle on the left can be readily identified by the notches that form the smallest cross-sectional plane as denoted by the arrows. The post-June

2003 knuckle on the right has a thicker (2 mm) boss. These later knuckles use the increased 50 Nm + ¼ turn torque specification starting on June 1, 2005.

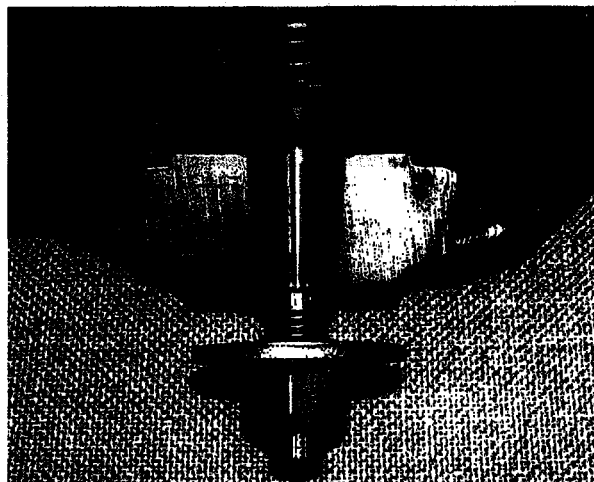
Figure 3

1. Surface contact specifications indicate that no less than 75% of the two surfaces (being the stud and the tapered hole) must be in contact to prevent stress concentrations that could cause an inadvertent overload (See Figure 3). All samples retrieved from the field indicated surface contact percentages were within specification.
