# ODI RESUME

Investigation: EA 05-022  
 Prompted By: PE05-046  
 Date Opened: 12/27/2005      Date Closed: 12/21/2006  
 Principal Investigator: John Abbott  
 Subject: Front Seat Belt Buckle Malfunction

Manufacturer: DaimlerChrysler Corporation  
 Products: 2002 Jeep Liberty  
 Population: 208,710

Problem Description: Alleged failure of the driver's seat belt buckle to latch, as well as, allegations of difficult to latch and unlatch.

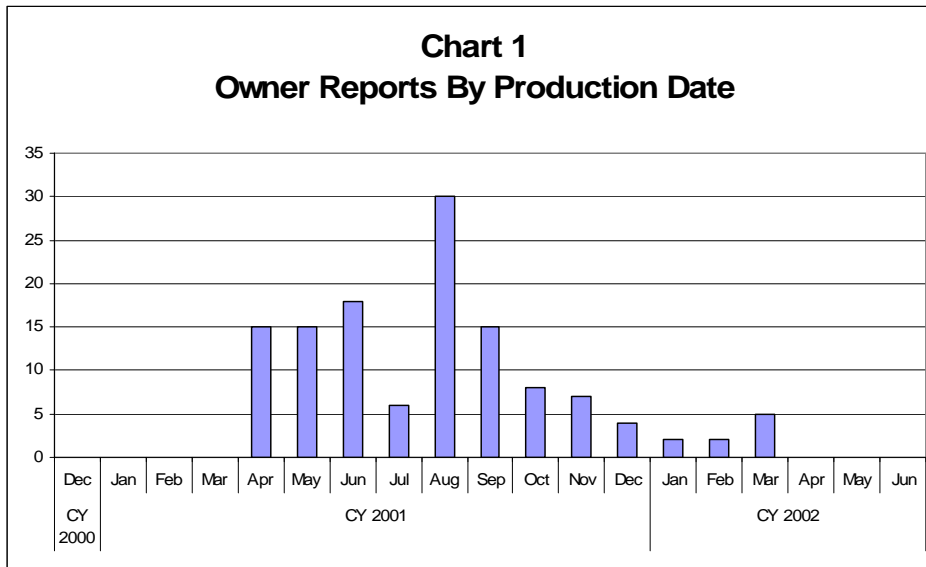
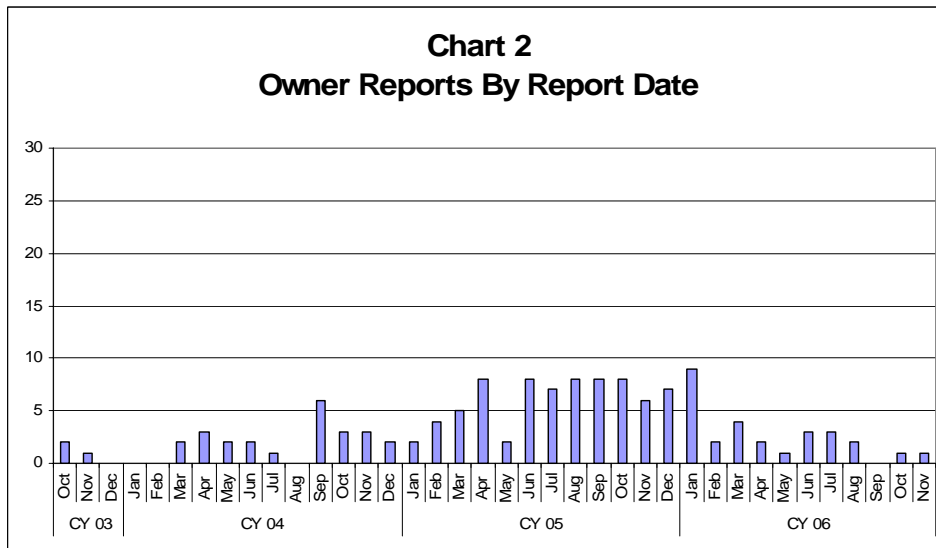
The reports are predominantly from early production vehicles produced in calendar year 2001. Table No. 2 below provides a distribution of reports by production year and this is also shown in Chart No. 1. In Chart No. 2 the reports are shown by report date.

The current data shows a declining trend. As charts 1 and 2 show, the vehicles that have experienced the problem are early production vehicles built primarily in CY 2001, and the frequency of complaints in CY 2006 has dropped to that of CY 2004. As a result of the tooling change, it is expected that the trend will continue to decline.

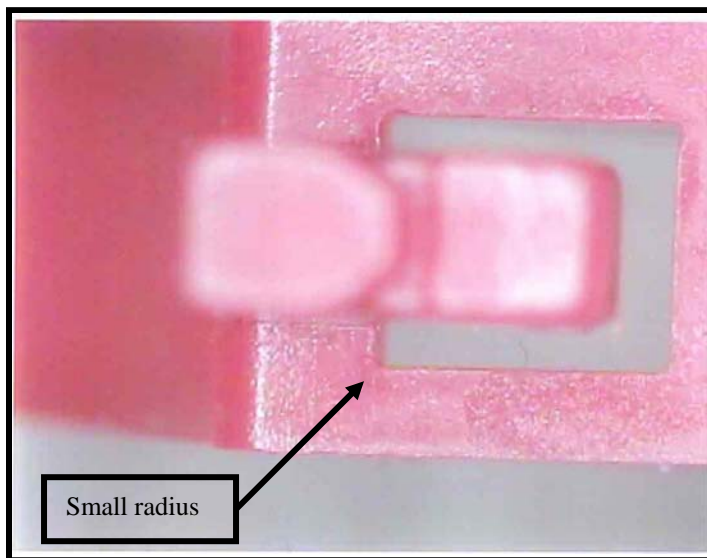
**Figure 1. Original Production LGLS**

**TOOL REVISION:** The subject buckles incorporate two plastic leaf springs, known as "Latch Guide Leaf Springs" (LGLS). The purpose of these springs is to aid the return of the red push button to its normal position after latching and unlatching the belt. In early calendar year 2002, a revision was made to the tool that is used to produce the LGLS. The revision enlarged the inside corner radii of the LGLS (see figures 1 and 2) which would, as DCC states "facilitate buckle assembly." DCC also stated that this revision appears to correspond to a "cessation" of warranty

**ODI ANALYSIS:** The LGLS in the front seatbelt buckles of early production MY 2002 vehicles can fracture and separate from the latch guide. The LGLS are small and can migrate around inside of the buckle housing and interfere with the operation of the release button. Depending upon the location of the LGLS and their relative position to other parts of the internal buckle mechanism, various conditions occur. The button can stick in the down position, and in some instances it must be manipulated up in order to re-latch the belt. In other instances the release button can also require more force than usual to push in. ODI's discussions with owners found instances in which the buckle function subsequently returned to its normal operation with no further problems. From interviews with owners, ODI was unable to identify any trend of the alleged defect condition preventing proper belt use.

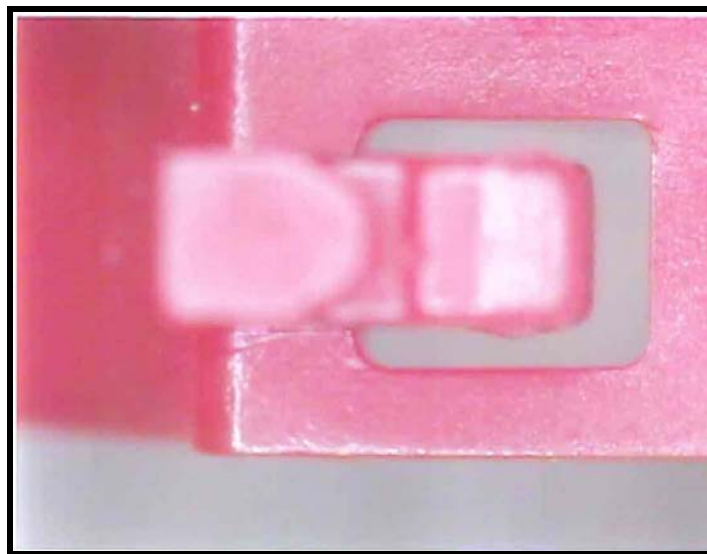
**Figure 2. LGLS with Enlarged Inside Corners**

claims relating to separated LGLS and to consumer complaints associated with the alleged defect. DCC is not aware of any instances of separated LGLS in buckles produced after the radii change.
