U.S. Department  
of Transportation  
**National Highway  
Traffic Safety  
Administration**

Investigation: EA 05-005  
Prompted By: PE04-078  
Date Opened: 03/22/2005 Date Closed: 08/02/2006  
Principal Investigator: Bruce York-B  
Subject: Engine Compartment Fires

## ENGINEERING ANALYSIS CLOSING REPORT

**SUBJECT:** Speed Control Deactivation Switch Fires.

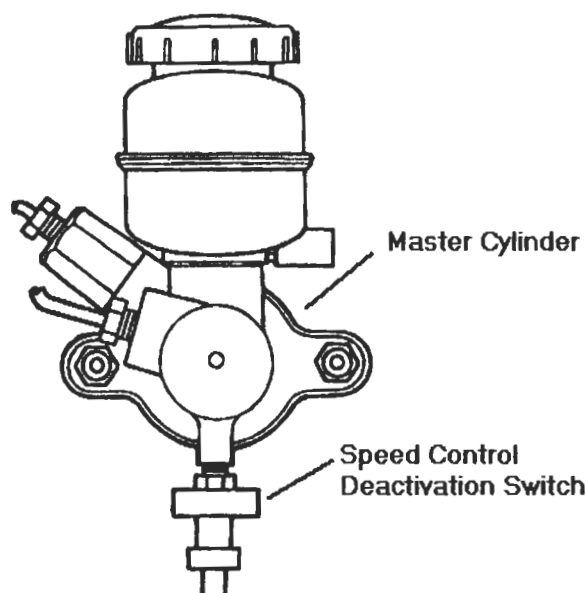
**SCDS Orientation.** Orientation of the SCDS as mounted in the Master Cylinder is another factor contributing to the alleged defect. When the electrical contacts start to corrode and corrosion products, metallic debris, and electrolysis products start to form, they move downward in the solution inside of the electrical cavity. These corrosion products move downward as a result of being denser than the brake fluid solution. Normal vehicle vibration also helps facilitate the downward settling of these products. In order for the short circuit to develop, these corrosion products must settle in such a way that dendrite growth might start and develop. When the SCDS is mounted in the master cylinder in a vertically down orientation (Figure 7.) it is believed that the metallic corrosion products settle in the plastic base of the switch completely away from the grounded hexport body. With the metallic debris settled away from the grounded hexport body, dendrite growth is inhibited and a short circuit does not develop. When the SCDS is mounted in a vertically up or angled down orientation (Figures 8. and 9.), the metallic corrosion products can settle in such a way that dendrite growth can develop.

Figure 7. SCDS Vertical Down.

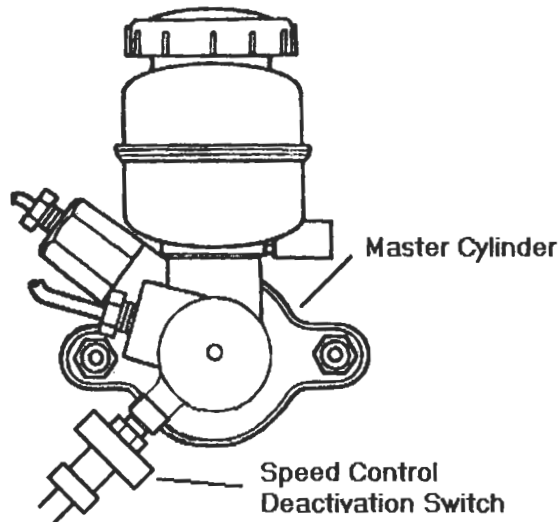
Figure 8. SCDS Angled Down.

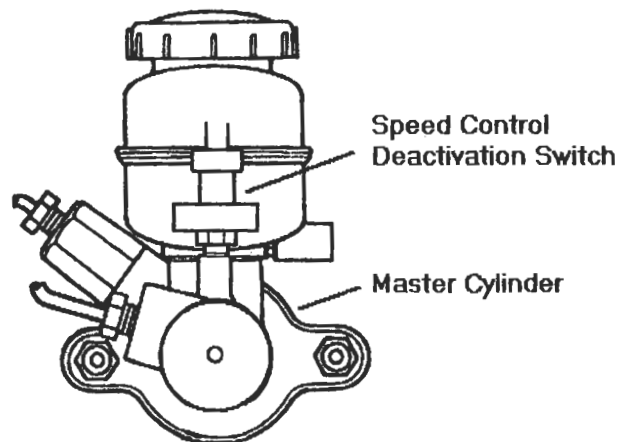
Figure 9. SCDS Vertical Up.

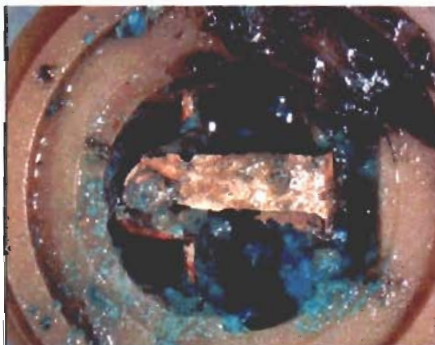
ODI and Ford both developed testing programs involving filling the base of a SCDS containing the electrical contacts with brake fluid. The contacts were then connected to a power supply and the switch was monitored. The brake fluid along with corrosion products contained in the electrical cavity created an electrolytic cell (Figures 10. and 11.).

Figure 10. Corrosion Of Electrical Contacts.

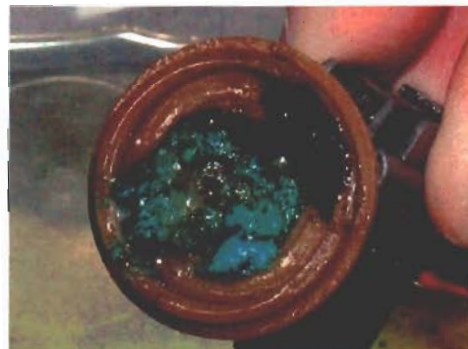
Figure 11. Electrolysis Products.

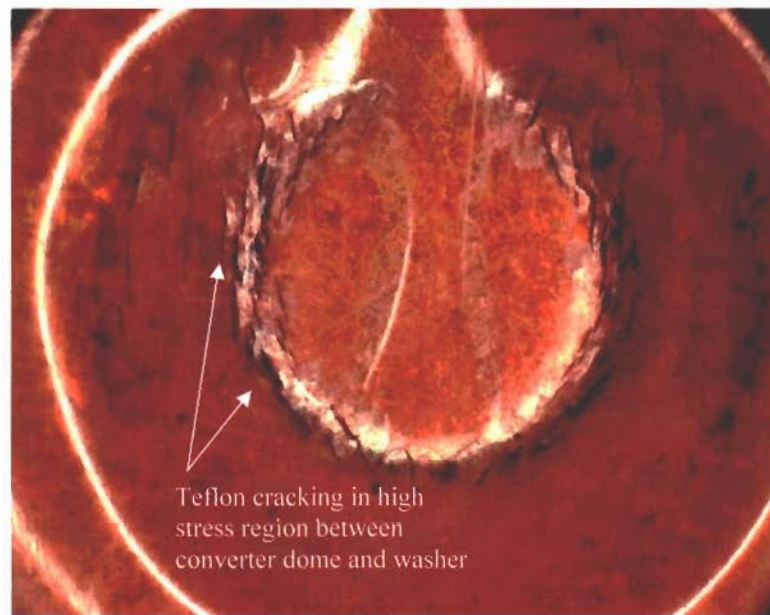
The leak results from fatigue failure of the Kapton allowing brake fluid to move from the hydraulic side of the switch to the electrical side of the switch. Fatiguing of the Kapton diaphragm results in cracks initiating in the Teflon layer (Figure 13.) of the laminate. Once the Teflon layer has been breached, the Kapton is then compromised by the water that is contained in the brake fluid. DuPont, the manufacturer of the Kapton material, indicates that hydrolytic degradation of the Kapton can be caused by water-contaminated brake fluid penetrating a cracked Teflon layer. A Kapton substrate that has been degraded from such exposure can become brittle and crack. Figure 14. shows a Kapton crack that appears to have resulted from fatigue imposed by over cycling the material.

Figure 13. Teflon cracking.

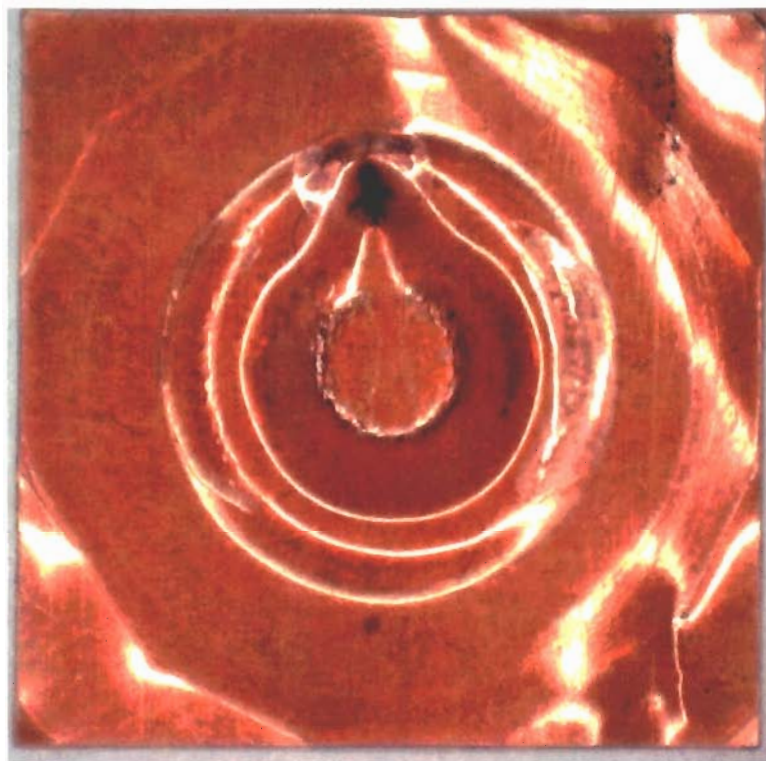
Figure 14. Crack through Kapton substrate with "Tear Drop" failure pattern.

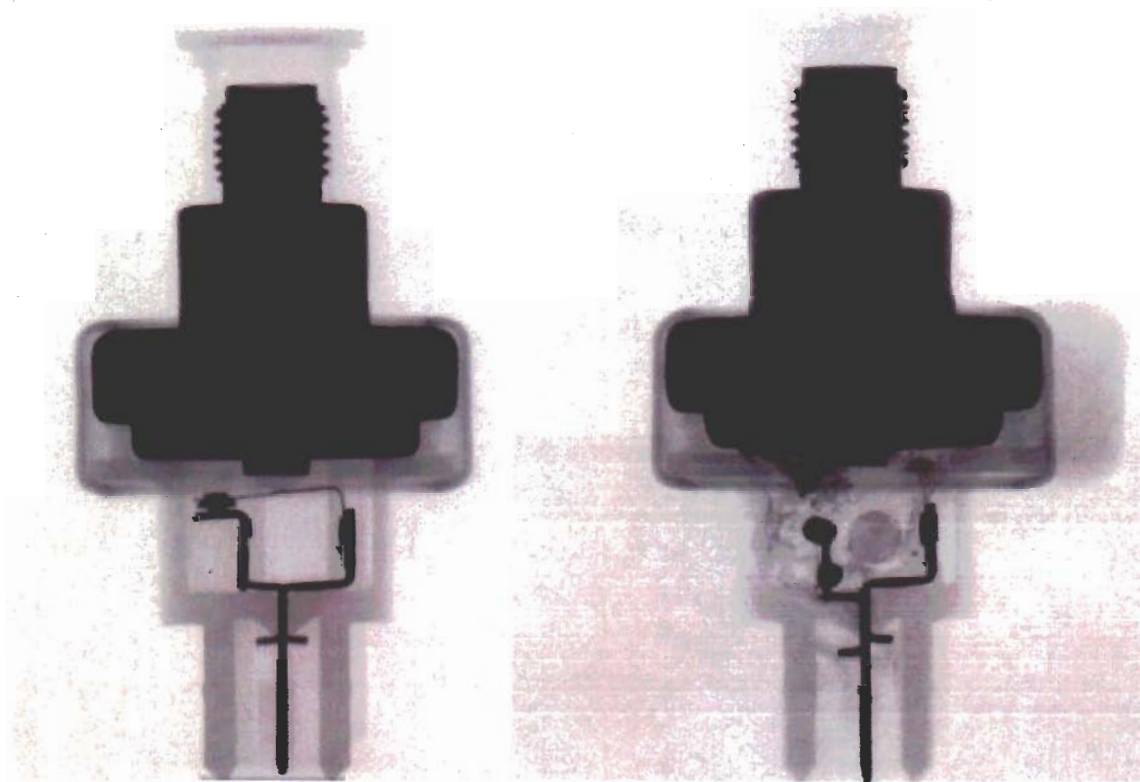
Examples of arc generated brass and copper beads and the resulting melted base of a failed SCDS can be seen in x-ray images and photos of a failed switch obtained by ODI from a complainant's vehicle (Figures 15. and 16.). This x-ray image is one of over fifty that ODI has taken of failed switches that have been collected from complainant vehicles. These x-ray images are consistent with ODI's analysis and the analyses performed by and for Ford.

Figure 15. SCDS electrical cavity before and after contact corrosion and arcing.

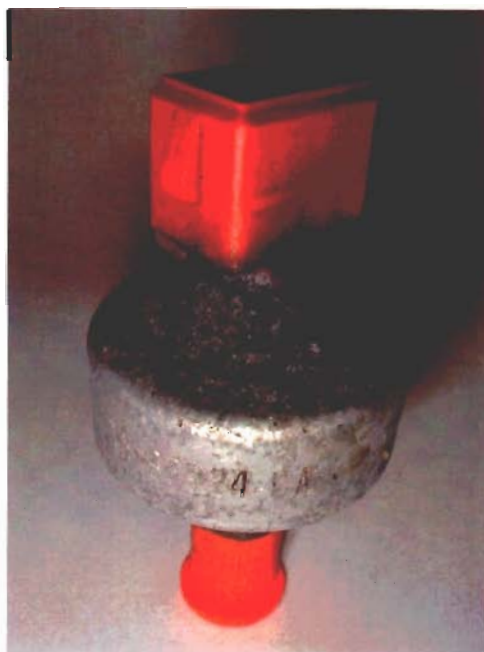
Figure 16. SCDS with melted base.

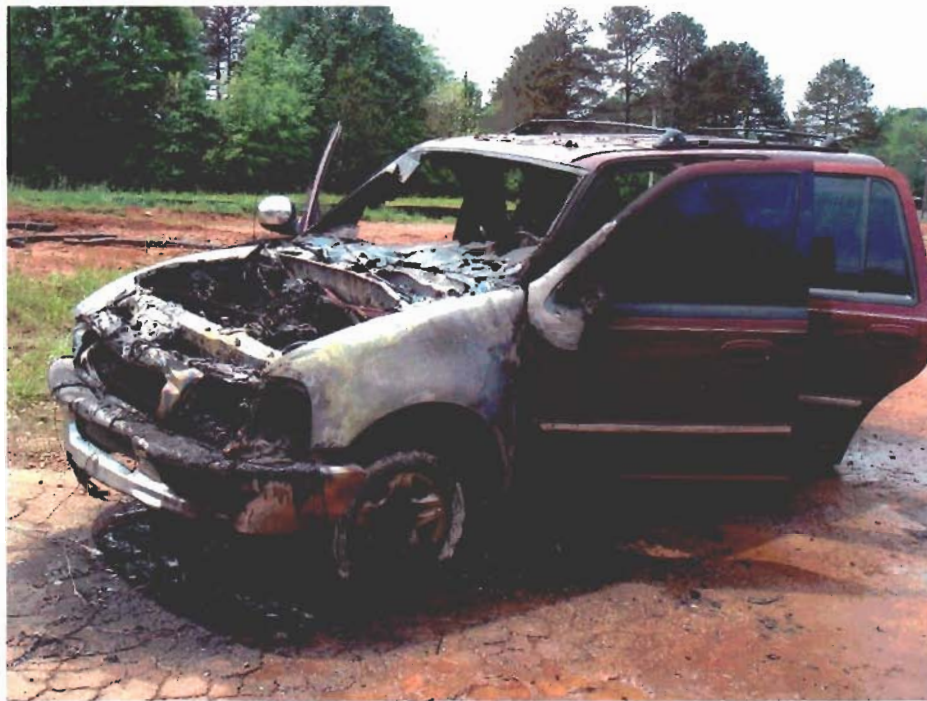
after the fires were extinguished (Figure 17), were used as a reference in evaluating complainant vehicle fires. Along with eye witness testimony, owner interviews, and physical evidence, the fire test data assisted ODI in determining if a complainant vehicle fire was likely to have been caused by a defective SCDS.

Figure 17. Burns Patterns On Test Vehicle.
