Closing Report – EA05-008

Tailgate Support Cable Breakage in General Motors Model Years 1998-2004 S/T (Sonoma and S-10) Series Vehicles

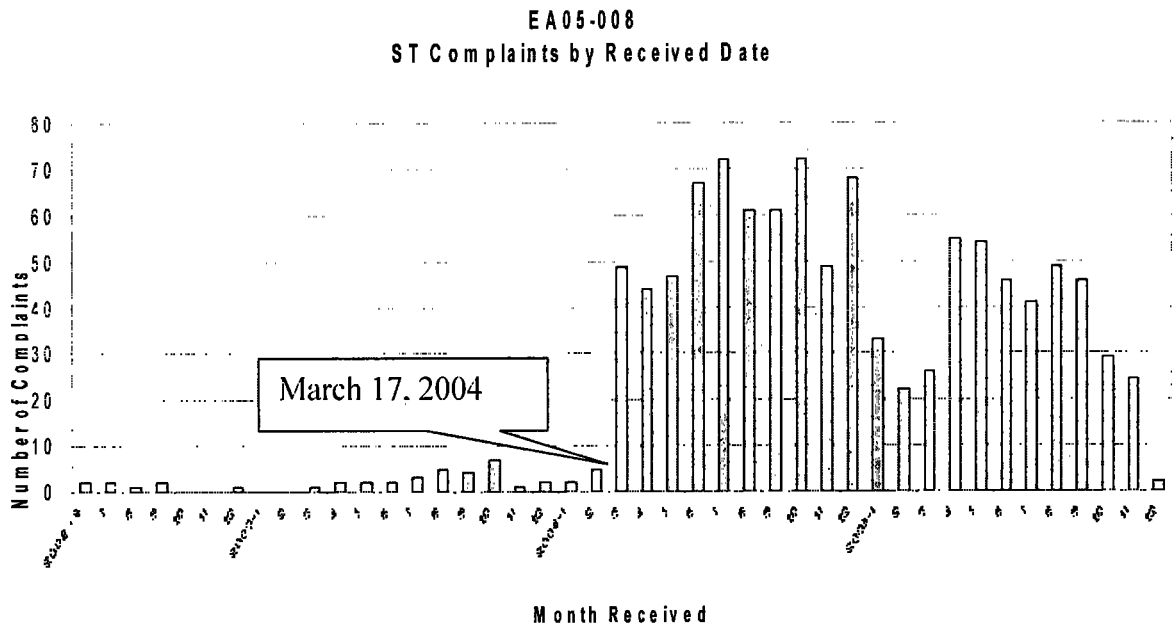
Analysis of the timing of Tailgate Support Cable Breakage Complaints by Date Received

GM postulated that post-campaign announcement complaints were influenced by the publicity associated with GM's campaign to replace tailgate support cables in model years 2000-2003 C/K vehicles (04V-129) which was announced on March 17, 2004. As seen in the above chart, a significant number of complaints had been made after March 17, 2004, the date that GM announced Campaign 04V-129 (addressing model year 2000-2004 C/K vehicles).

ODI concurs that it is probable that campaign publicity created a public awareness which was a factor in the increase of complaints to both ODI and GM. However, ODI believes that these complaints are not inflated or fabricated but rather represent under-reporting of incidents that had occurred prior to the publicity-generated public awareness. In addition, a significant portion of the complaints reported several months after the publicity had faded more likely represent an increase in the number of complaints over time that is characteristic of components that fail due to corrosion and fatigue.

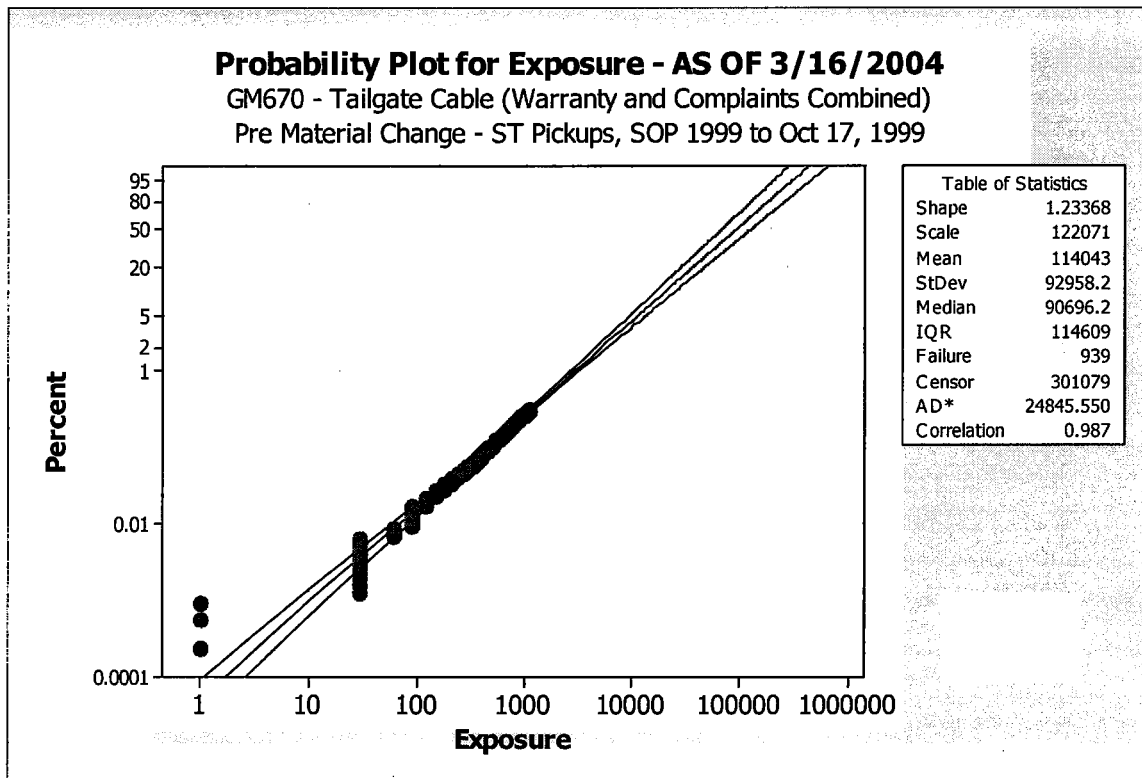
The shape parameter (beta) indicates whether the failure rate is increasing (beta > 1), constant (beta = 1), or decreasing (beta < 1). This analysis indicates that the tailgate cable failure rates in vehicles manufactured prior to October 17, 1999 (beta = 1.23 as depicted in the first chart) have been and are expected to continue to increase, but at a modest rate.

Exposure (x-axis) is measured in days of service.

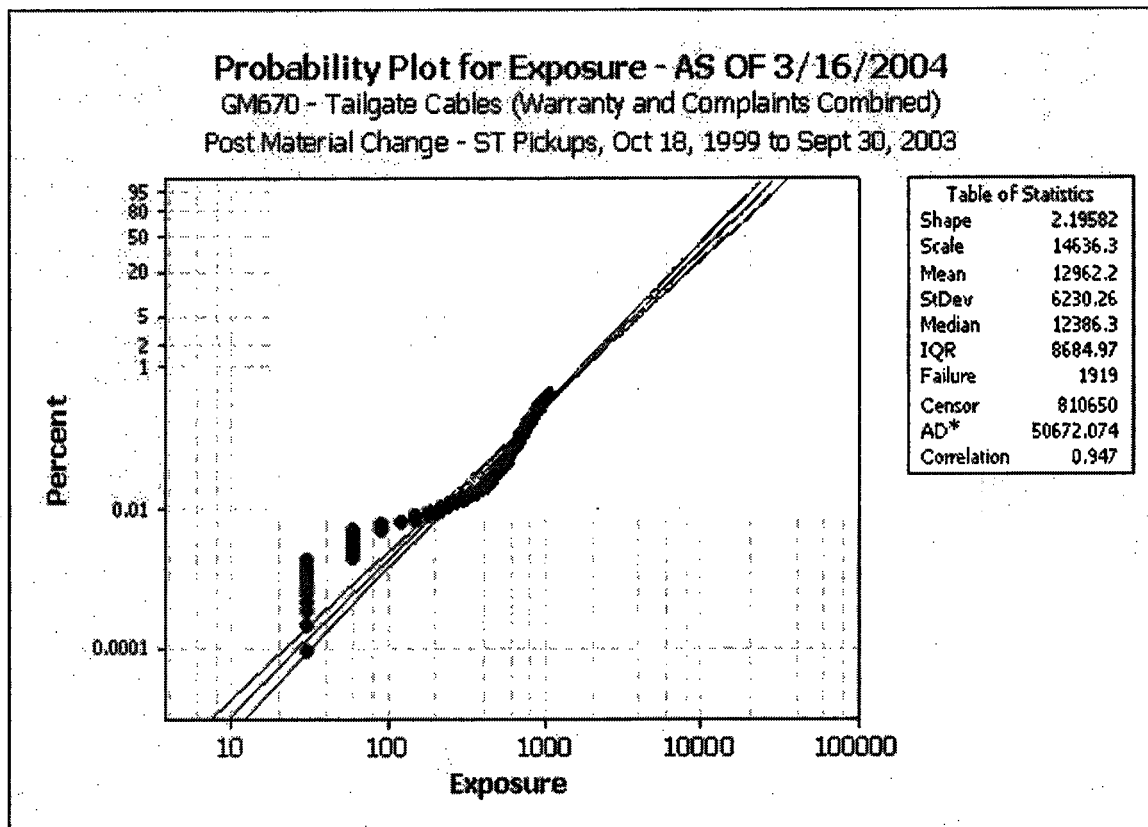
The tailgate cable failure rates in vehicles manufactured after October 17, 1999 (beta = 2.19 as depicted in the second chart) also have been and are expected to continue to increase at a modest rate.

As expected by the loss of integrity in the tailgate cable coating, the failure rate for tailgate cables installed in vehicles built after October 17, 1999 have been and are expected to increase at a faster rate than vehicle built prior to October 17, 1999.

Exposure (x-axis) is measured in days of service.
