Closing Report – EA05-011

Front Tire Failures in 1995 - 2000 Model Year
Country Coach Intrigue and 1996 - 2000
Country Coach Allure Model Motorhomes

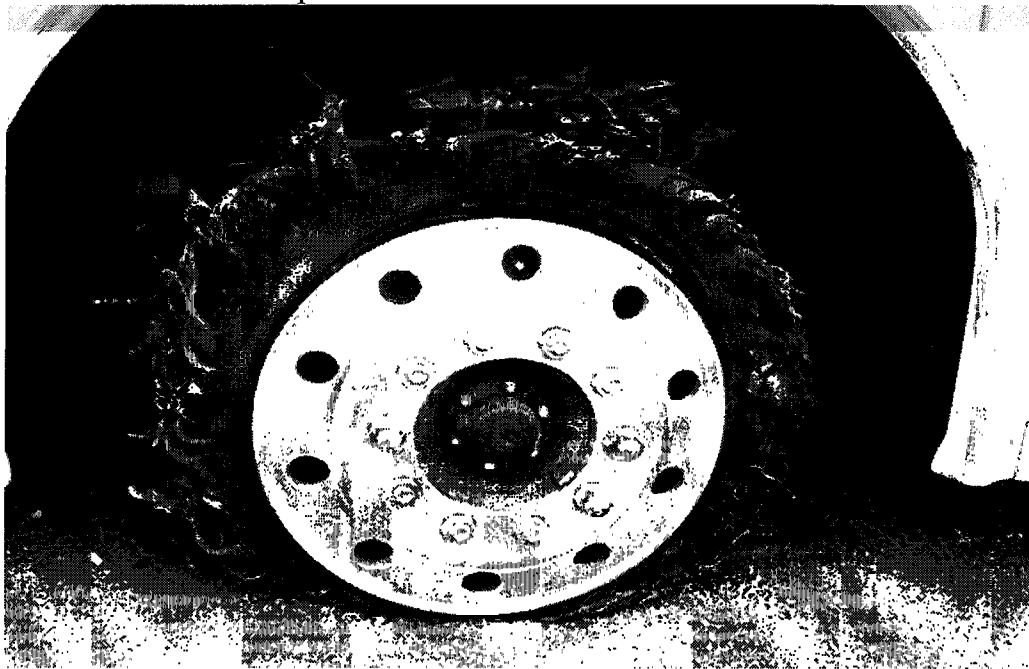
Photograph 2 -

Tire failures on the subject vehicles have typically involved a tread separation such as depicted in Photograph 2, below. Many owners that ODI interviewed after they experienced a front tire failure in their vehicle described hearing a sudden “blowout” sound or the “beating” sound of the separating tread striking the wheel well of their vehicle. Several owners reported an explosive failure that immediately affected the owner’s ability to control the vehicle.

Representative Left Front Tire Failure

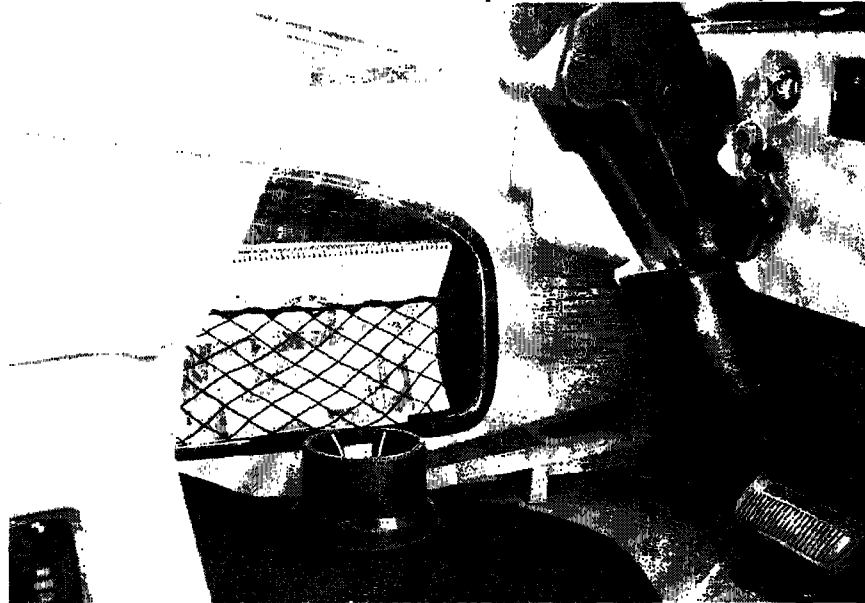
Photograph 3 -

An obscurely placed tire information placard on the subject vehicles made it difficult for owners to understand and comply with Country Coach's recommended tire inflation pressures. Country Coach elected to affix the originally installed vehicle certification placard (which includes tire pressure information) below knee level to the left of the driver's seat on the interior vehicle wall. (See Photograph 3, below).

Tire Certification Placard in Interior of Representative Country Coach Vehicle

Affixing the placard in this inconspicuous location (and recognizing that typical owners of luxury motorhomes are older and likely less-agile individuals), compromises the intent of the tire information placard since it is extremely difficult for owners to access and read the recommended tire inflation pressure information. For this reason, some owners kept the corrected placards provided through recall campaigns with their service records rather than install them in the vehicle. In some of these vehicles, subsequent vehicle purchasers, who had no reason to suspect that the placard information had been updated, relied on the incorrect original pre-recall tire inflation pressure information affixed to their vehicle.
