# ODI RESUME

Investigation: EA05-018  
 Prompted By: PE05-027  
 Date Opened: 11/02/2005  
 Principal Investigator: Chris Lash  
 Subject: Engine Stall  
 Date Closed: 08/29/07

Manufacturer: DaimlerChrysler Corporation  
 Products: 2004-05 Dodge Durango/Ram Pickups with 5.7L V8 Engine  
 Population: 425,198

## ENGINEERING ANALYSIS CLOSING REPORT

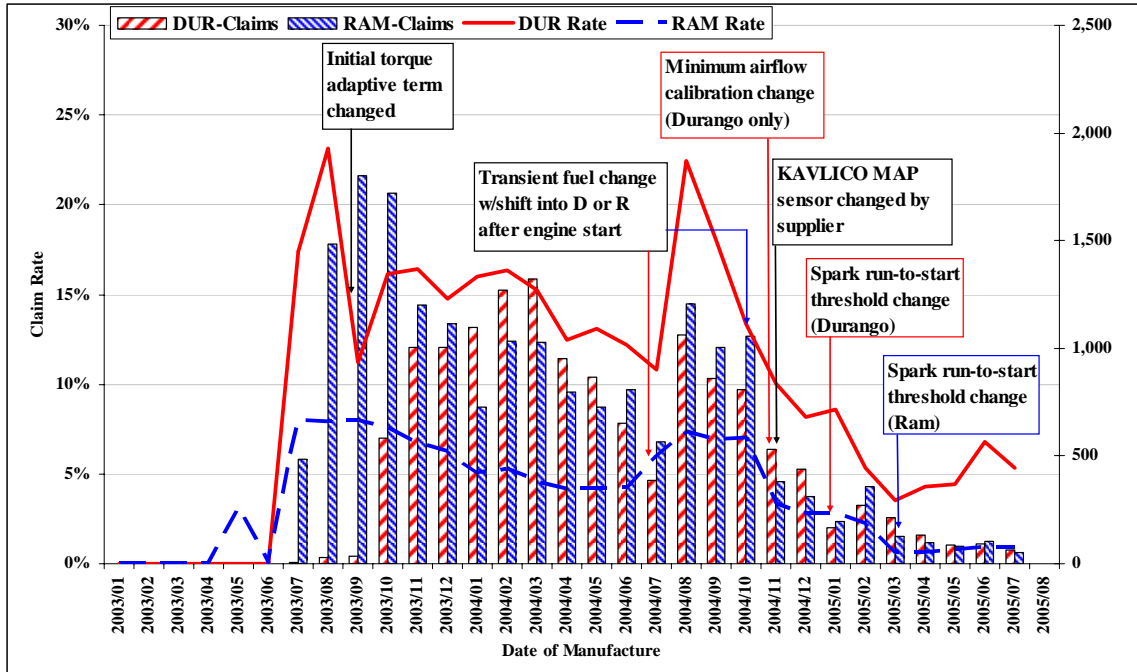
Figure 1. Total PCM Warranty Claims and Claim Rates (%), by Model and Month of Build.

Figure 1 shows the warranty claims and associated claim rates by model and month of build for all conditions related to PCM replacement, reprogramming or diagnostics. The Durango claim rates are approximately 2 to 3 times higher than the Ram rates. DCC identified several factors that could explain the different rates for the two models: 1) PCM calibrations; 2) Ram has a totally integrated program module (TIPM) and Durango has a front control module (FCM); 3) wiring routings; 4) fuel vapor purge system routings (Durango purge hose is in frame rail); 5) fuel tanks; 6) engine compartments; 7) air induction systems; 8) ESP calibrations; and 9) A/C systems (dual A/C system on Durango with increase load).

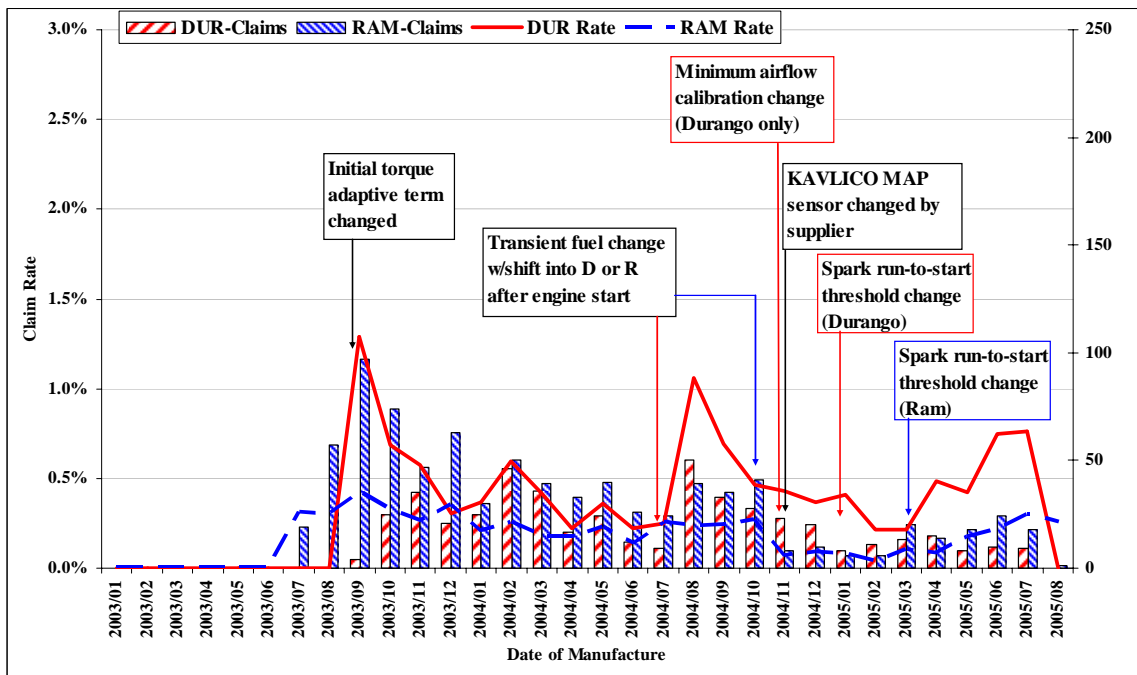
Figure 2. Stall/Die-out Engine Calibration Warranty Claims and Claim Rates (%), by Model and Month of Build.

Figure 2 shows a similar plot limited to warranty claims coded “stall” or “die-out.” This data is of limited analytical value as (1) these claims did not necessarily involve a stall while driving incident and (2) there were likely to be claims involving repairs for stalling that were not coded “stall” or “die-out.” This chart shows less difference between the Durango and Ram vehicles for MY 2004, but again shows greater Durango rates for MY 2005 vehicles – particularly at the start

of MY 2005 production from August through October 2004.

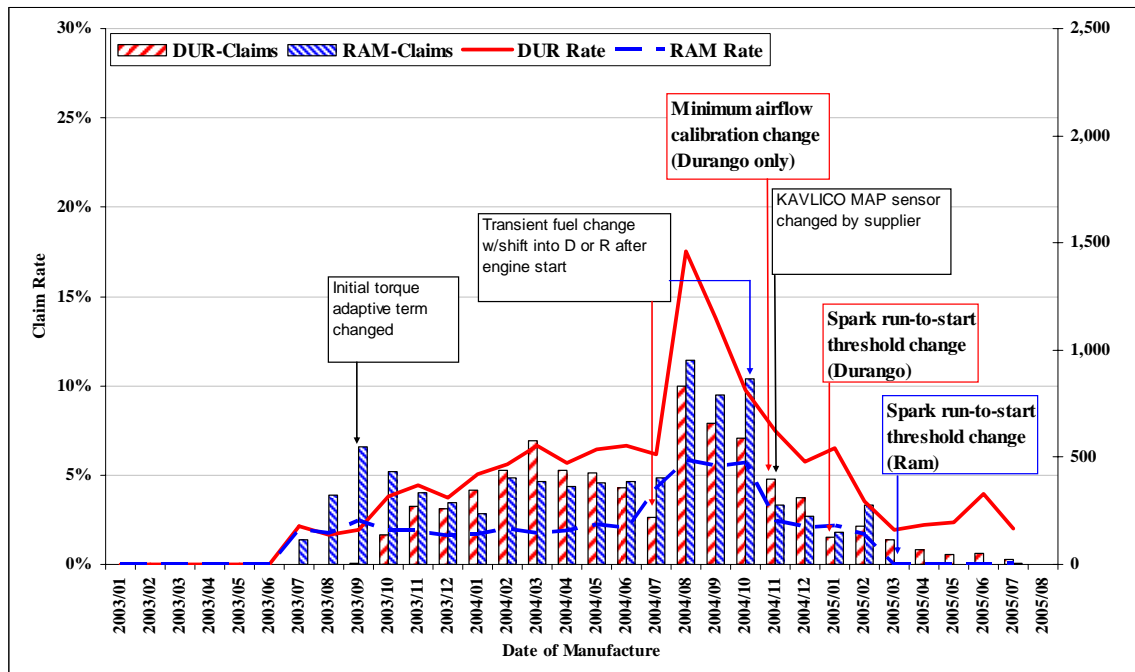
Figure 3. PCM Reprogramming Warranty Claims and Claim Rates (%), by Model and Month of Build.

Figure 3 shows the warranty claims and rates for repairs involving PCM reprogramming. Repairs in this category were predominantly related to the technical service bulletins issued by DCC in early 2005 (see Tables 5 and 6). Once again the Durango rates are significantly higher with experience peaking in early MY 2005 production, when there were multiple PCM calibration issues identified by DCC for the Durango vehicles.<sup>5</sup>

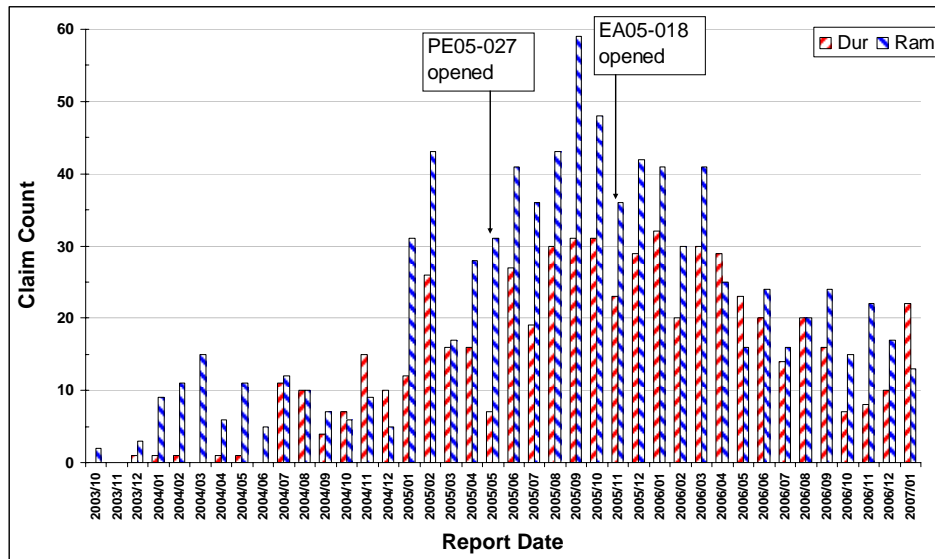
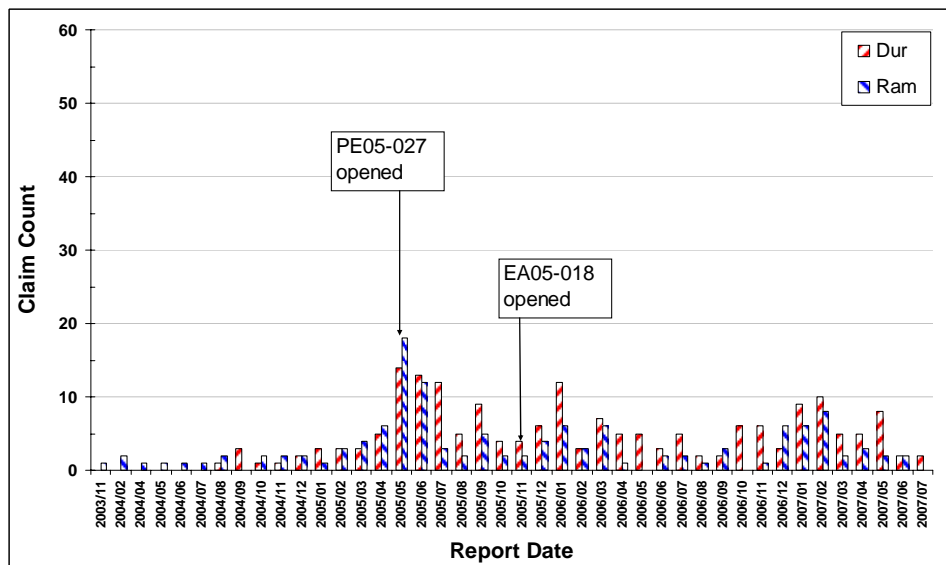
**Trends.** ODI analyzed complaint and warranty claim data by month of report and claim to assess whether the stalling experience in the subject vehicles is increasing, decreasing or constant over time. Figures 4 and 5 show the number of complaints received by DCC and ODI from late 2003 through January 2007 (DCC) and July 2007 (ODI). The data show that complaint inputs to DCC and ODI both peaked in 2005. After 2005, complaints continued at lower but steady levels with a slight increase noted in ODI input in early 2007.

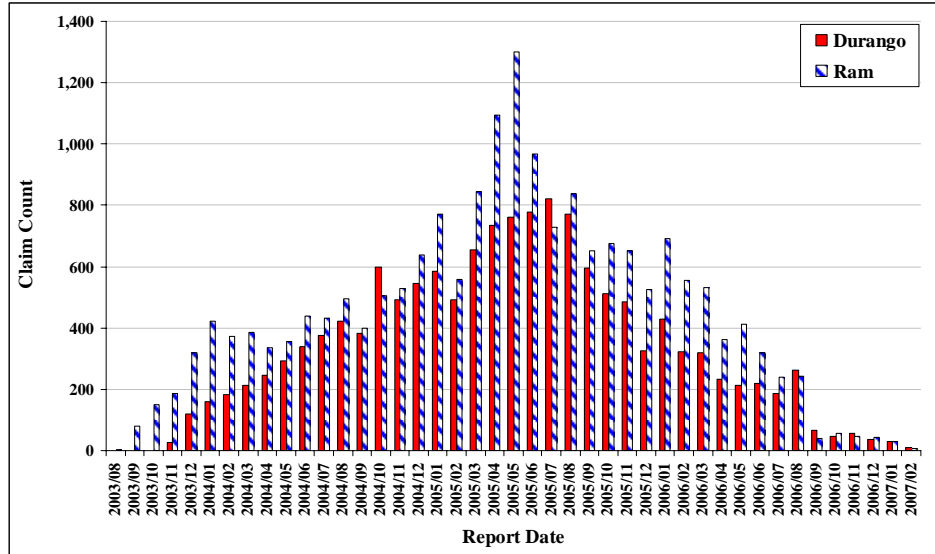
Figure 6. Warranty claim trends by model and repair month.

Figure 6 shows the overall trend in warranty claims related to PCM replacement, PCM reprogramming and engine or electrical diagnostic claims in the subject vehicles by model and repair month. Claims peaked in mid-2005 and showed a steady decline through 2006 and into early 2007.

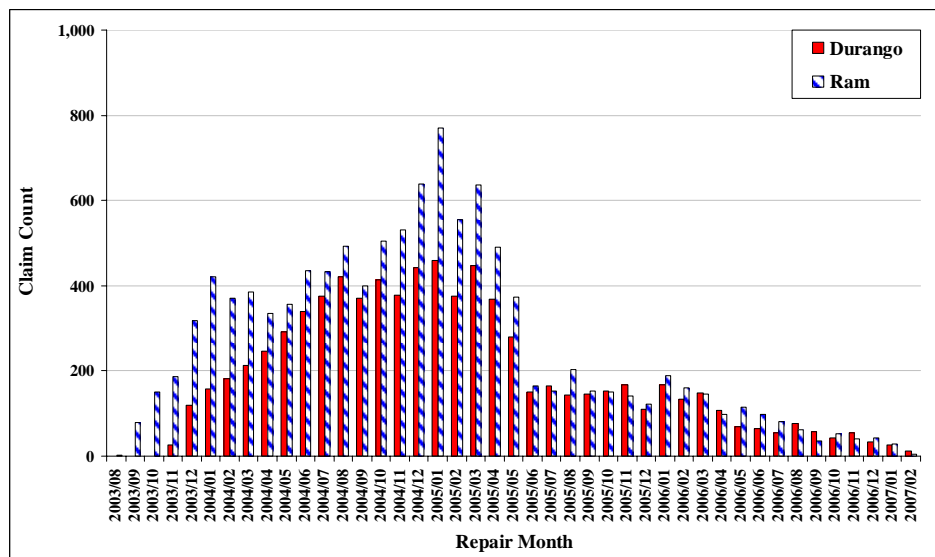
Figure 7. Warranty claim trends, not related to PCM reprogramming, by model and repair month.

Figure 7 shows the trends for claims not related to PCM reprogramming. These claims primarily involve engine or electrical diagnostics, which were the predominant claim type prior to DCC’s issuance of TSB 018-13-005 in early 2005. These claims dropped sharply when the TSB was issued and have continued to decline in number in the months that followed.

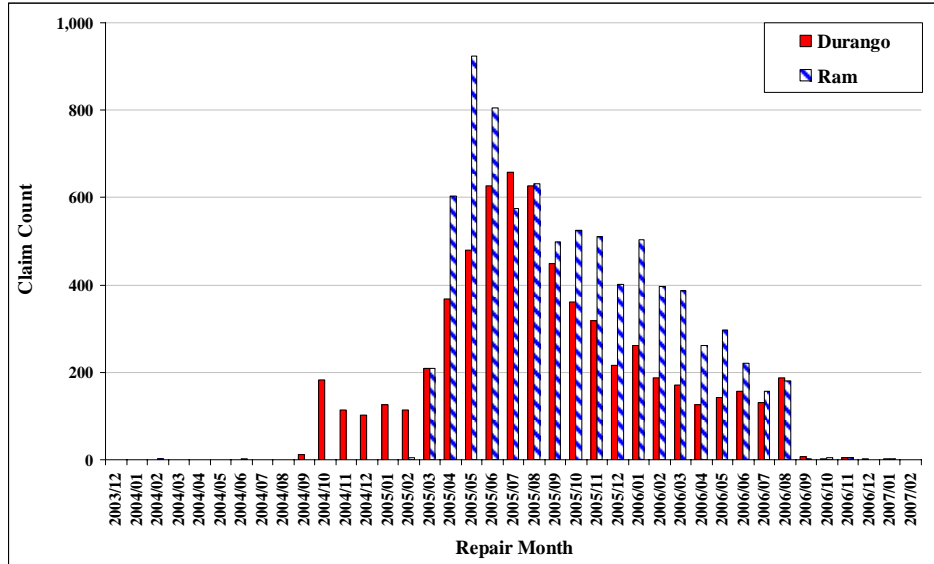
Figure 8. Warranty claim trends, PCM reprogramming, by model and repair month

Figure 8 shows the trends for claims involving reprogramming of the PCM. These claims rose sharply in early-2005 when the PCM reprogramming TSB’s were released, but have shown a steady decline in 2006 and again in 2007.
