**National Highway
Traffic Safety
Administration**

NVS-212am
DP05-004

Denial of Motor Vehicle Defect Petition

ACTION: Denial of petition for a defect investigation.

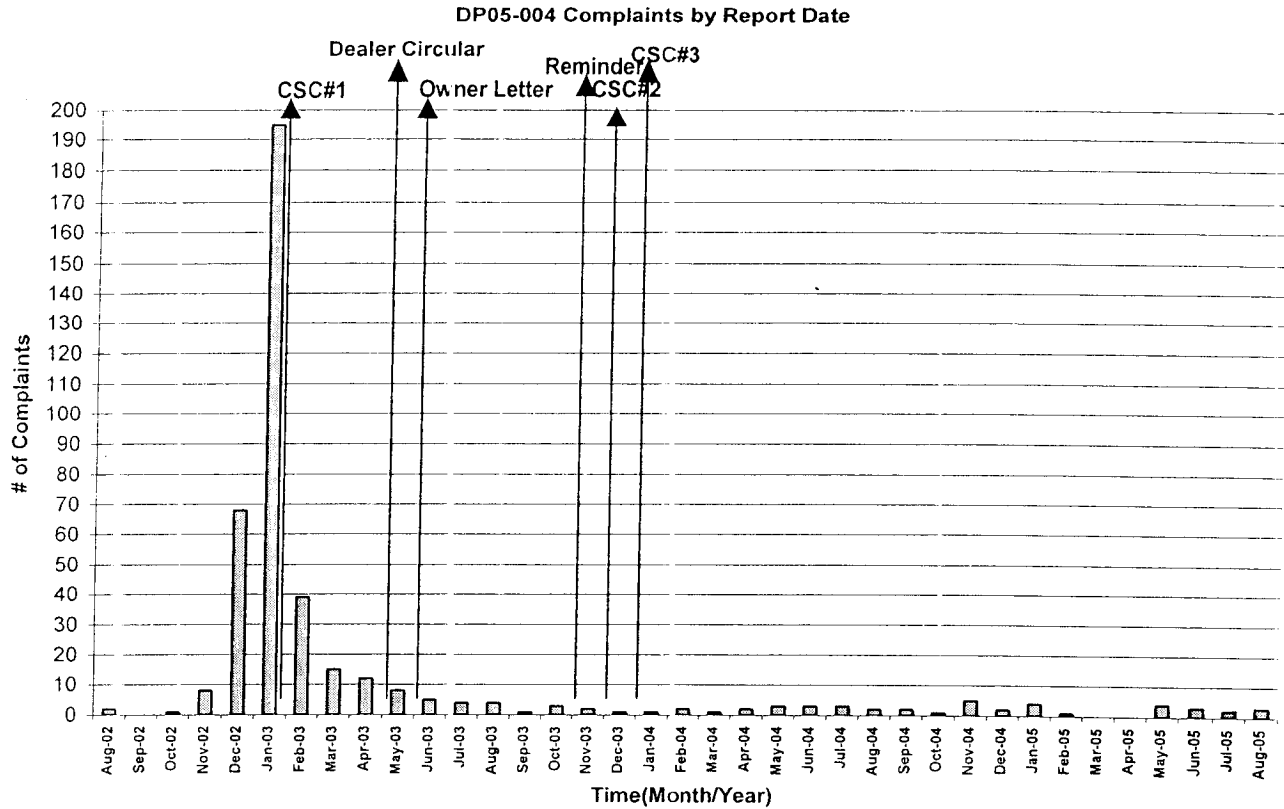
Figure 1: Complaints by Report Date

Within the last 12 months ODI has received only 17 complaints regarding either stalling or drivability issues with these ignition coils. Within the last two years ODI has received only 38 complaints. After the first CSC was sent to dealerships on January 31, 2003, by VW, the number of complaints regarding this issue has rapidly declined. (Figure 1)
