FIELD TECHNICAL REPORT

TQCN DOC# FTR-JR1116141		Affiliate TMS	Dept. QA-Chassis	Source FTS	Location REG-CIN	Ref 20787-1	Date 6/14/2004
Problem Area Base Vehicle	Primary Model Tundra	Model Year 2003	Production Date 11-2002	Odometer 19492 mi	VIN (confirm 17 characters): 5TBBT441 [REDACTED]		
Condition Title LEFT FRONT WHEEL BALL JOINT

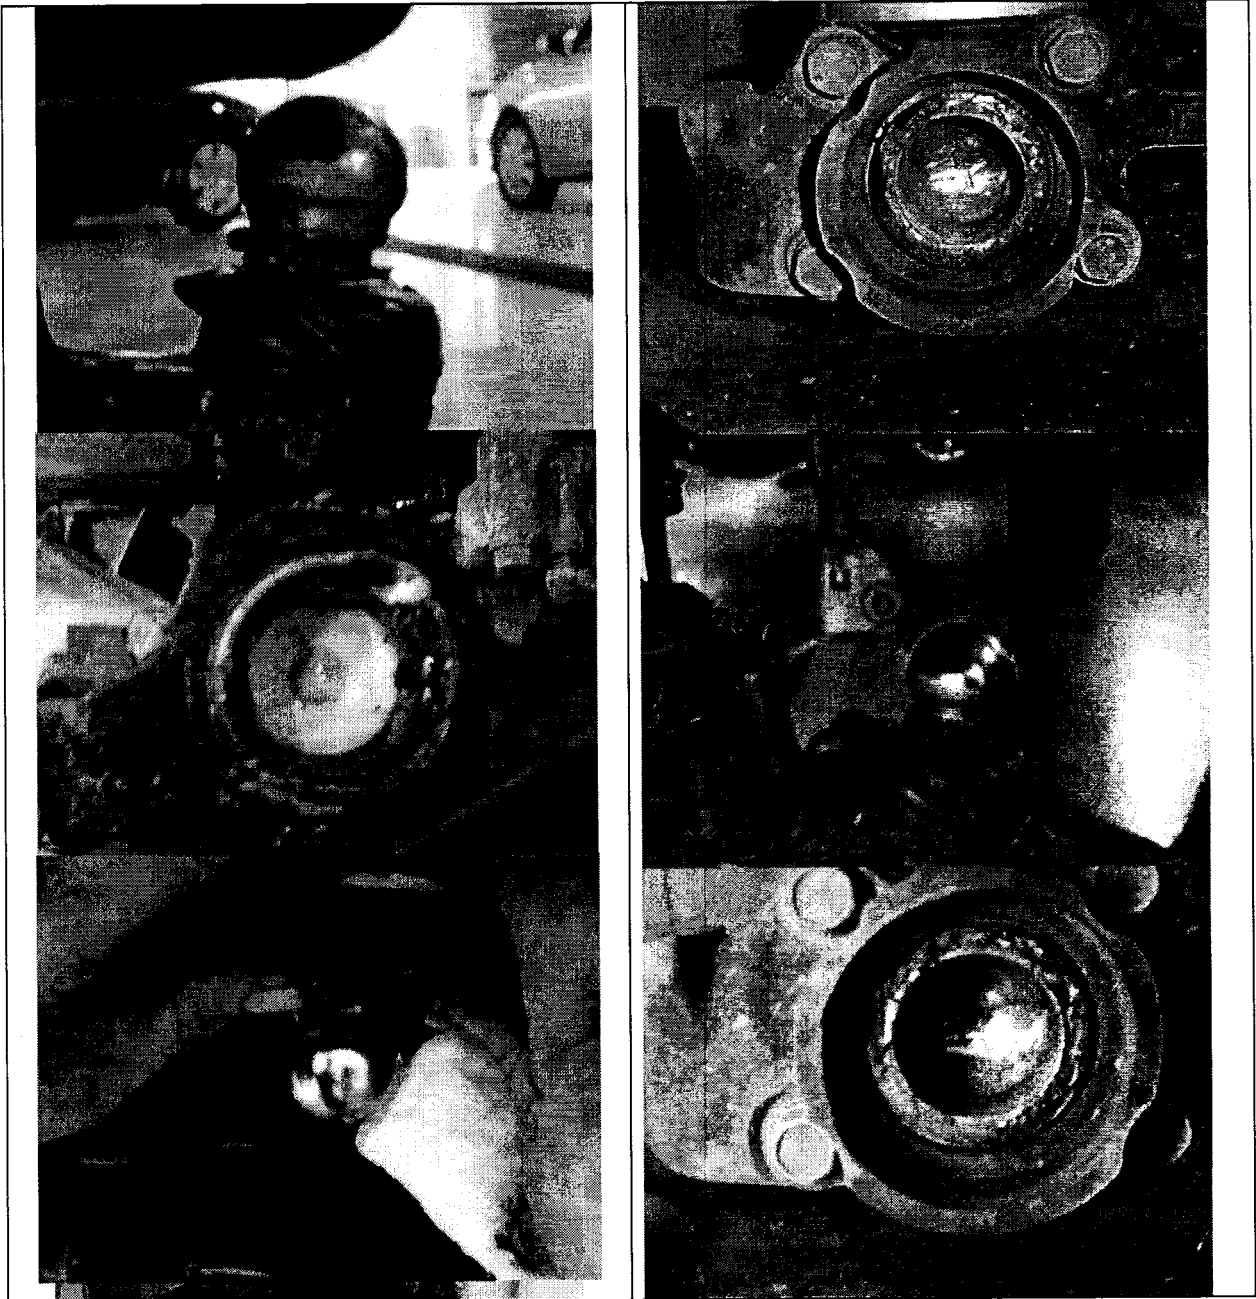
Customer states while driving the left front wheel came loose and skidded to a stop. Left front wheel assembly appears to have separated from suspension at the upper and lower ball joint sockets.

Dealership and D.S.P.M. indicate there is no indication of off road use such as mud, unusual amounts of dirt or bent or scrapped components under vehicle. It appears the upper and lower control arm ball joints separated ball from socket. Unable to determine which separated first.

<p>LEFT FRONT WHEEL DAMAGE</p>	<p>BODY DAMAGE</p>

Lower and upper ball joints and associated and damaged parts replaced with new components.

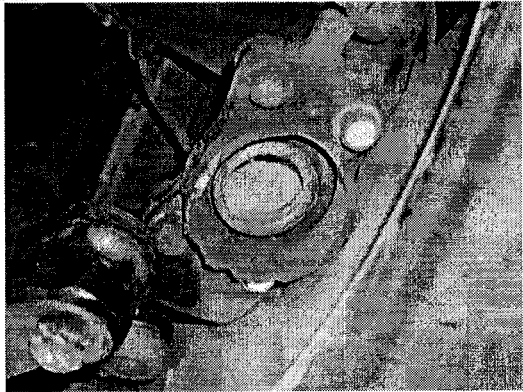
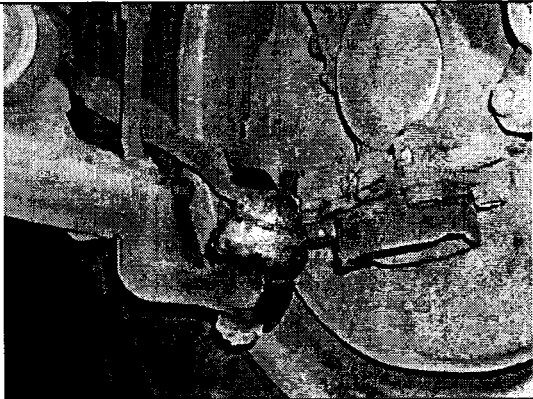
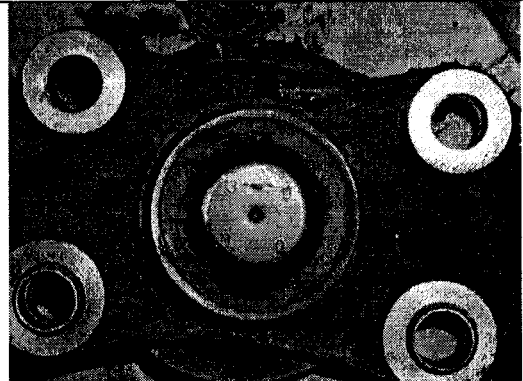
<p>Production Lot No. 39 30 (9/30/2003)</p>

Found left front of vehicle dropped onto wheel. Inspect suspension components and found left lower ball joint stud separated from socket. Ball socket heavily scored and enlarged to the point where the ball stud was able to separate.

Replace lower ball joint.

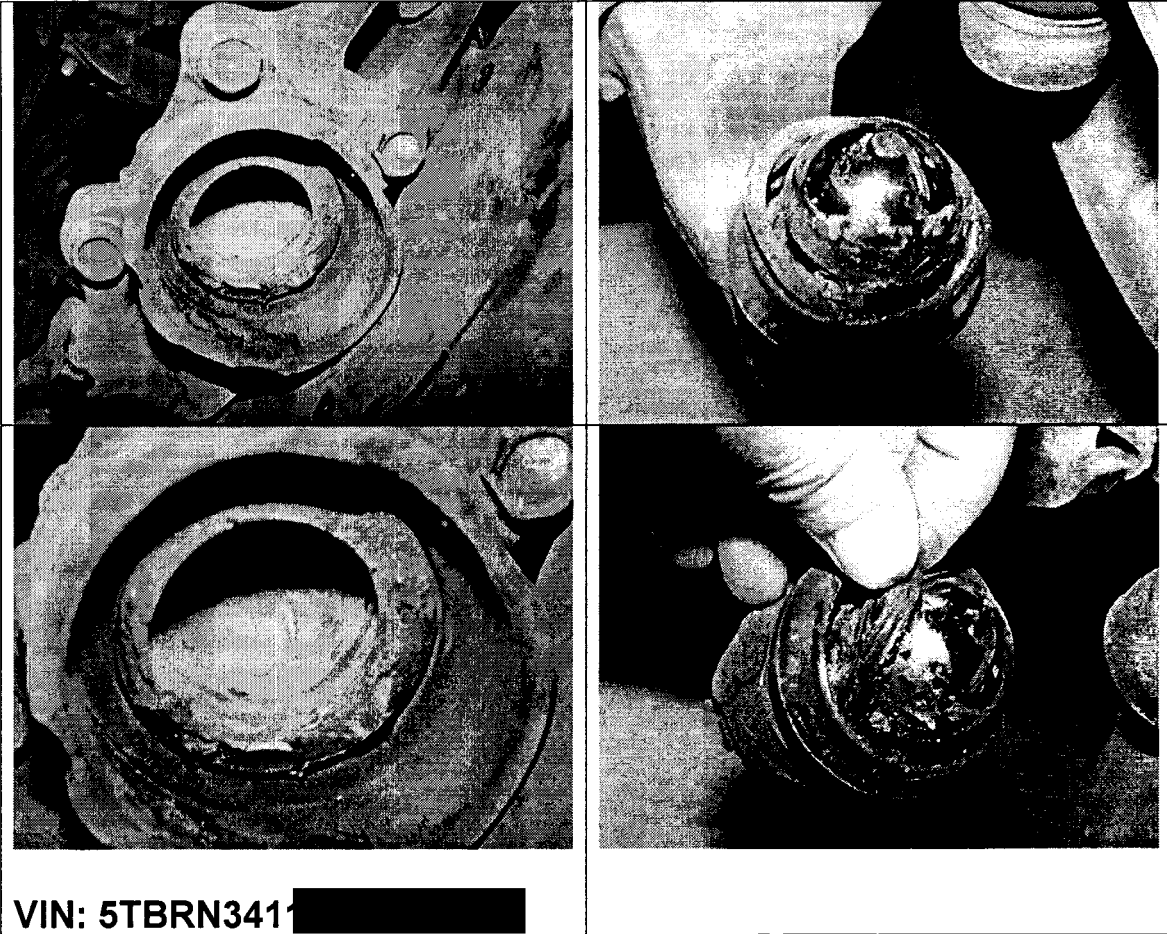
VIN: 5TBRN341 [REDACTED]

Found the ball joint had evidence of dirt entering the socket area. The grease mixed with dirt caused sufficient abrasion to wear the ball and socket enough that the joint separated. This is the third vehicle examined with this condition.

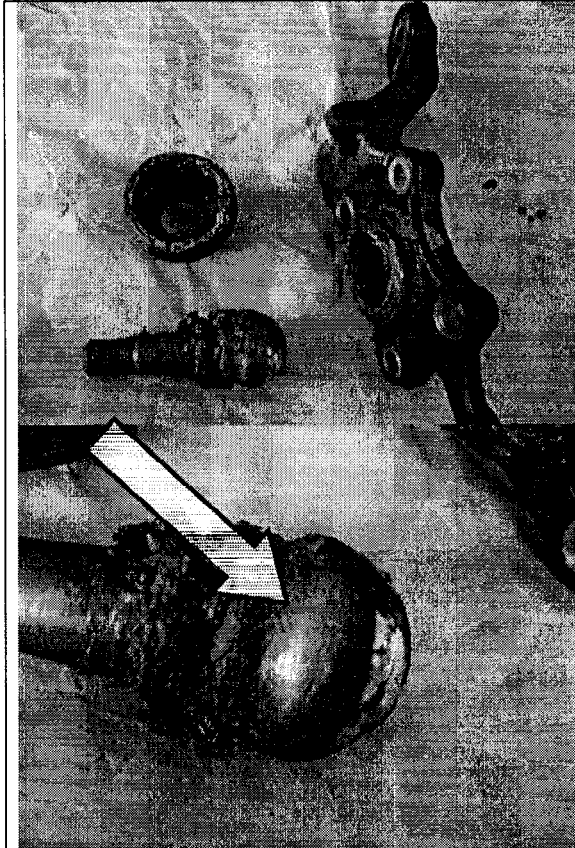
Note the wear marks on the ball.
VIN: 5TBJN3217 [REDACTED]

Replaced the ball joint assembly and other parts related to the concern.

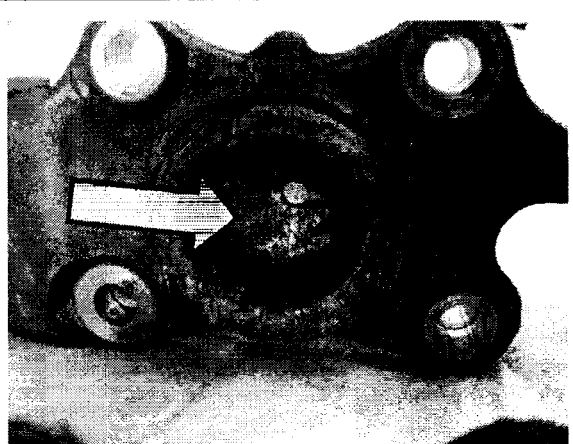
The socket shows the presence of contamination.

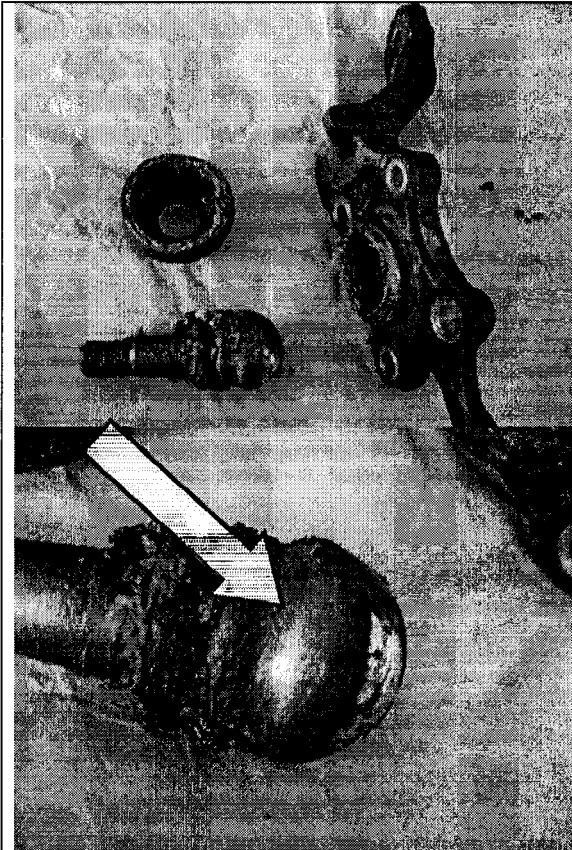
Found the ball joint had evidence of dirt entering the socket area. The grease mixed with dirt caused sufficient abrasion to wear the ball and socket enough that the joint separated. This is the third vehicle examined with this condition.

Note the wear marks on the ball.
VIN: 5TBJN321 [REDACTED]

Replaced the ball joint assembly and other parts related to the concern.

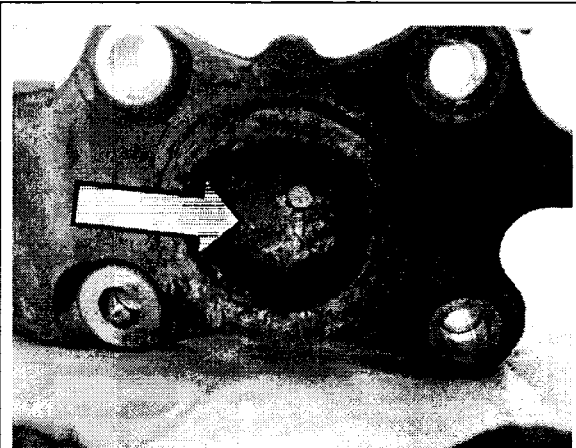
The socket shows the presence of contamination.

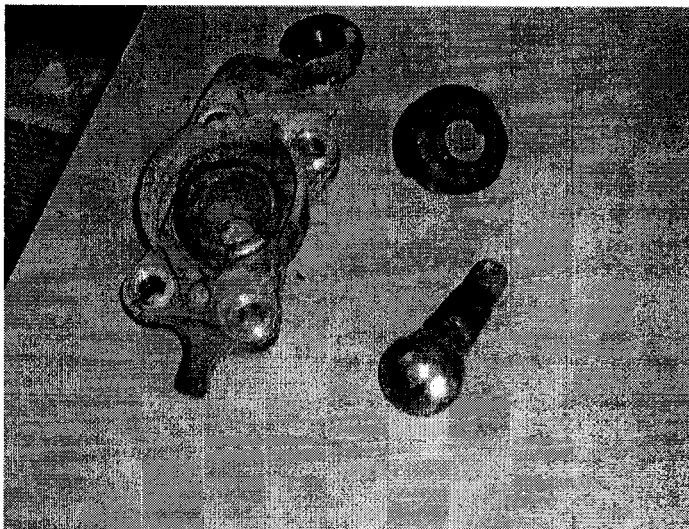
Separated ball joint components

Replace ball joint and related damaged parts. Parts have been recovered and will be provided to CQE.

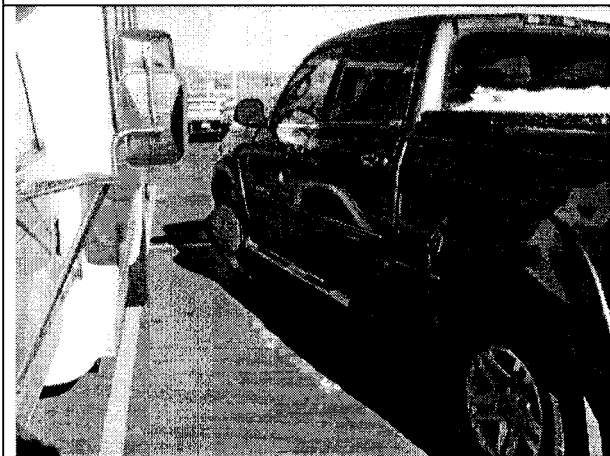
Truck looks very clean especially considering the high mileage. Toolbox appears to be a permanent fixture in this contractor vehicle. Bed liner looks well worn but there are no breaks or deep scratches (condition is consistent with frequent light loads as the customer indicated).

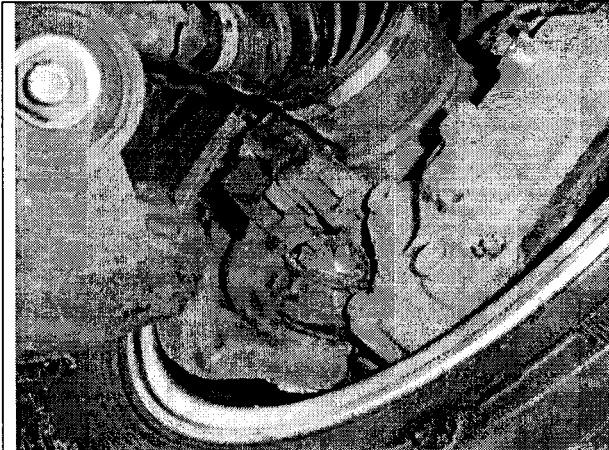
- 1) Suspension inspection revealed a worn lower L/F ball joint that had separated.
- 2) No collision damage, past or present, was noted anywhere on the vehicle.

Wear on lower L/F ball joint suggests that separation was root cause of suspension damage.

L/F and R/F upper and lower ball joints were replaced as well as all other components that had suffered incidental damage to repair the problem.

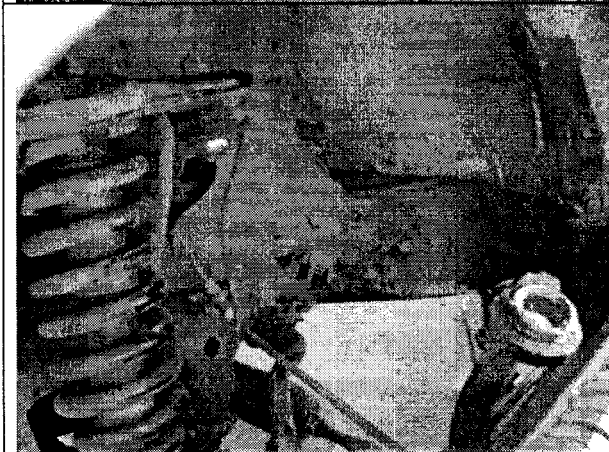
Upper ball joint also separated but it showed no signs of wear. Upper BJ separation was believed to be incidental damage.

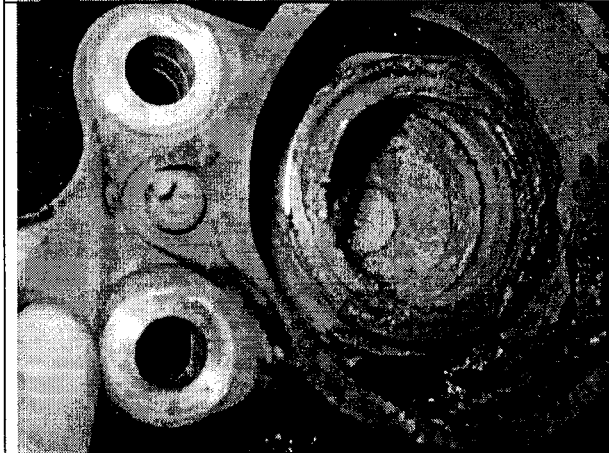
Socket for L/F lower ball joint after removal.

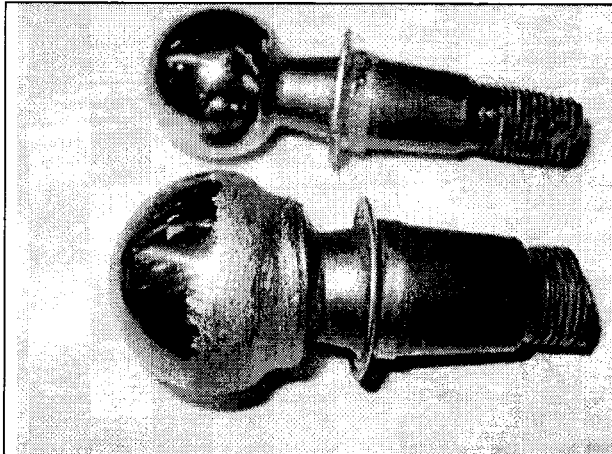
L/F upper ball shows no signs of wear

L/F lower ball joint shows 1-1.5 mm of wear depth in the load bearing area. Missing portion of threaded stud was caused by contact with road after separation occurred.

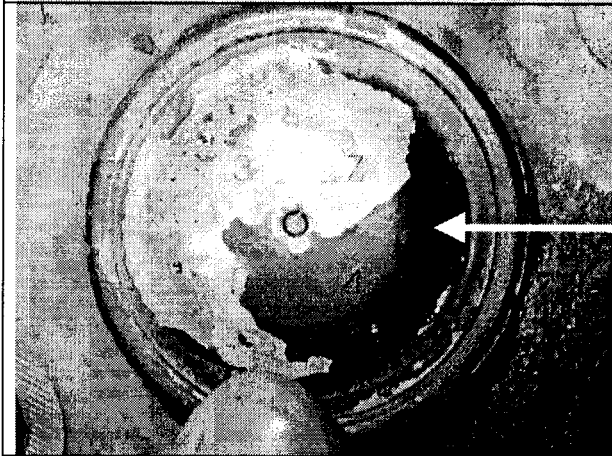
Production date coding of lower L/F ball joint is not completely explained by the SSC 50J technical instructions:

3 Z
0 4

Suspect that the 'Z' designator for month is October, November, or December yielding Month "Z", 4, 2003.

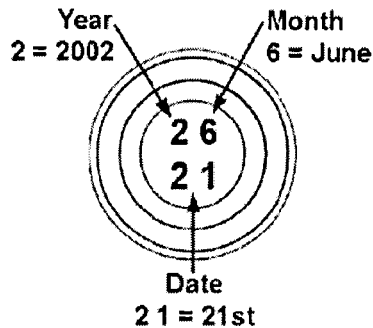
SSC shows the month having a numeric indicator. Suspect alpha characters may be used for months 10-12.

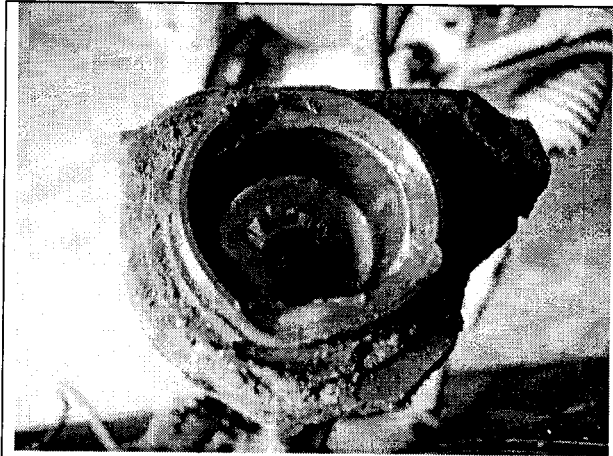
Upper Ball Joint assembly grease: clean.

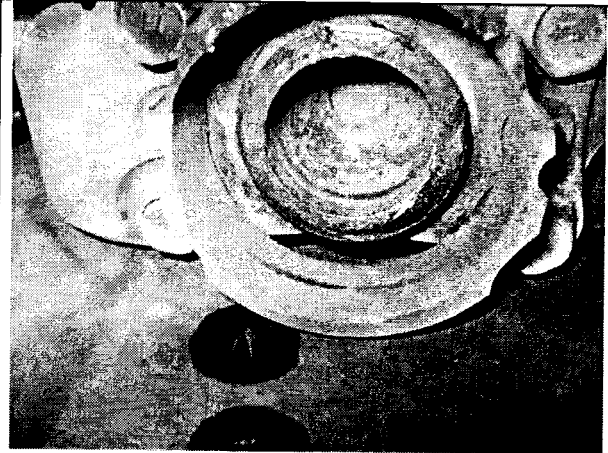
Lower Ball Joint assembly grease: dirty.
