REPORT OF ANALYSIS

EA05-005

I. Problem Statement

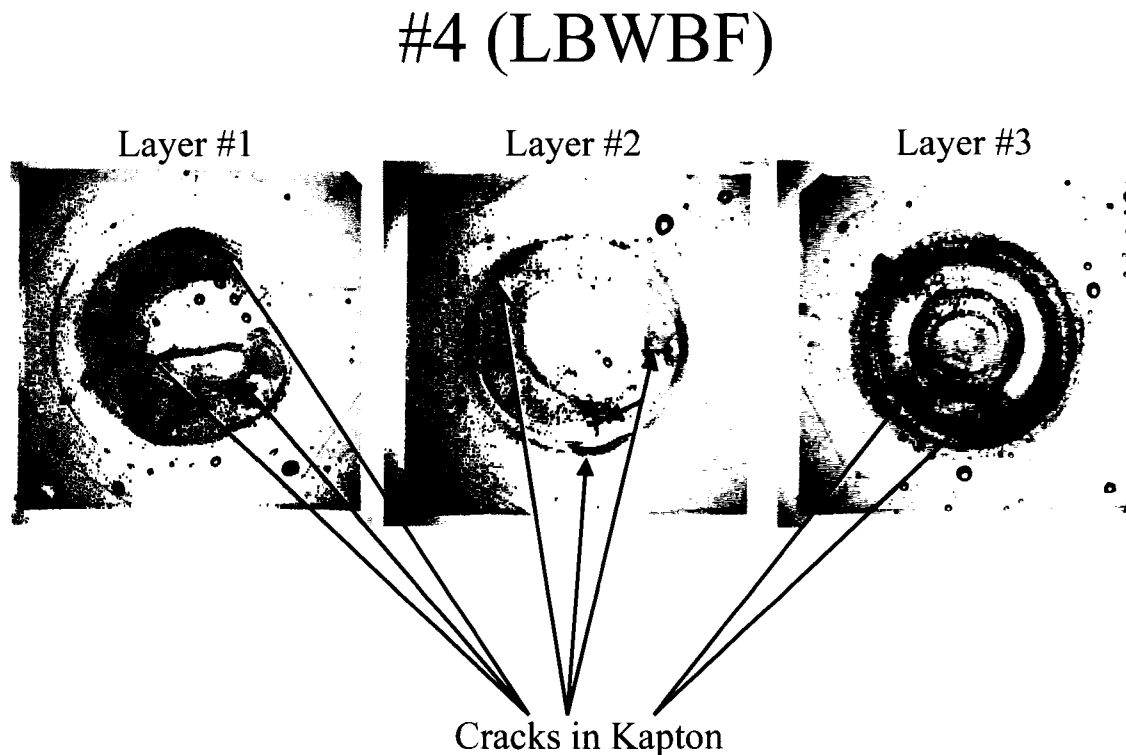
In general the Kapton seals from the bad SCDSs were found to have cracks such as those shown in Figure 5. In contrast, the Likely Good specimens were usually found to be devoid of the large cracks found in Figure 5 (see Figure 6 for comparison). However, around the button region of the converter (see Figure 1b) small microcracks were typically found to occur (see Figure 7) in specimens labeled as Likely Good.

Figure 5. Optical images of Kapton film layers from #4 speed control deactivation switch (SCDS). This SCDS was characterized as a bad device that was lightly burned with brake fluid remaining (LBWBF). Note the cracks in each of the layers. Layer #1 is the film that is next to the brake fluid.

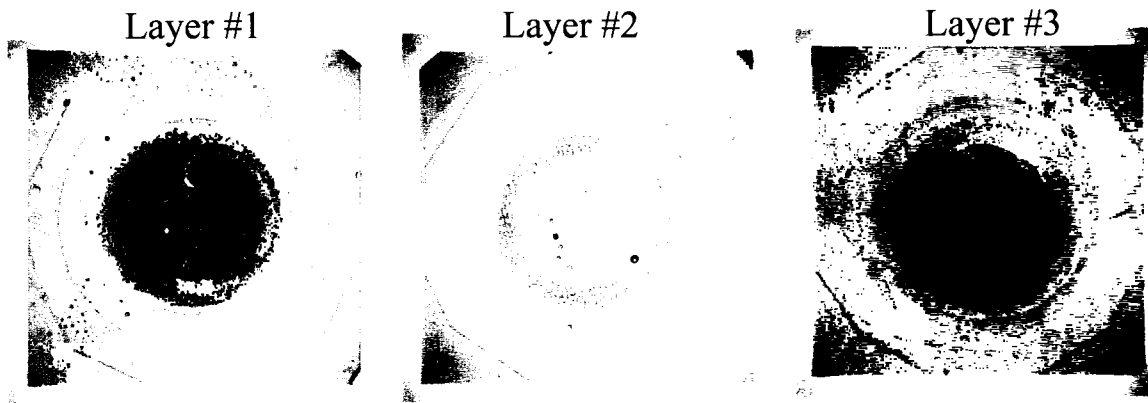
#5 (Likely Good)

Figure 6. Optical images of Kapton film layers from #5 speed control deactivation switch (SCDS). This SCDS was characterized as a "Likely Good." Note the absence of large cracks in each of the layers. Layer #1 is the film that is next to the brake fluid.

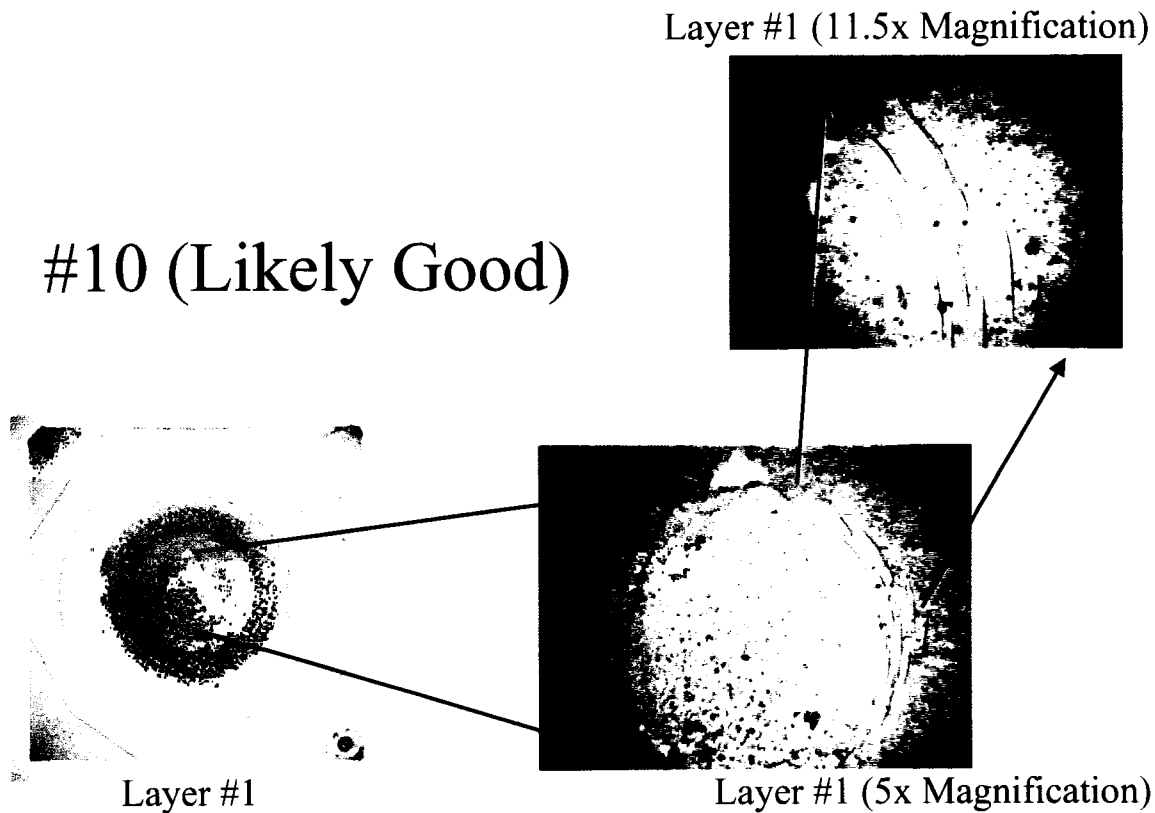
#10 (Likely Good)

Figure 7. Magnification of region on Kapton film where it is deformed by the button on the converter (see Figure 1). Note circular pattern of cracks.

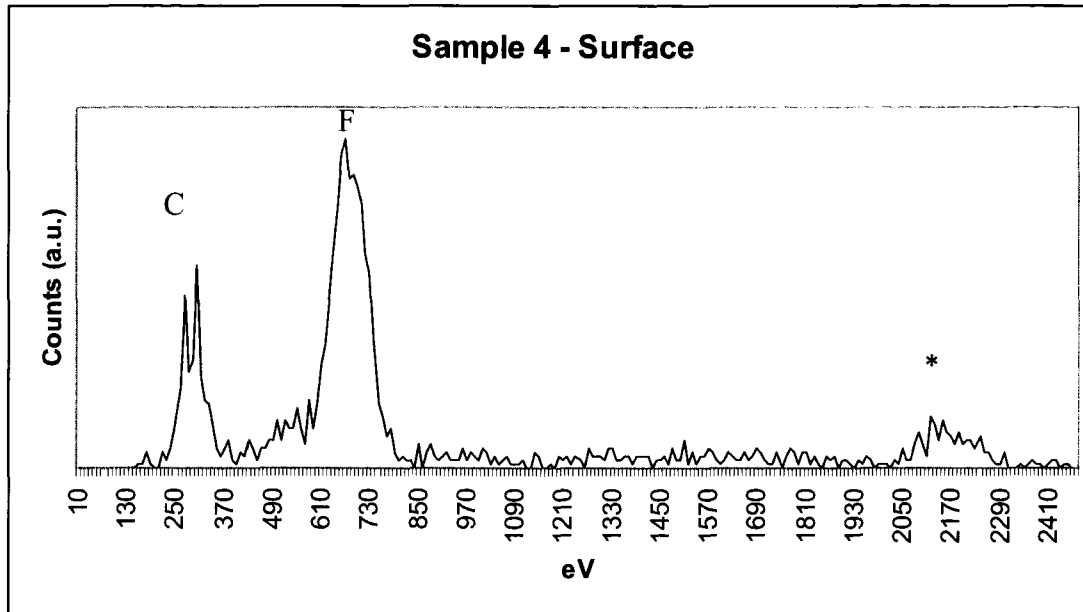
Figure 14. X-ray microanalysis of SCDS #4, Surface, * This peak was not expected, possibly a contaminant, possible matches are Na, Cu, Zn

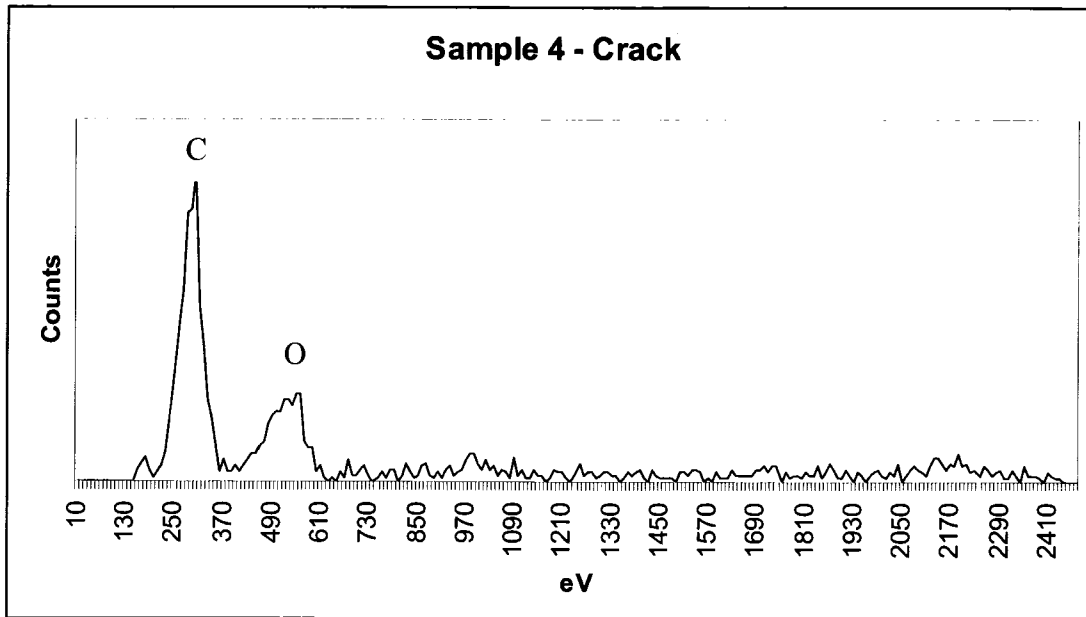
Figure 15. X-ray microanalysis of SCDS #4, Crack

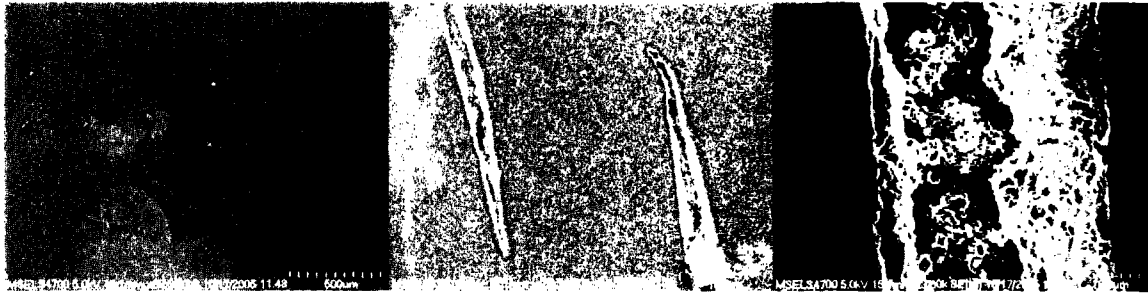
Figure 16. TEM micrographs of damage regions on SCDS #7.

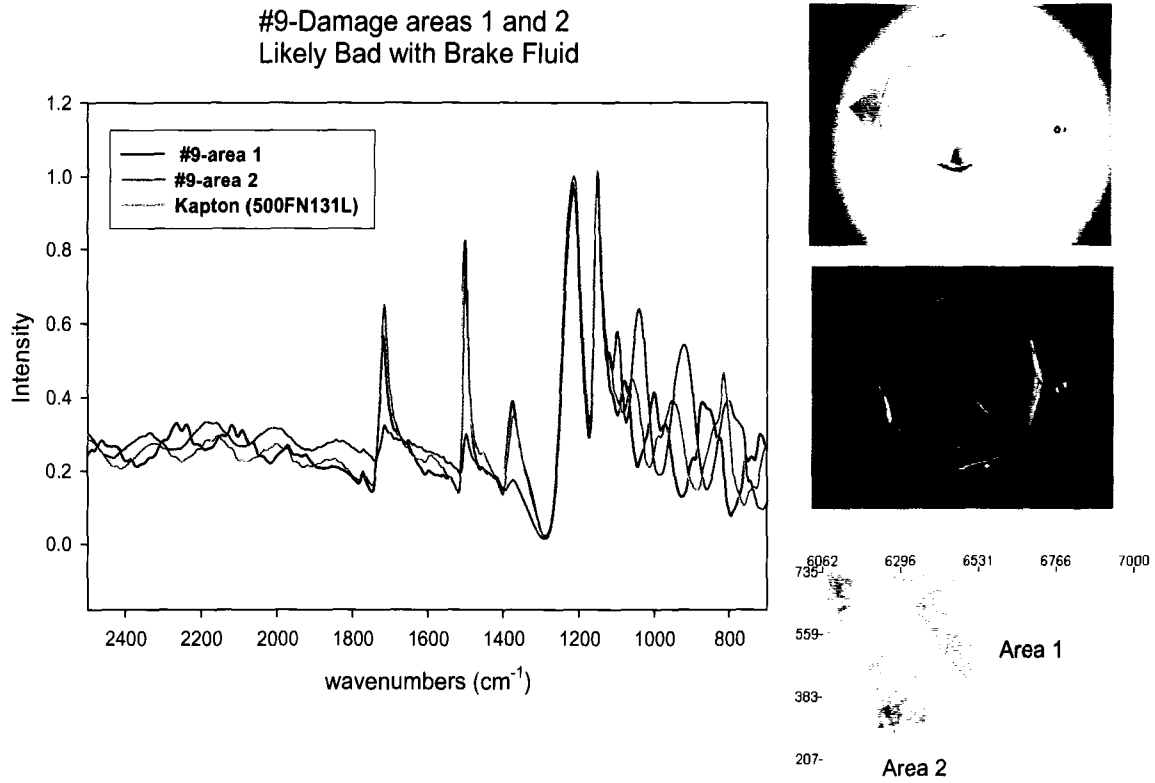
Figure 24: FT-IR reflectance spectra of damaged and undamaged areas and associated optical images.

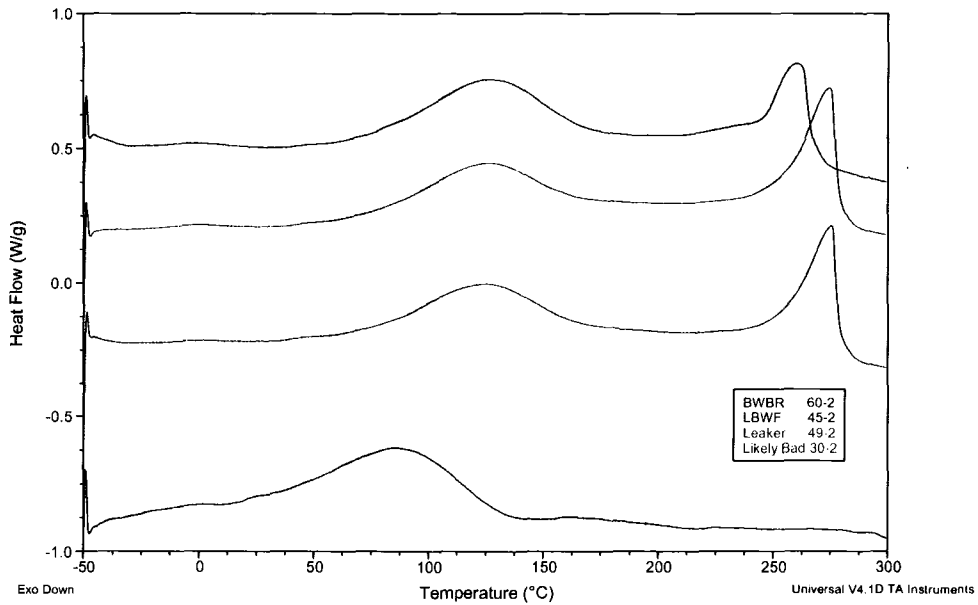
Figure 30. Typical DSC scans comparing “bad” and likely to go bad SCDS’s. (Note that these are the same SCDSs displayed in Figure 28.)

It is apparent from the LBWBR and BWBR DSC scans in Figure 30 that burning resulting in temperatures nearing or exceeding the melting point of the FEP crystals. In both case there is a change in the shape or loss of magnitude in the crystal melting peak.
