EA05-005

**US DEPARTMENT OF
COMMERCE 3/1/2005**

REPORT OF ANALYSIS

PART 2 OF 2

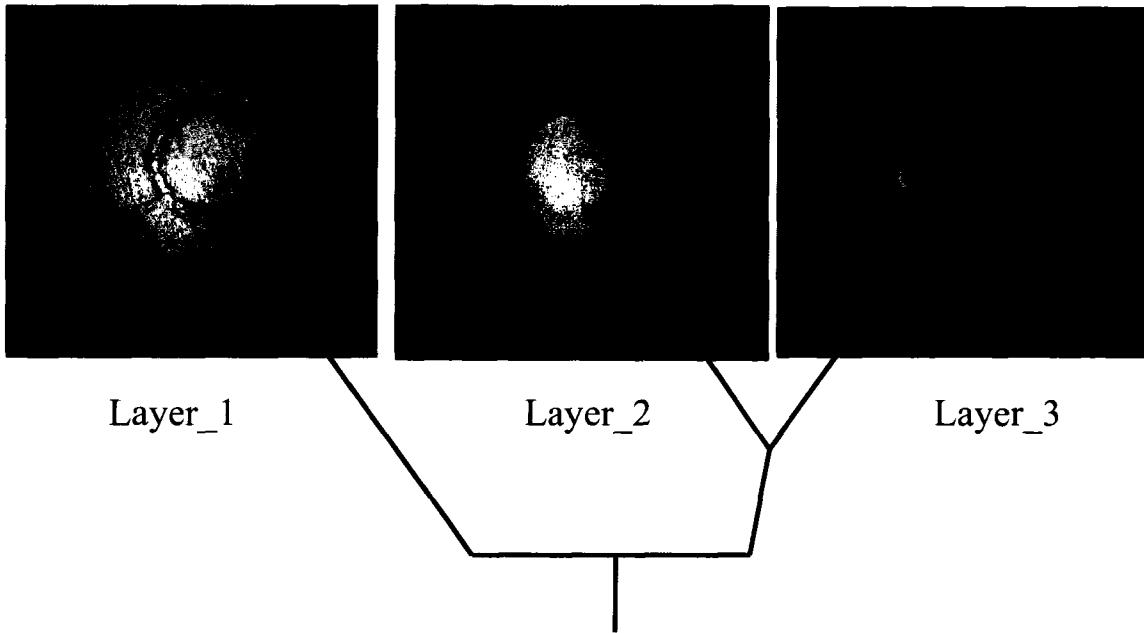
SCDS #26

(Note: Layer_1 Normal seat Ring barely visible. Normal Seat Rings clearly observed on Layer_2 & Layer_3)

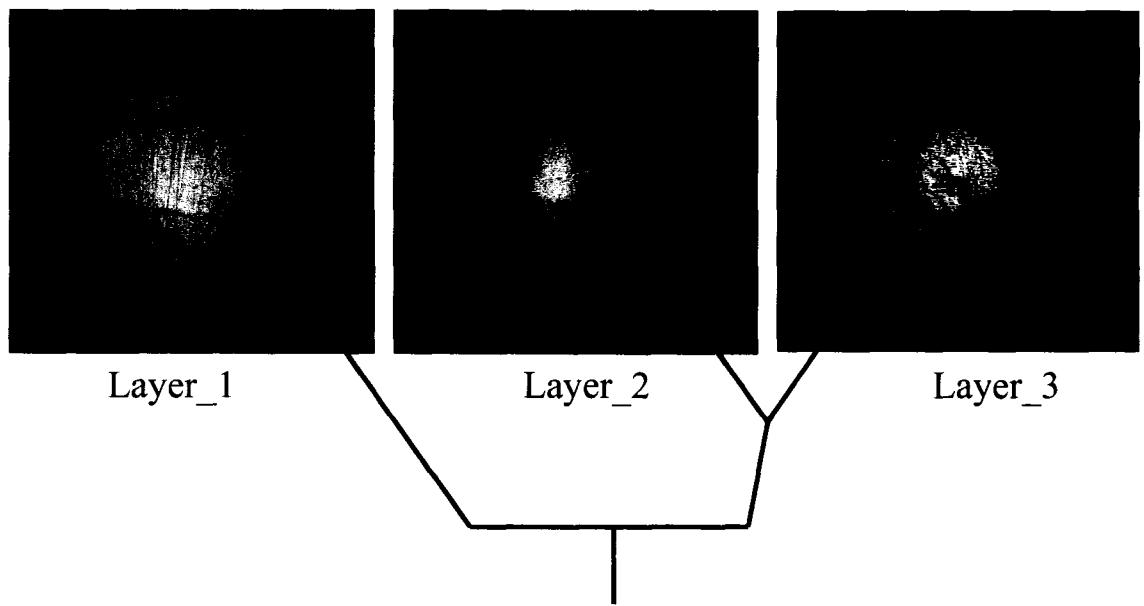
SCDS #27

(Note: Normal Seat Rings clearly observed on all Layers)

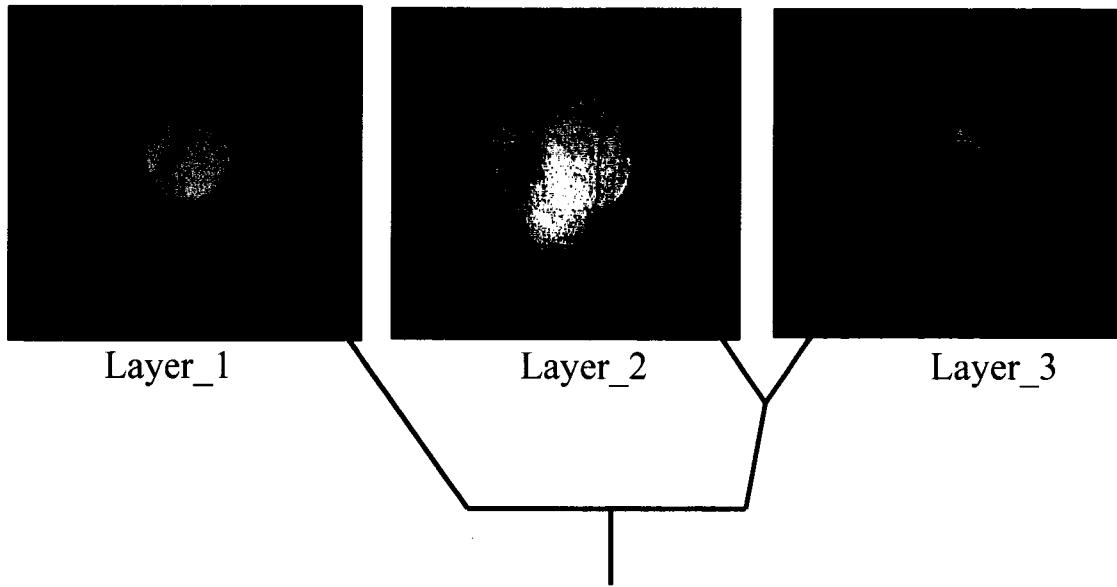
SCDS #28

(Note: Normal Seat Rings clearly observed on Layer_1 & Layer_3)

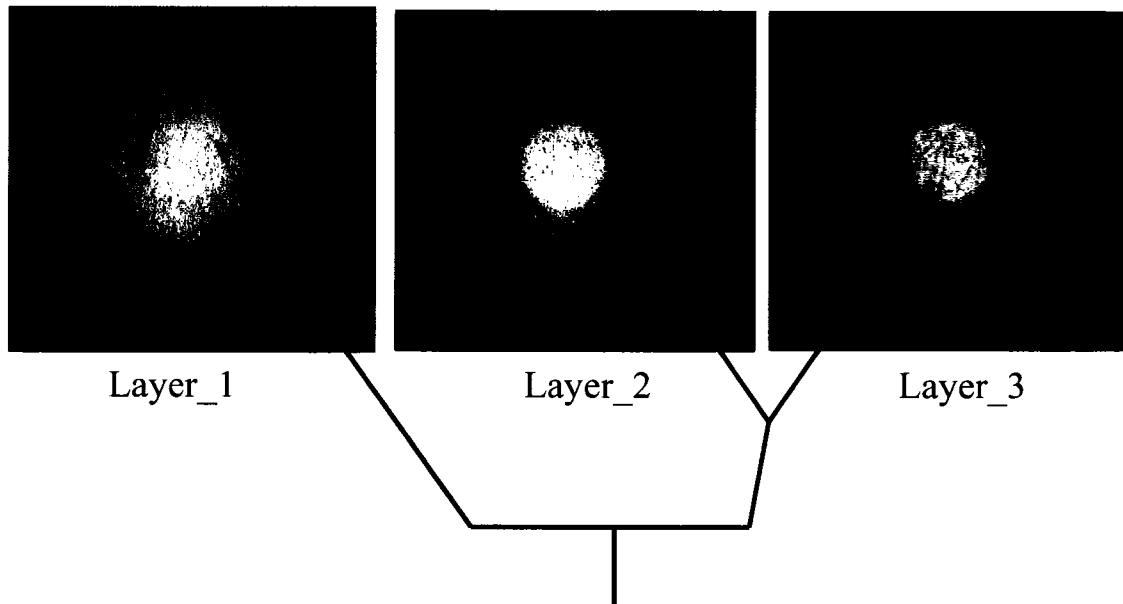
SCDS #29

(Note: Normal Seat Rings clearly observed on all Layers)

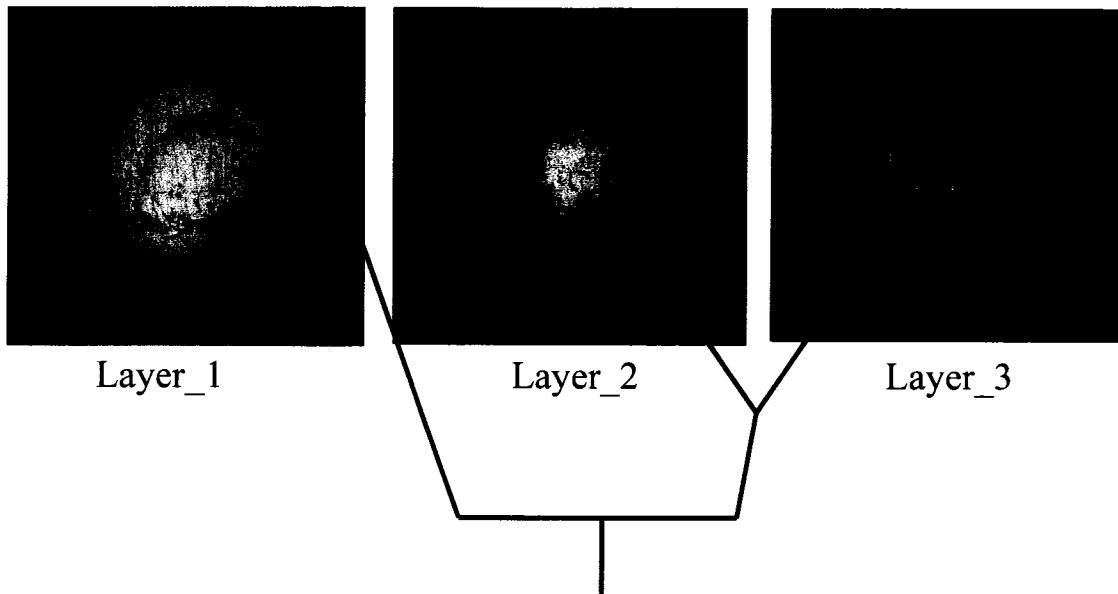
SCDS #34

(Note: Normal Seat Rings clearly observed on Layer_2)

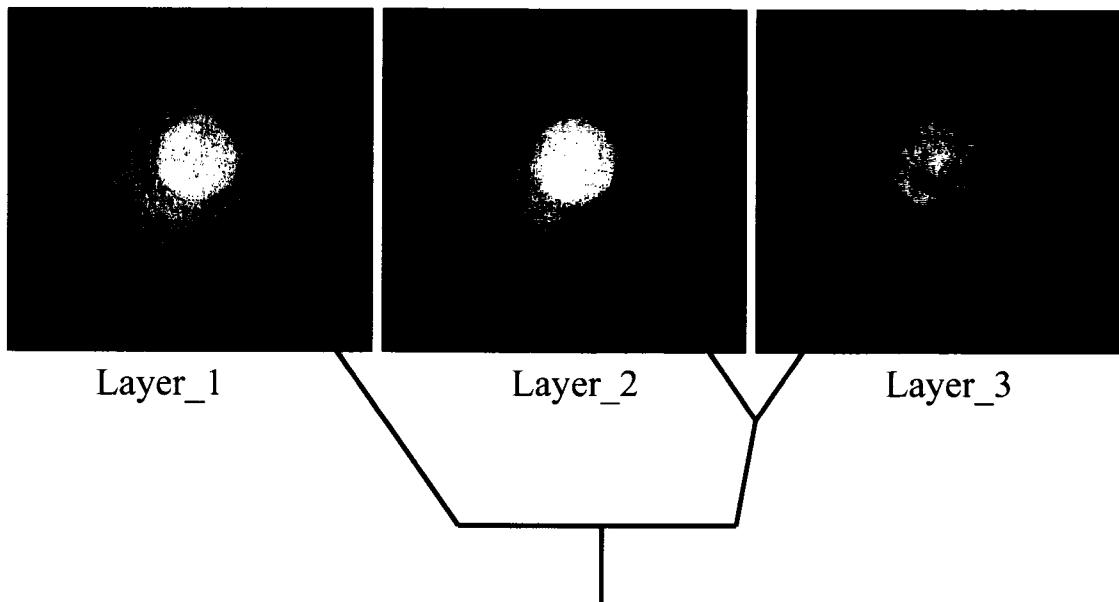
SCDS #36

(Note: Normal Seat Rings clearly observed on all Layers. Layer_1 indicates some damage due to normal wear.... I particular debonding in seat region)

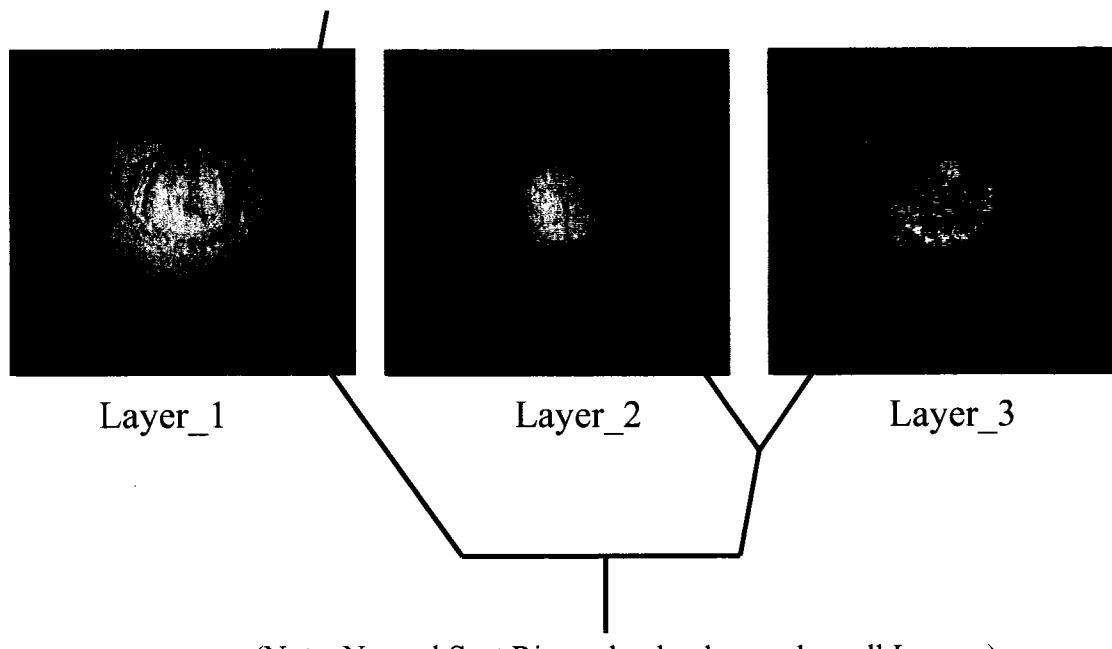
SCDS #40

Possible TearDrop Formation

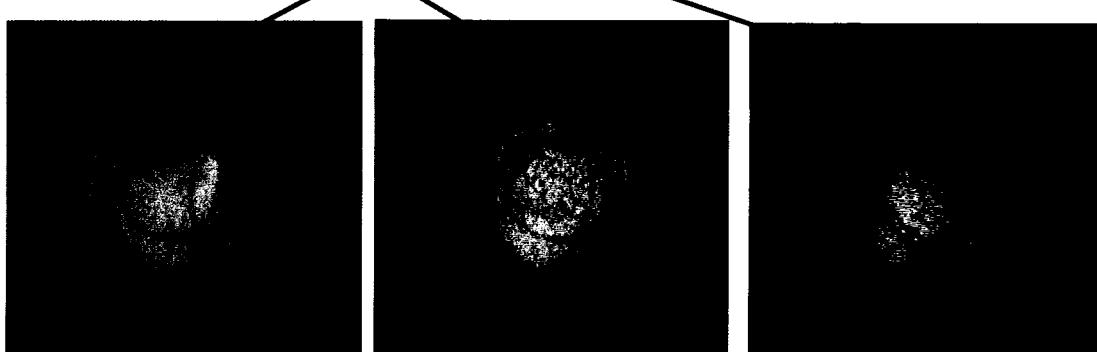
SCDS #3

Double TearDrop Formation on all Layers

(Note: Normal Seat Rings distorted on all Layers.)
