Re: Lexus RX330 Brake Booster Service Campaign SLA

Special Service Campaign 5LA

TECHNICAL INSTRUCTIONS
FOR
SPECIAL SERVICE CAMPAIGN 5LA
2004 MODEL YEAR
NORTH AMERICAN PRODUCED (NAP) RX 330
BRAKE BOOSTER

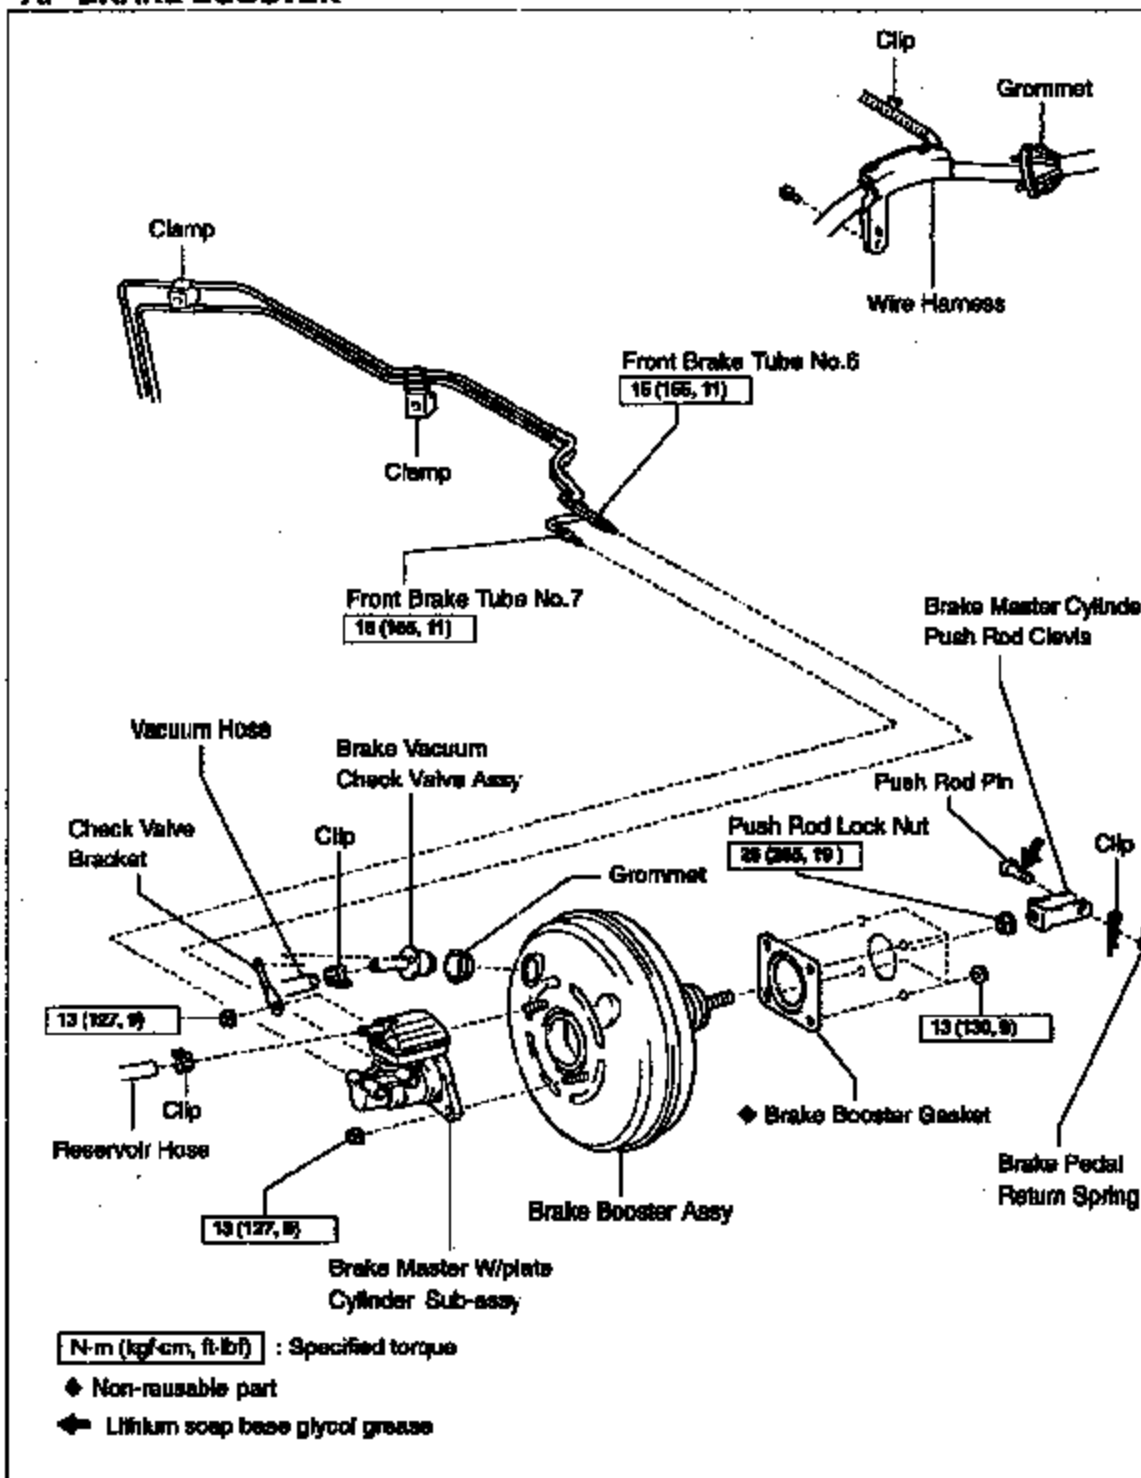
A. BRAKE BOOSTER

Certain 2004 Model Year Lexus RX 330 vehicles may exhibit a hard brake pedal feeling during cold starts that may cause the brake warning light to illuminate. This condition is caused by a vacuum leak, and is due to inadequate seating of portions of the brake booster diaphragm as it moves within the brake booster housing.

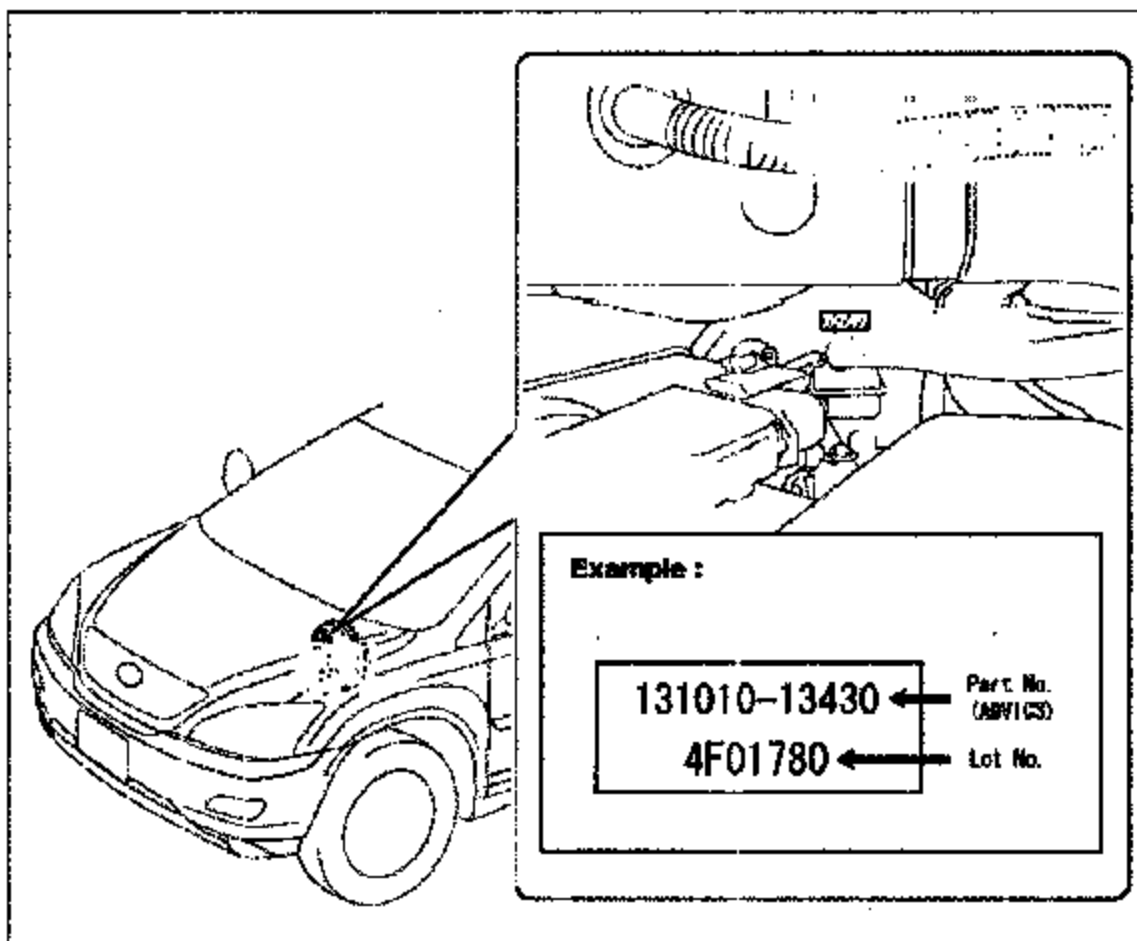
1. LOCATE THE PRODUCTION LOT NUMBER

- (a) Locate the production lot number on the brake booster as shown in the illustration below.

(c) If the production lot number is **NOT** affected, brake booster replacement is **NOT** necessary.

(d) If the production lot number is affected

- Replace the brake booster following the procedures outlined in the Lexus RX 330 Repair Manual.
- Transfer the push rod clevis and lock nut from the old brake booster to the new one; then check and adjust the brake pedal height following the procedures outlined in the **Brake Pedal Sub-Assy Adjustment** section in the Lexus RX 330 Repair Manual.
