Liberty Mutual Fire Insurance Company

OUR INSURED: [REDACTED]
OUR CLAIM NUMBER: [REDACTED]
YOUR INSURED: FORD MOTOR COMP
YOUR CLAIM NUMBER: [REDACTED]
DATE OF LOSS: 11/18/2003
PLACE OF LOSS: [REDACTED]
LOSS: SAULT SAINTE MARIE, MI

Based on our investigation of this accident, we believe your Insured to be responsible for the damage to our Insured's vehicle. I have enclosed documentation to support the following subrogation claim:

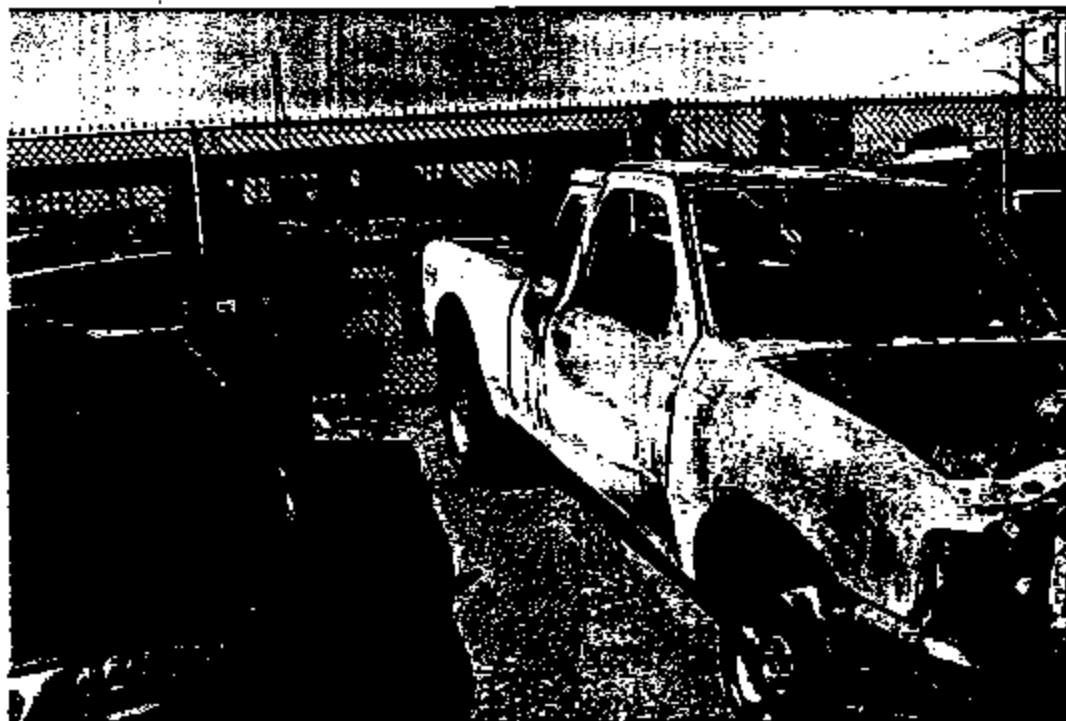
FIGURE #1

This is a view of the right side of the subject vehicle. As shown, damage was heavy at the front end and decreased moving rearward. The right front tire had been destroyed, while the right rear tire was still intact and undamaged.

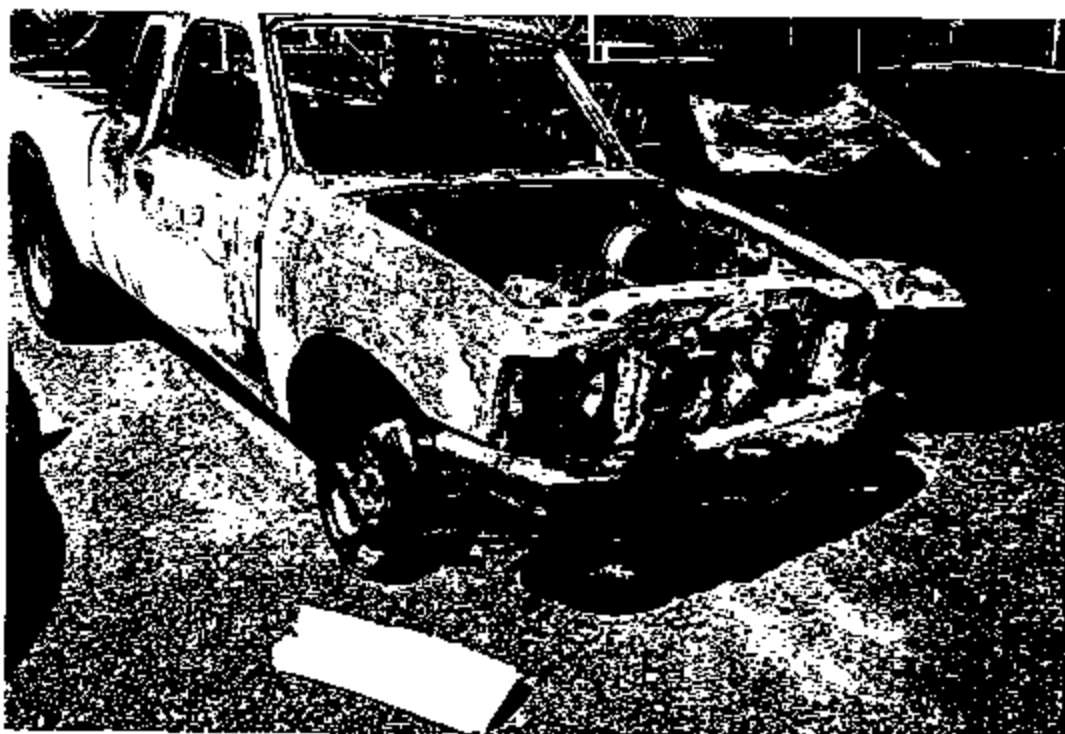
FIGURE #2

This is a view of the front and right front of the subject vehicle. The hood had been destroyed along with the radiator, condenser, grill assembly and headlight assemblies.

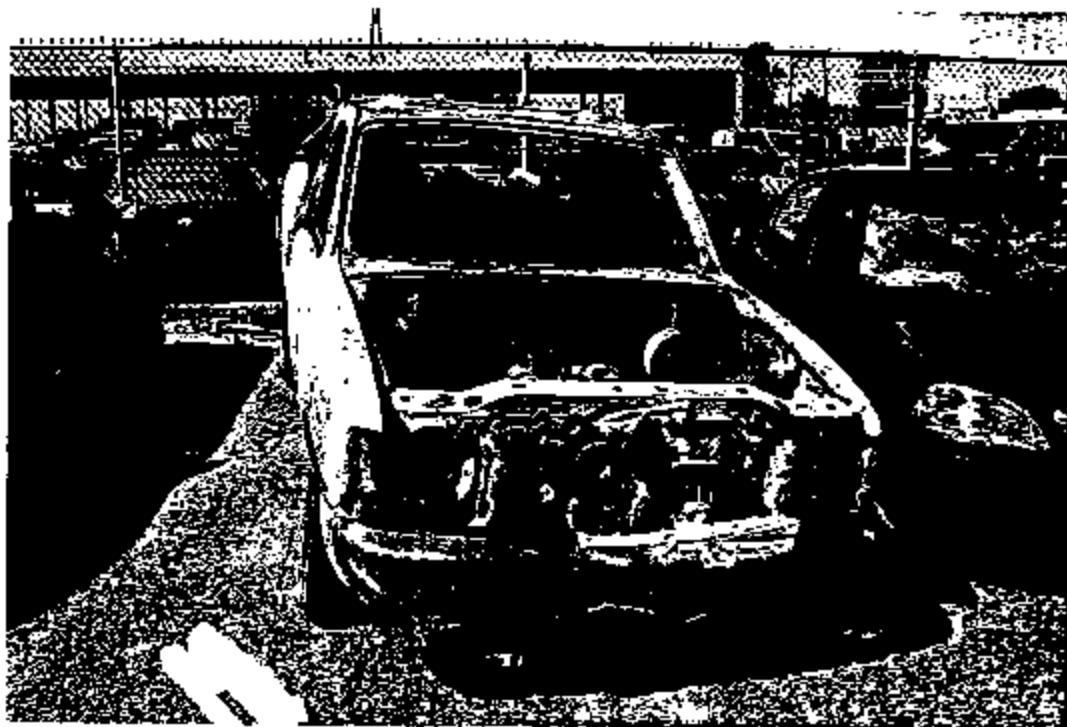
FIGURE #3

This is a view of the front of the vehicle. As previously indicated, the radiator and condenser had burned out of the front end of the vehicle along with all combustible components on the front end.

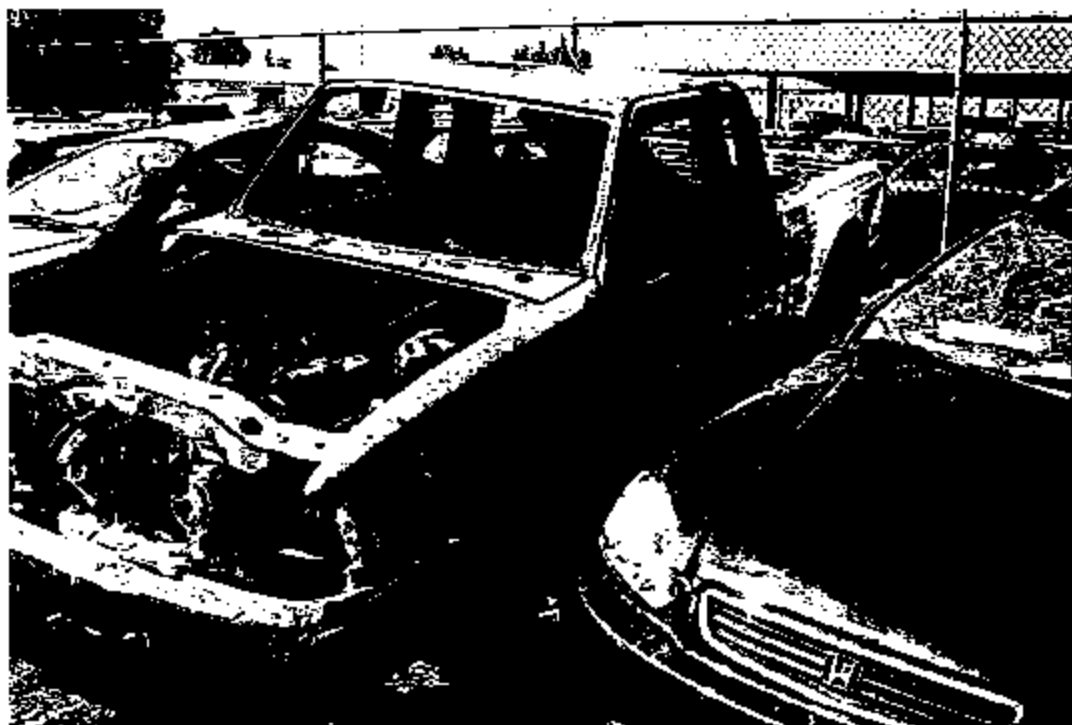
FIGURE #4

This is a view of the left side of the vehicle. The left front tire had been destroyed, while the left rear tire was still intact.

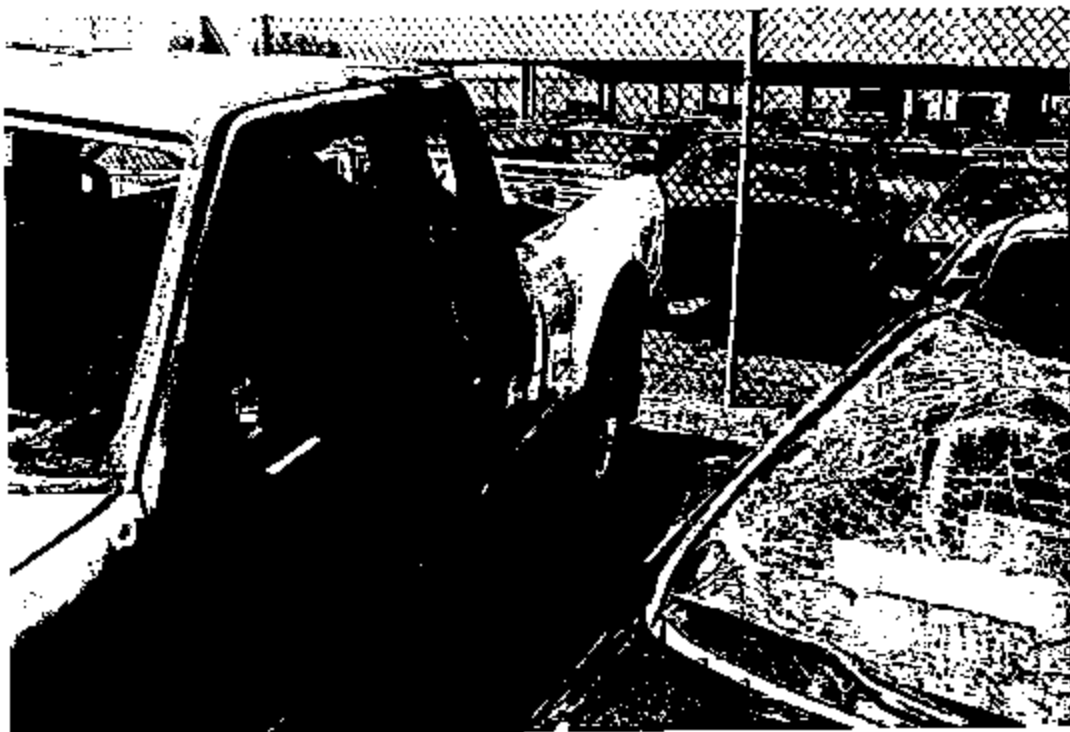
FIGURE #6

This is a view of the left side of the vehicle showing the lack of heavy damage on the rear body panels. The left rear tire, as previously indicated, was undamaged.

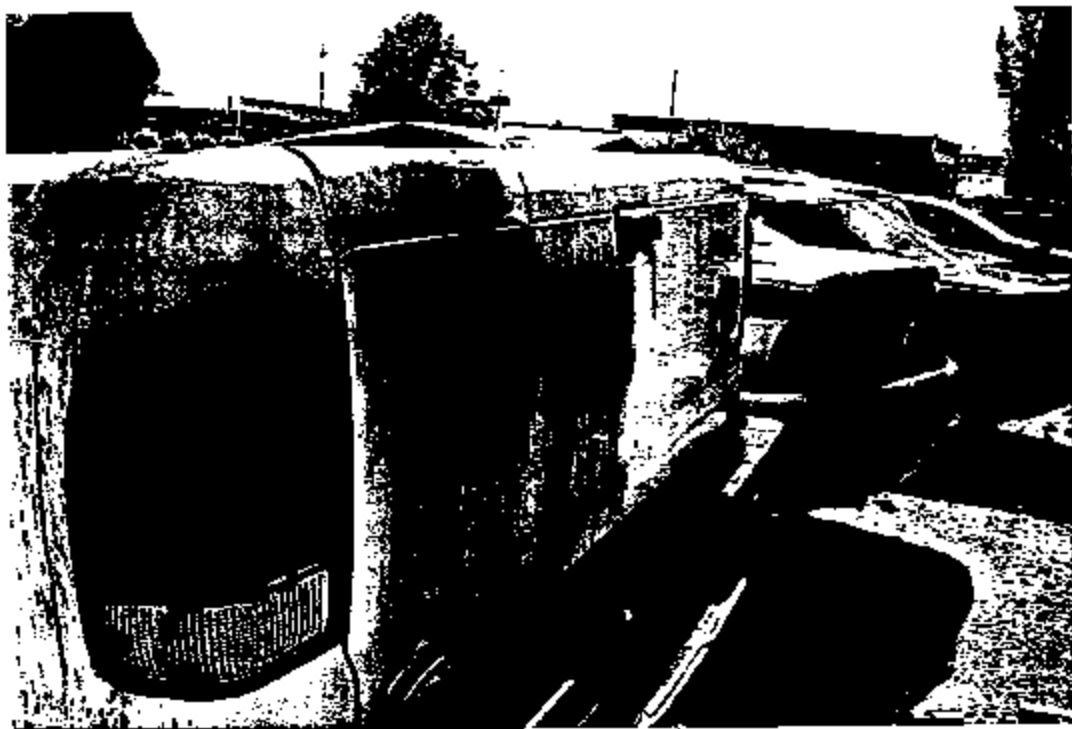
FIGURE #7

This is a view looking across the tailgate from left to right. The rear body panels suffered minimal damage.

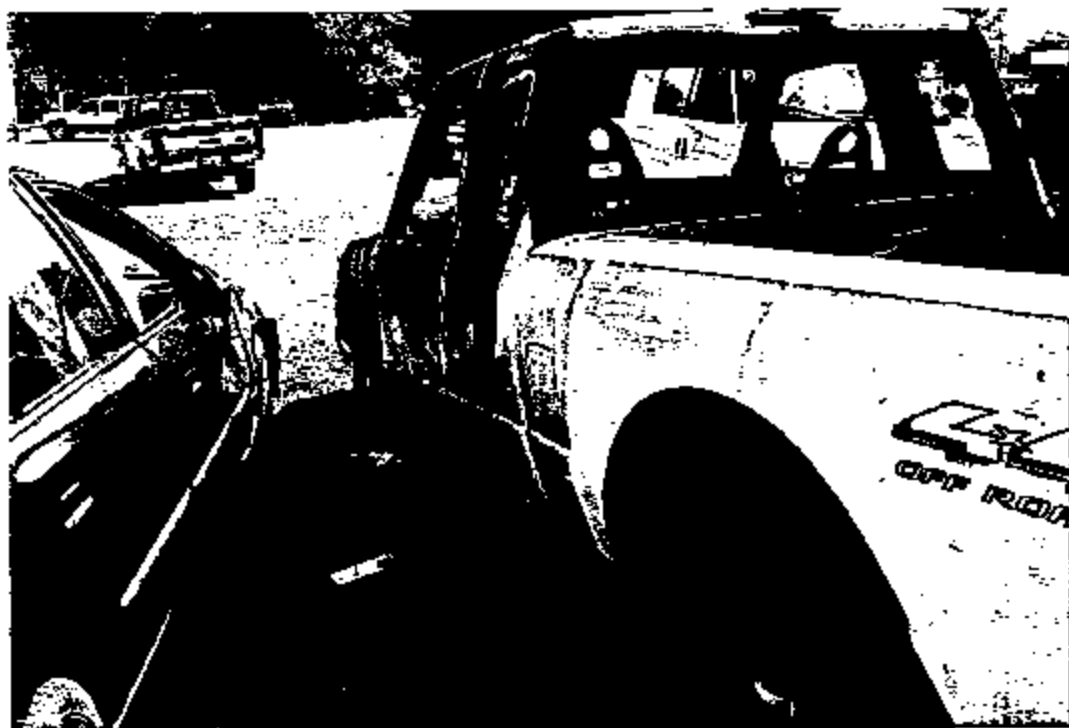
FIGURE #8

This is a view looking along the left side from rear to front. Patterns and damages on the exterior of the vehicle indicated a front to rear burn.

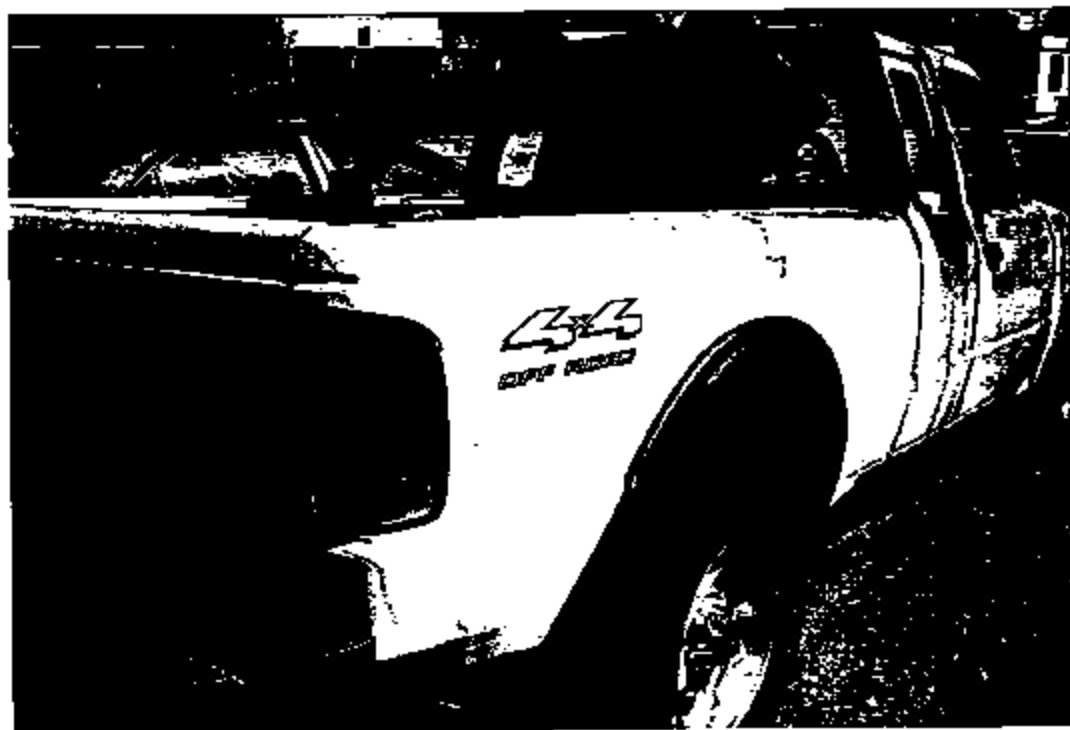
FIGURE #9

This is a view of the rear and right rear of the subject vehicle. As shown, the right rear tire escaped damage, as did the rear body panels.

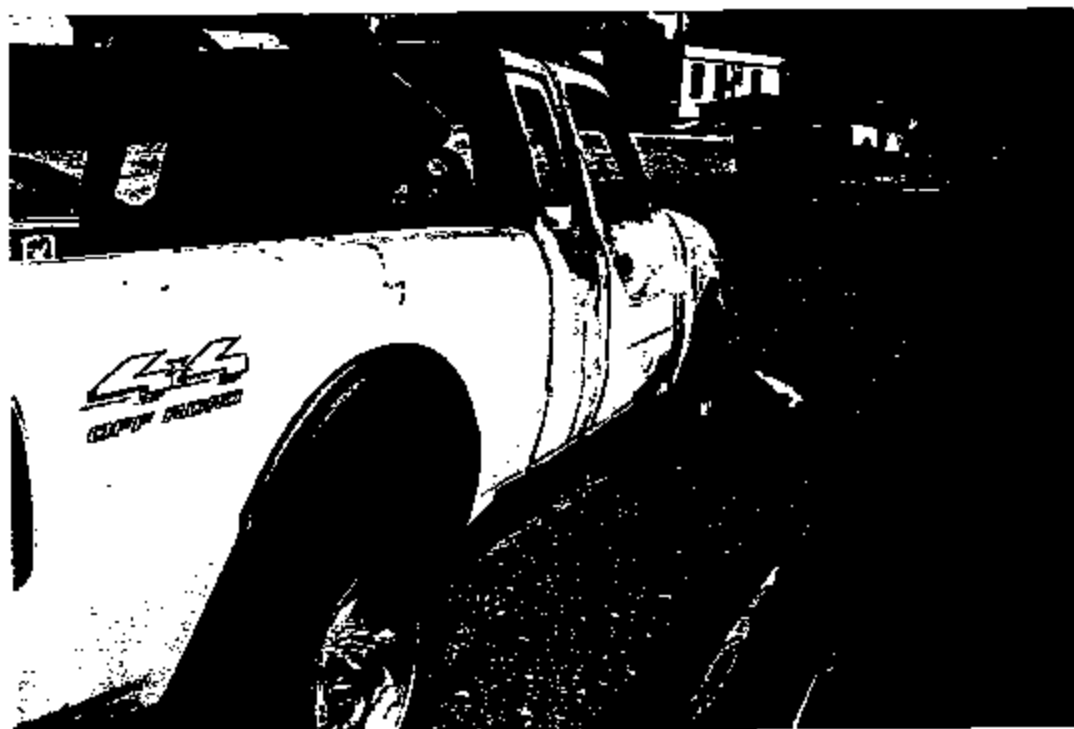
FIGURE #10

This is a view looking along the right side of the subject vehicle. The burn patterns on the front end of the right side were almost identical to the burn patterns on the front end of the left side.

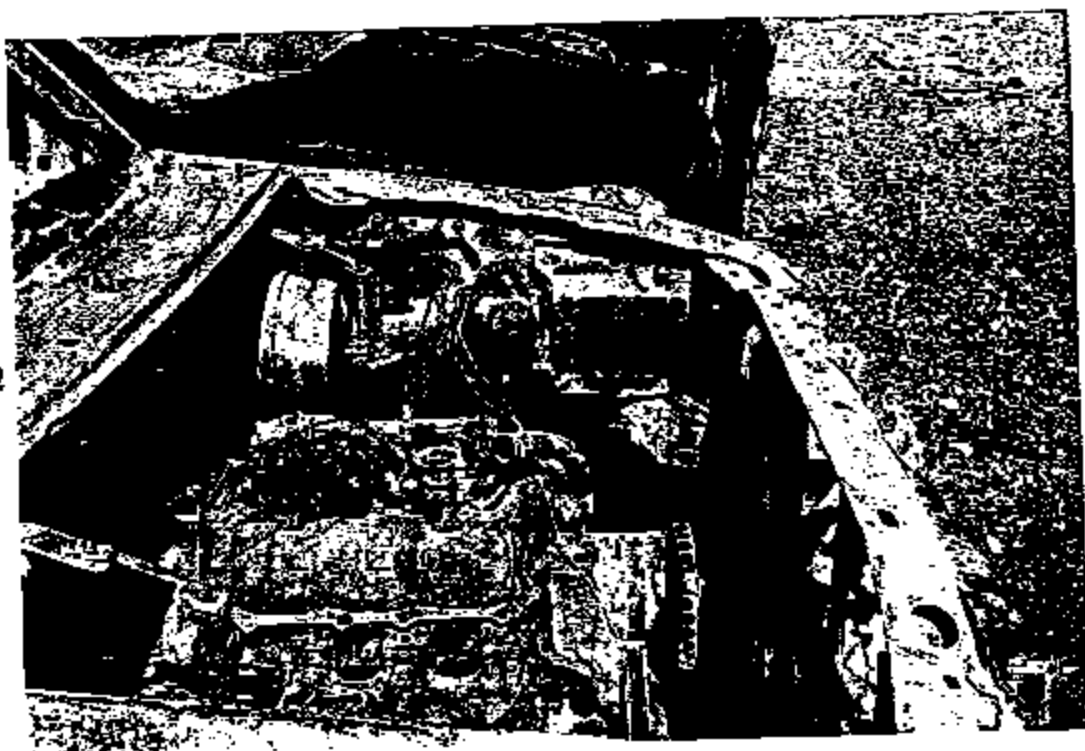
FIGURE #22

This is a view looking across the engine compartment from right to left. Note the heavy oxidation on the right side valve cover and other metal components on the right side and front of the engine. Also note that the alternator has melted off its mounting bracket at the right side of the engine.

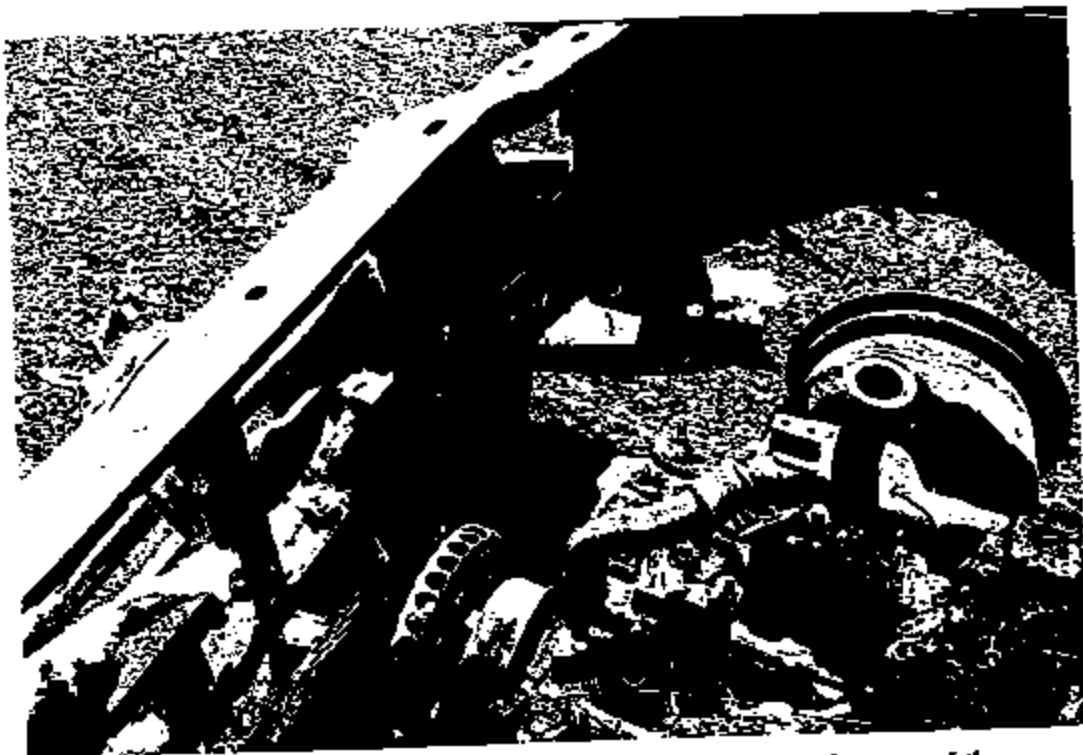
FIGURE #28

This is a view looking from the left rear quadrant across the front section of the engine toward the right front quadrant. Again note that part of the upper plenum has burned away completely, while the rest remained, melted but in place.

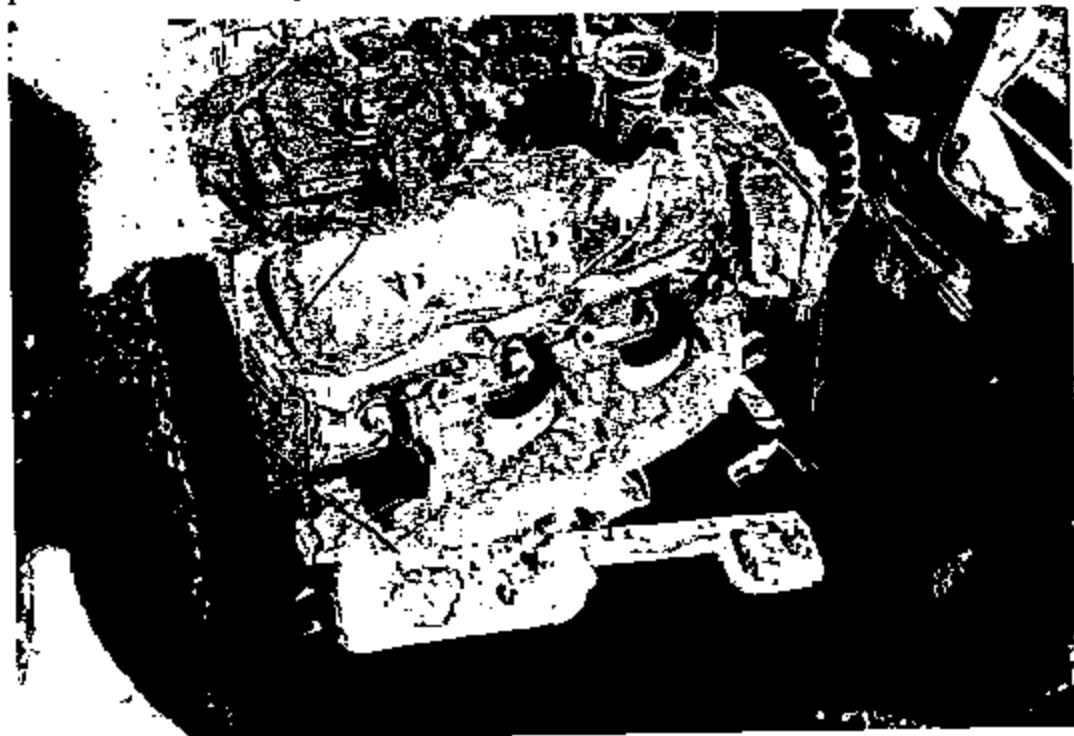
FIGURE #31

This is a view of the right side of the engine looking toward the left side of the engine compartment. Sparkplug wires and boots had been totally destroyed, and heavy oxidation was noted on the valve cover.
