Tempe Police Department

Incident Report

This assignment was received on June 6, 2003 from Daye Dixson of State Farm Insurance Company. I was instructed to conduct an origin and cause investigation as a result of extensive fire damage that occurred to the insured's 1998 Ford Expedition.

Reportedly, on May 23, 2002, a fire occurred involving a 1997 Ford F-150 vehicle. On May 24, 2002, Forensic Analysts, Inc. was retained by Mr. Hugo Benavides of Allstate Insurance Company to inspect the vehicle and determine the origin and cause of the fire.

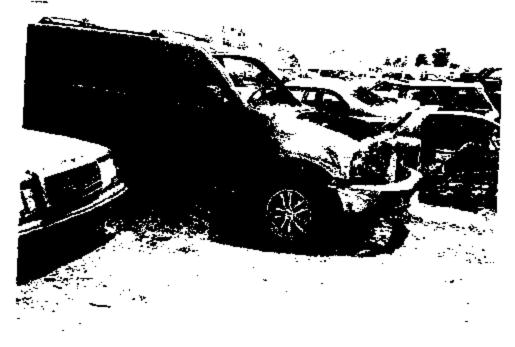
Photo 5. Damage occurring to the engine compartment
