Unified Investigations & Sciences, Inc.

UIS FILE #: TX01-05928

The assignment was received on May 14, 2004 from Mr. John Gonzalez of Allstate Insurance Company. The instructions were to evaluate the evidence collected by Mr. Mike Beres of Unified Investigations and Sciences, Inc. from subject vehicle to determine the cause of the fire.

1. The cause of the fire was the catastrophic failure of the brake pressure switch.
2. The first fuel was the thermoset plastic material that made up the body of the electrical portion of the switch.

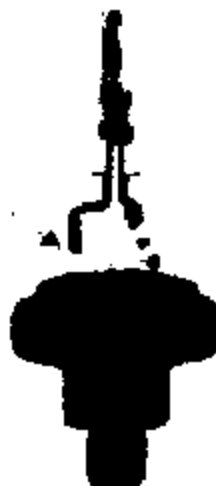
The brake pressure switch is in the middle of the area of origin, as defined by Mr. Beres. From my examination of the switch, the x-ray, and the photos of the surrounding fire damage, it is my opinion that a fault or defect in the brake pressure switch caused the fire.

Image of x-ray of  
switch from subject  
vehicle. Note the  
switch had a  
catastrophic internal  
failure and has an  
almost identical  
appearance as the file  
image on the previous  
page.
