REPORT OF FINDINGS

1997 FORD F150 TRUCK

ProNet File No. 5904

EA05-005-LC-2003

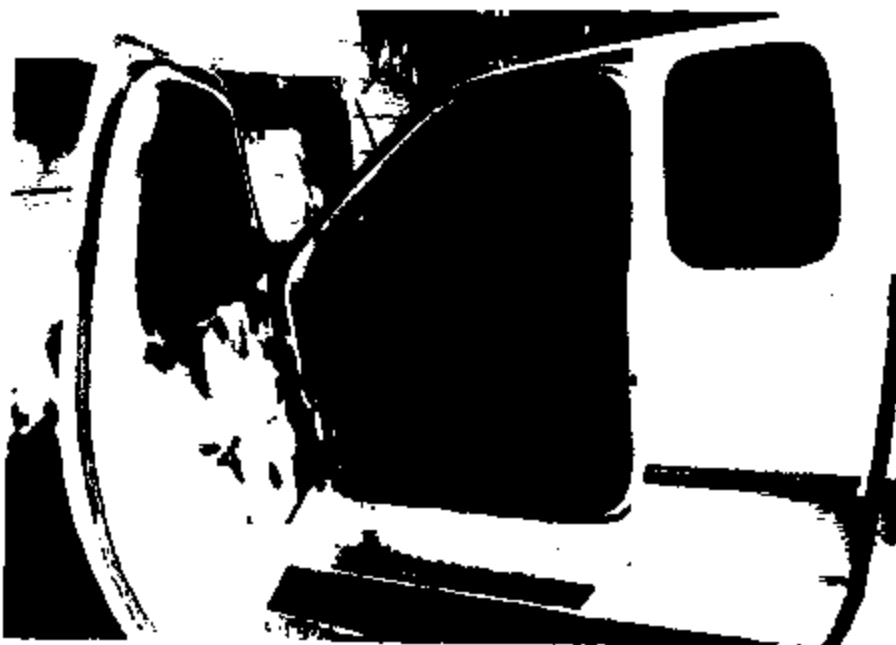
8. View of the fire damage
observed to the interior as
viewed from the left-to-right.

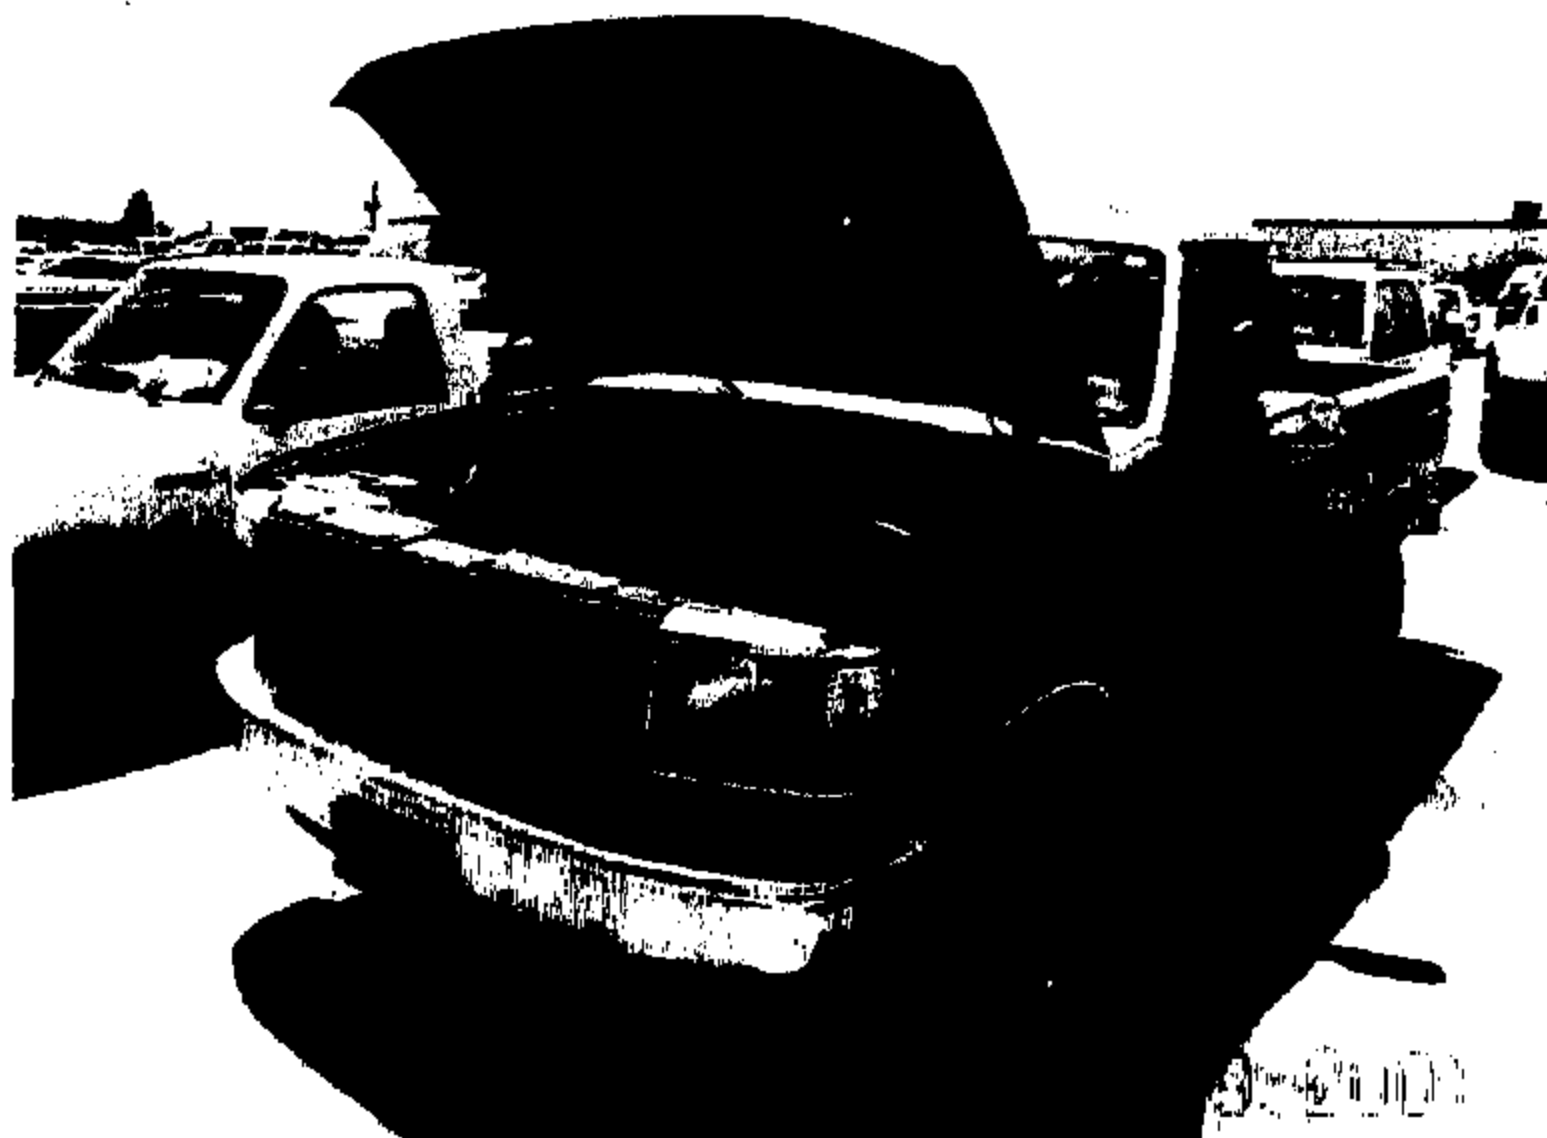
L FRT CORNER - 7 PHOTOS - 06 F150 - BLUE -SA
