1996 Ford F150 Pick-up truck adu.

The identified 1996 Ford F150 Pickup is insured by State Farm Mutual Automobile Insurance Company. This vehicle experienced an engine compartment fire.

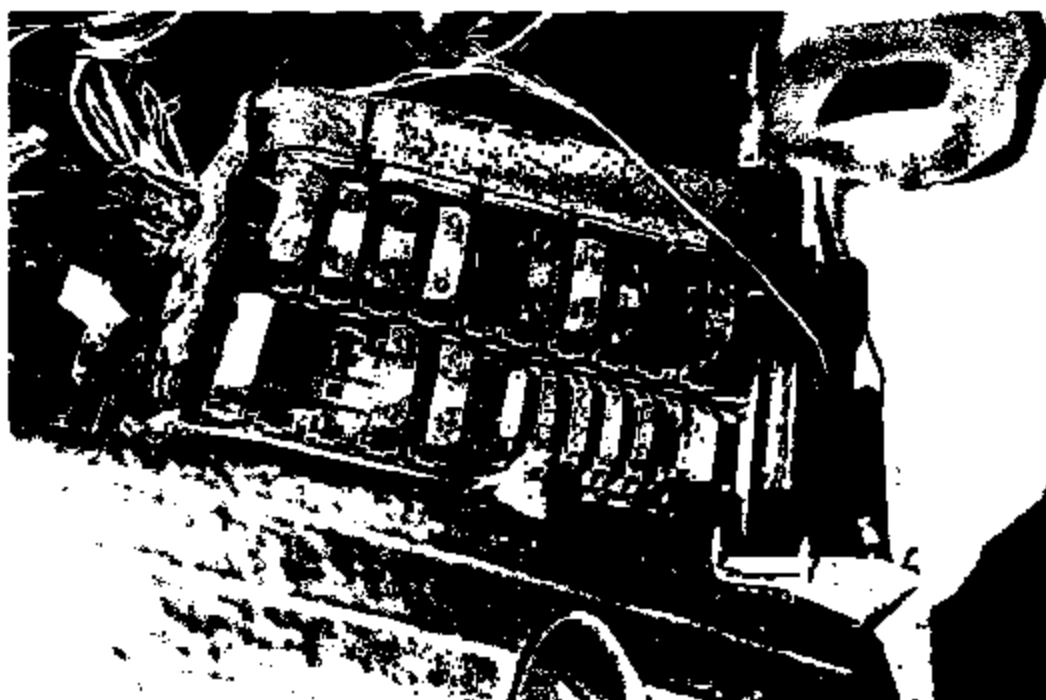
#15

PHOTO #15: Shows a view of the power distribution box. Note two fuses identified by the red arrows were in the BLOWN position. One was a 60 amp fuse and the other a 30 amp fuse.
