CAUSE NO. 05-105 H

FORD MOTOR COMPANY, TEXAS
INSTRUMENTS, INC., E.I., and PAYNE MOTORS
INC. d/b/a WESLACO FORD-MERCURY and
WESLACO MOTORS

PLAINTIFFS' ORIGINAL PETITION

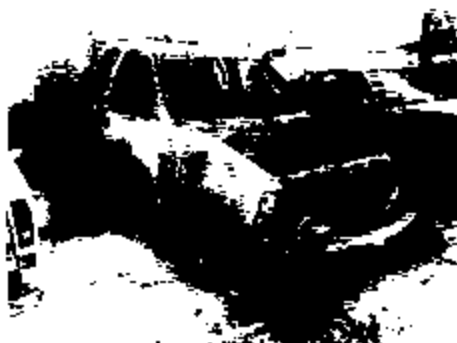
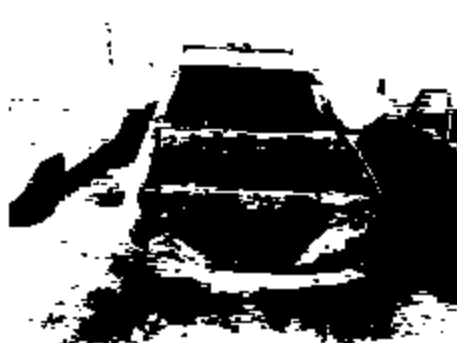
TOTAL BURNT

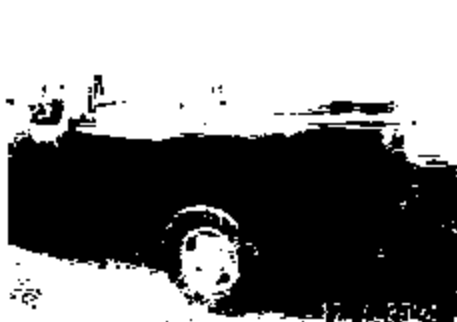
REAR BED NO DAMAGE
