RE: Fire Analysis Report
Insured: [REDACTED]
Address of Loss: I-10 at Prairieville Exit
Prairieville, Louisiana
Date of Loss: 12-09-98
Claim Number: [REDACTED]
MASA Contract Number: 12983070M

The purpose of our inspection was to determine the origin and cause of the vehicle fire that occurred May 14, 2005.

Received from: Michael Krause, Nationwide Insurance
Instructions: Conduct an Origin and Cause examination of a vehicle fire

Client File #: 13A 31088
WOLF Project #: 01-2858-0239

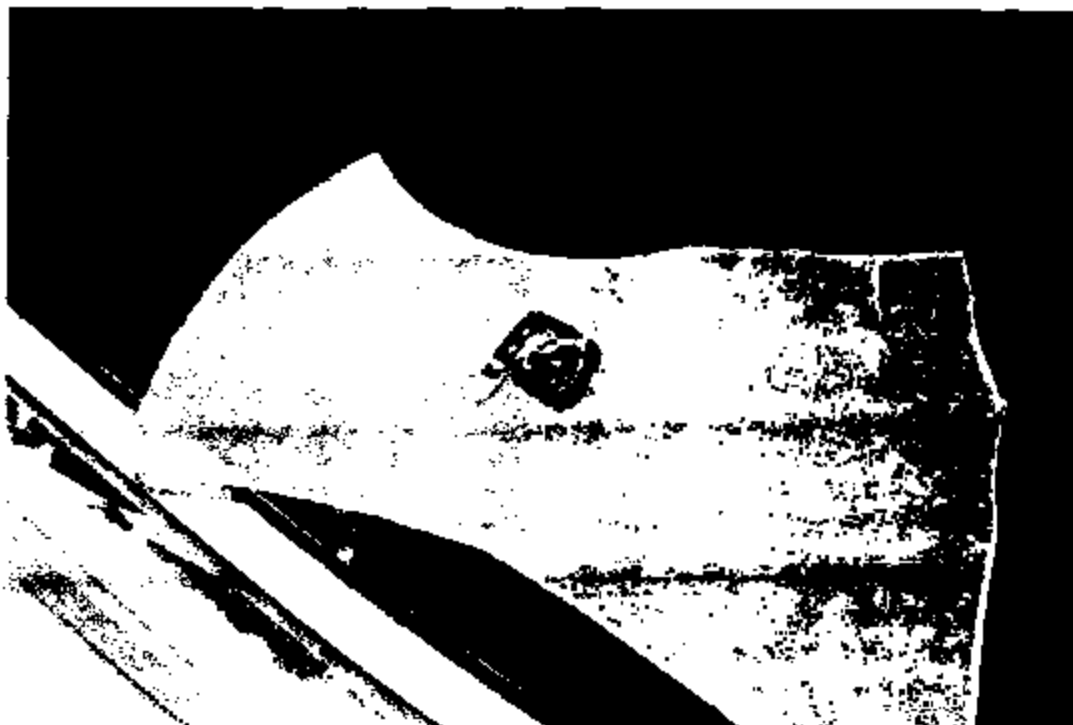
23

1. #10-7.5 amps for speed control servo-shift lock actuator -AC- heater assembly, turn signals
2. #13-20 amps for brake pedal position switch
3. #16-30 amps for windshield wiper motor, wiper hi-low relay, park relay
4. #17-25 amps for cigar lighter
5. #18-15 amps for driver's unlock relay, all lock relay
6. #21-15 amps for flashers
7. #22-20 amps for auxiliary power relay
8. #26-10 amps for battery saver relay, elect shift relay, interior light relay, power window relay, dome light, GEM, instrument Cluster
9. #29-15 amps for radio
10. Fuses #16 and #29 were observed to have evidence of heat damage, see photographs #23 and #24

20. Fuse Panel
21. Fuse panel damage to #16
22. Rear of fuse panel and connecting wiring
23. Fuse #16
24. Fuse #29
