BARRETT TOWNSHIP VOLUNTEER FIRE COMPANY

FIRE REPORT

Cause & Origin

CAUSE & ORIGIN REPORT

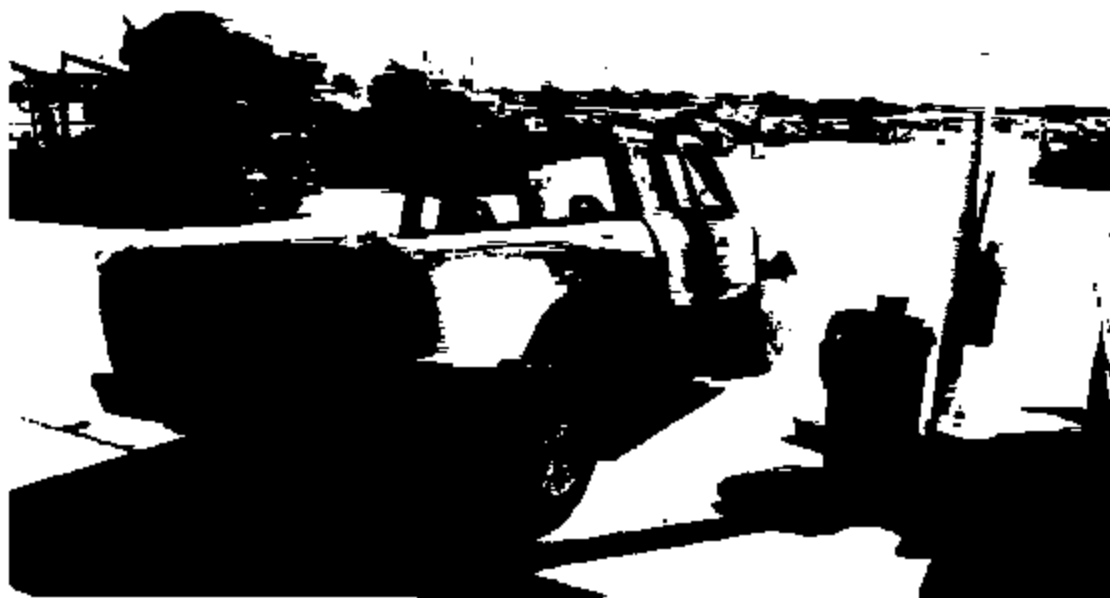
#6

PHOTO #6: Shows a view of the right front portion of the vehicle. Note there was a greater amount of heat damage to the right side of the vehicle.

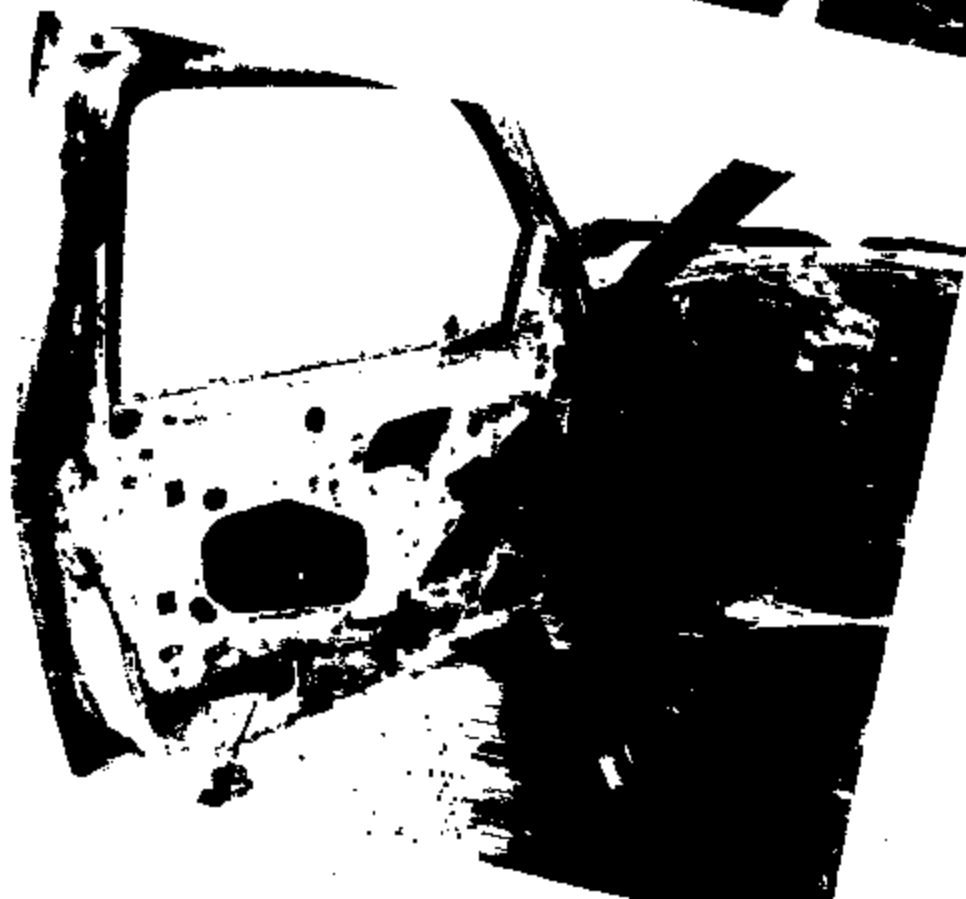
#8

PHOTO #8: Shows a view of the driver side door panel. Note the vinyl door panel was combusted and collapsed from the vehicle. Note the wiring did not exhibit any evidence of fault conditions.
