FORD MOTOR COMPANY AND
TEXAS INSTRUMENTS, INC.
Defendants.

PLAINTIFFS' ORIGINAL PETITION

Re: Vehicle Fire Origin & Cause
Williamsburg, OH
Your Insured [REDACTED]
Your File APV 000238063
Rzesutock Engineering Project No. OH040611A

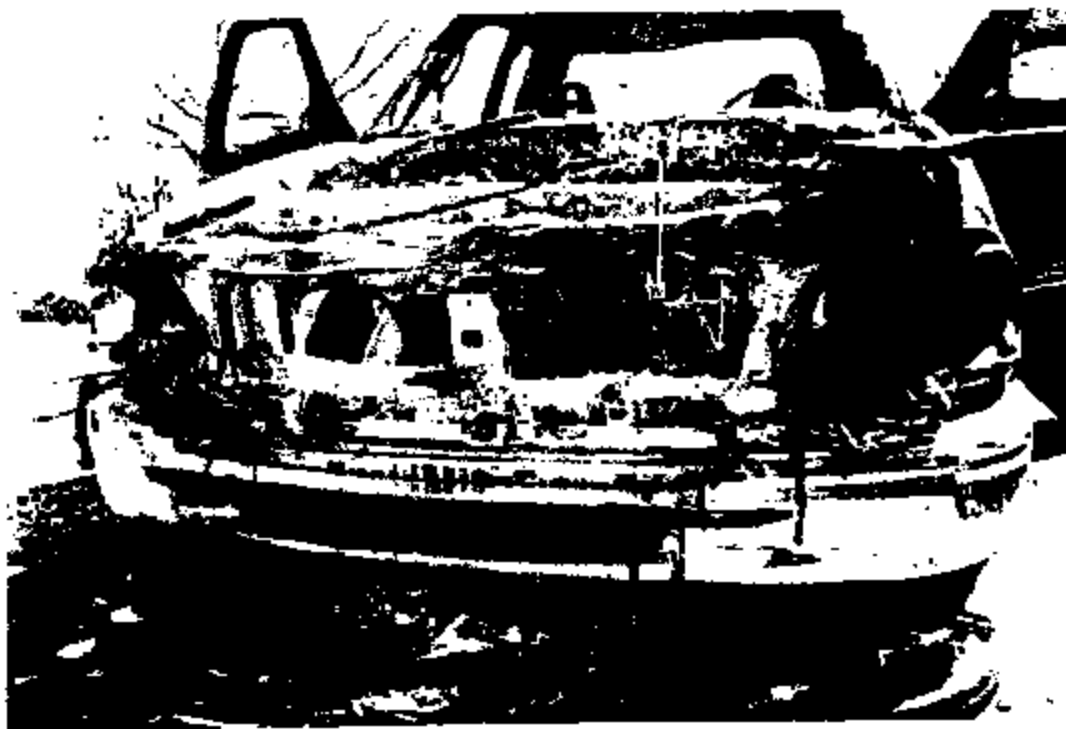
INSURED: [REDACTED] NO.: 10 OF 27

The burn patterns on the roof
