**FARMERS**

Baltimore Subrogation Center of Excellence

Re: Our Claim #: [REDACTED]  
Our Insured:  
Date of loss:  
VIN:

We are the insurance carriers for Bruce Luster. On January 6, 2001, [REDACTED] 1998 Ford XL 150 Pick-Up was damaged by a fire. An independent C&O report requested by Farmers Insurance Group concluded the fire was the result of a mechanical failure in the fuel system. (See attached report). We are now making a subrogation claim against Ford as the manufacturer of the truck. Please review the enclosed materials and advise of your decision on liability at your earliest convenience.

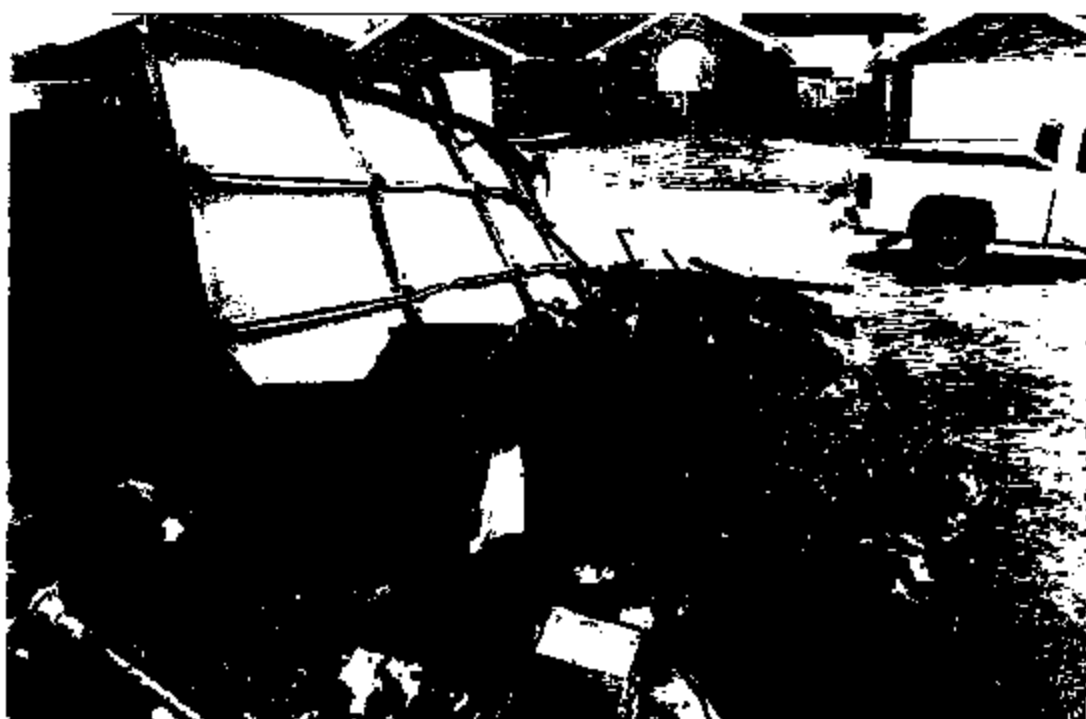
#23

**PHOTO #23:** Shows a view of a portion of the contents that had been removed from the garage. Note an examination of the debris revealed no evidence of any electrical appliances that had failed.
