Atlantic Claims Service, Inc.

RE: Insured: [REDACTED]
Our Policy #: [REDACTED]
Date of Loss: 02-03-95
Your Customer: [REDACTED]
Insured Vehicle: 1995 Ford 150

DETERMINATION OF CAUSE AND ORIGIN

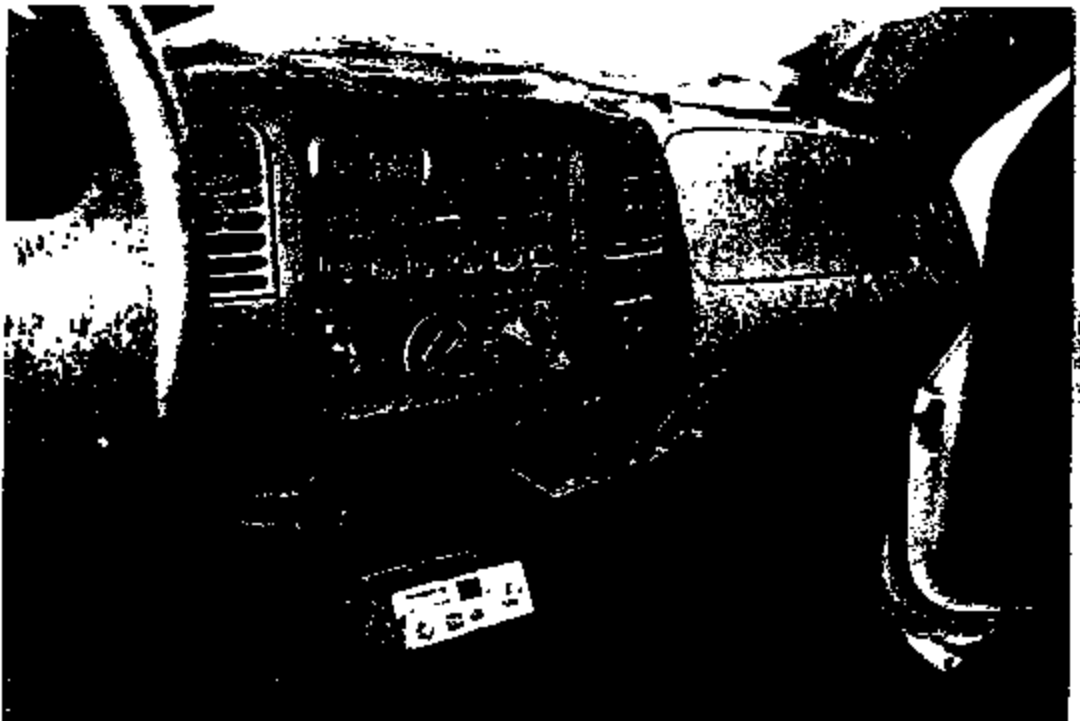
34

- Photograph Number 34: This photograph depicts the dashboard, radio and heating/air conditioning controls.
