RE: Fire Loss Of 1995 Ford F150

I represent [redacted] in regard to its subrogation claim resulting from a fire loss to a 1995 Ford F150 pickup truck. The fire occurred on May 12, 1995, and at that time the vehicle was owned by [redacted] and was insured through Kentucky Farm Bureau Mutual Insurance Company.

The pickup truck was destroyed when gasoline that had leaked from the vehicle ignited resulting in a total loss to the truck. Also enclosed for your consideration is the report of Mr. Frederick F. Franklin with Professional Analytical & Consulting Engineers, Inc., who was retained by Kentucky Farm Bureau to investigate the fire and determine its cause. You will note that the report also includes information obtained from [redacted] regarding the specific facts as to how the vehicle caught fire, and also the problems that he had been having prior to the fire with gas fumes from the truck. Mr. Franklin concludes that a leaking fuel line was the cause of the fire.

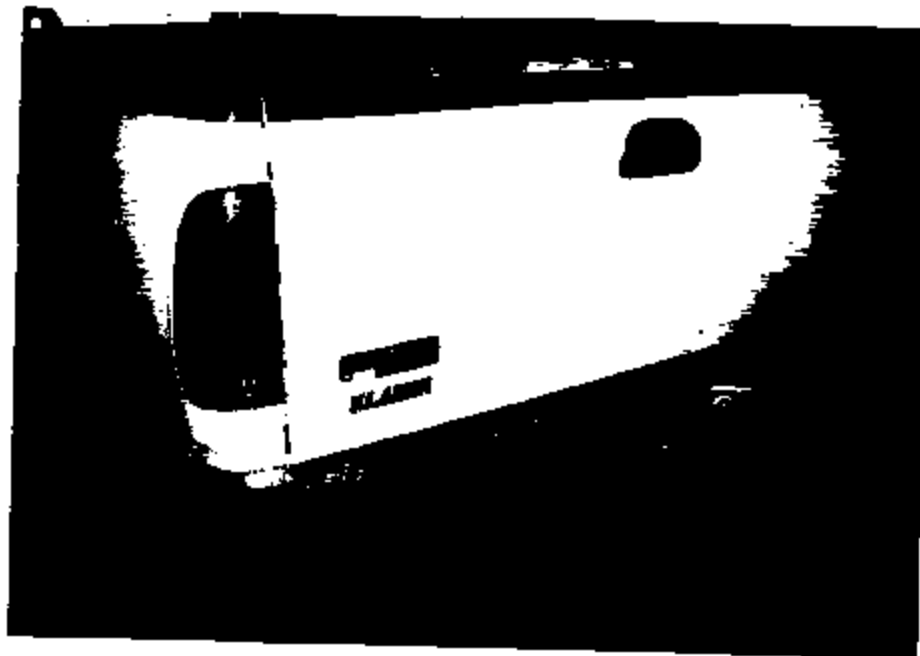
FIGURE #5

This is a view of the rear of the subject vehicle. No burn patterns were found at the rear.

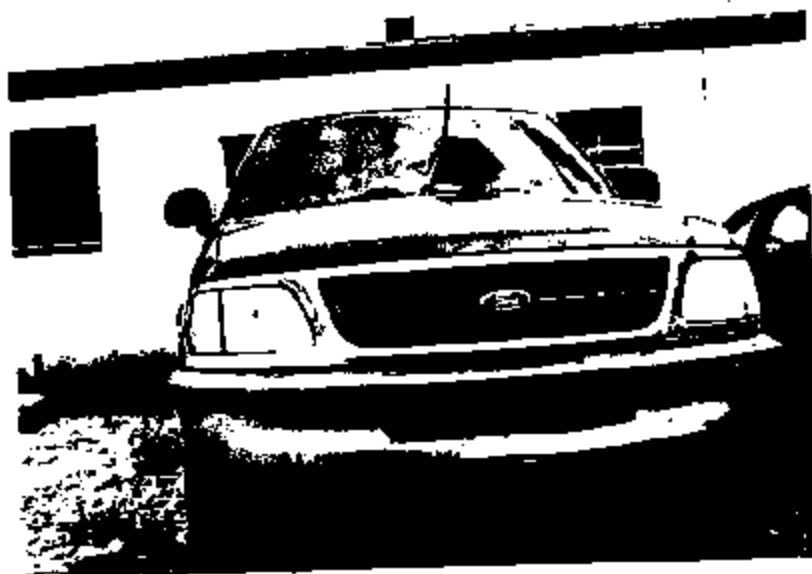
PHOTO #2

Photo #2 shows the front of the subject vehicle. Fire and heat damage were noted to the center of the vehicle windshield. No fire damage was noted to the vehicle hood.
