Unified
Investigations & Sciences, Inc.

**PRIVILEGED AND CONFIDENTIAL
REPORT NUMBER-ONE & FINAL**

ASSIGNMENT

Assignment received September 8, 2004, to conduct a vehicle fire examination of a 1998 Ford Explorer bearing a vehicle identification number of 1FMZU34E5WU [REDACTED] AND a Tennessee license plate of [REDACTED]. The vehicle examination was conducted at Southern Auto Salvage Pool at 3940 Jackson Avenue on September 13.

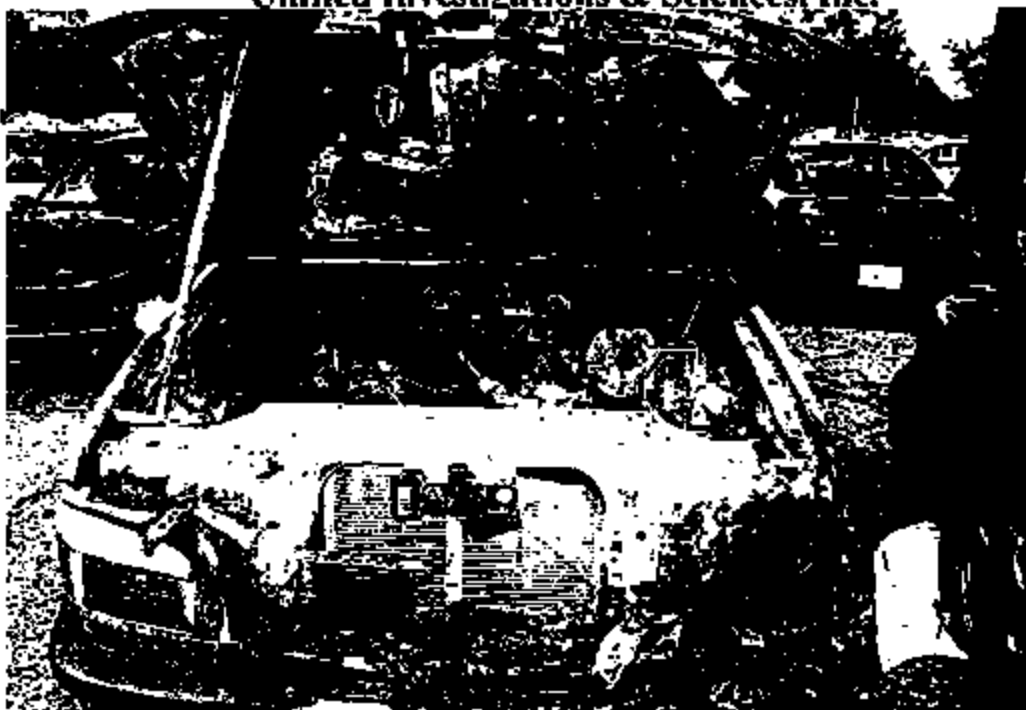
5

Examination revealed the vehicle had suffered a hostile fire on the interior of the engine compartment in the vicinity of the brake master cylinder. Burn and oxidation patterns established a point of origin at the brake pressure switch situated at the front of the master cylinder. The brake pressure switch suffered heavy destruction and consumption of the polymer materials, with melting of the aluminum section of the switch. The brake pressure switch's electrical connector extending from the cruise control had the aluminum remains of the brake pressure switch melted to the stranded conductor. A section of the ring like aluminum section of the brake pressure switch make-up was identifiable.

Fire spread from the point of origin involving the plastic brake fluid reservoir, which ignited the flammable brake fluid that added to the overall development and spread. Involvement of various plastic component parts and rubber hoses also added to the spread of fire. Fire dropping down into the area of the fuel lines compromised the fuel lines that involved gasoline. Fire burned a hole through the left bank valve cover, which aligned with the origin area.

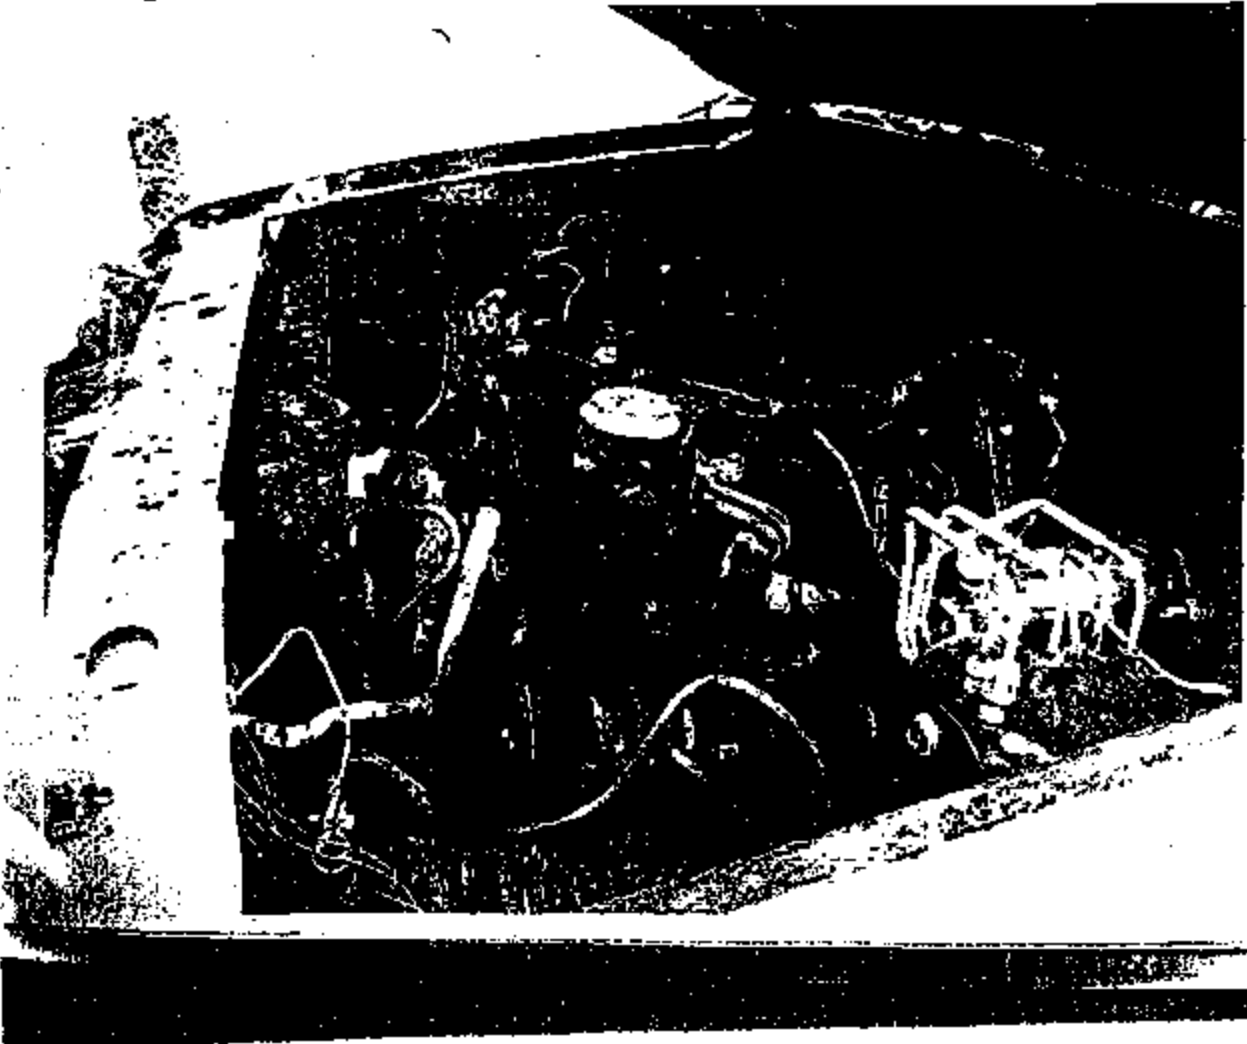
PHOTOGRAPH NO. 22

View of the master cylinder. Please note the melting that occurred. Also, please note that the brake fluid reservoir was consumed.

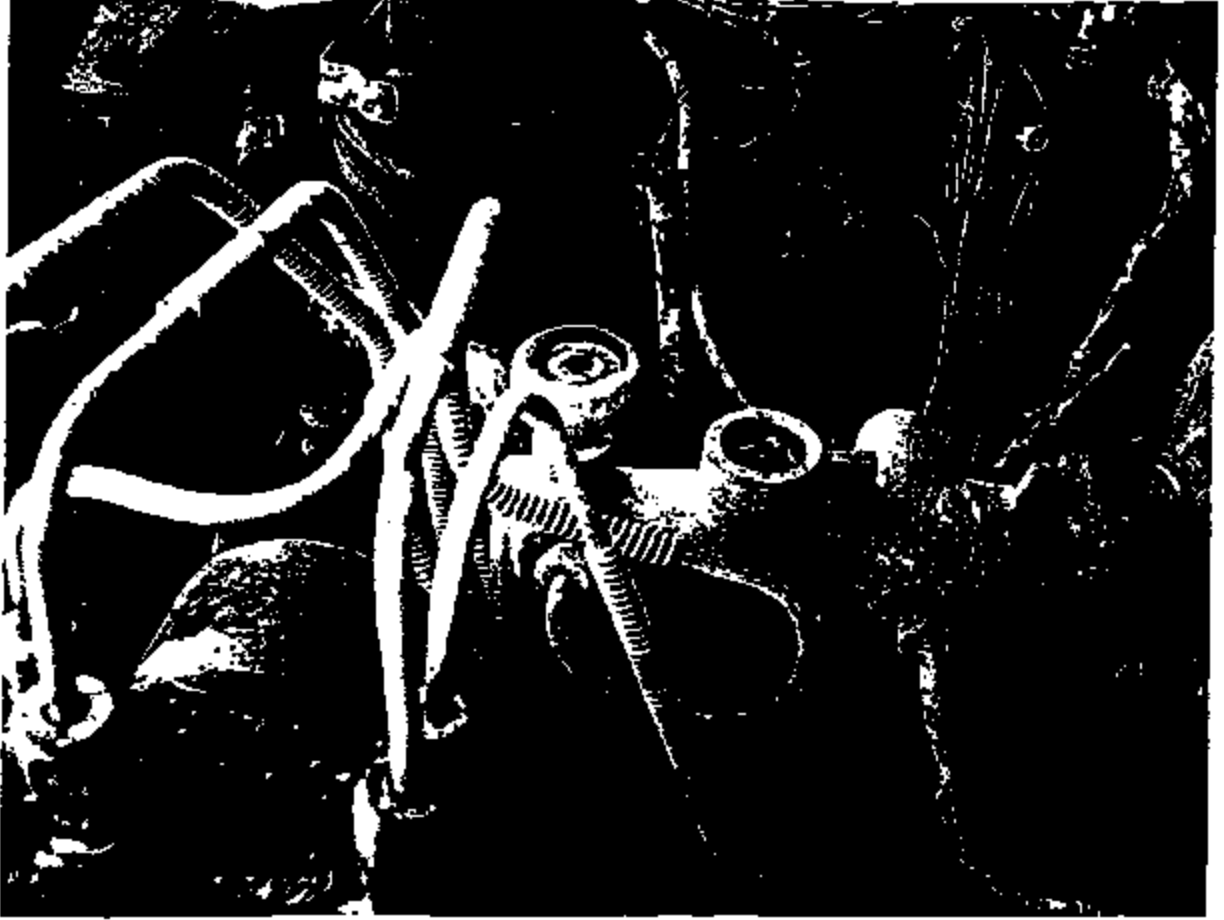
PHOTOGRAPH NO. 39

Examination in the area of the brake master cylinder revealed the remains of the brake pressure switch that is used to de-energize the cruise control feature upon application of the brakes of the vehicle. The switch was examined and found to have been severely damaged as a result of the fire. The switch showed internal melting of the contact material (RE: Photograph No. 39). The melting of the contact material indicates that the switch is unable to interrupt the flow of electric current to the Speed Control Servo Amplifier Assembly. This condition caused the fire by the heat produced by the failing brake pressure switch. There was also fire damage to the starter relay and the auxiliary relay box mounted on the

In my opinion, the fire was caused by the failure of the brake pressure switch.

Photograph of master cylinder with brake pressure switch.
