All Action Details for Issue

RE: Policy Holder : [REDACTED]
Claim Number : [REDACTED]
Date of Loss : 05/09/03
Vehicle : 1998 Ford Explorer
VIN : 1FMZU32X5WU [REDACTED]

On February 5, 2002, Mr. David Olson, of Kentucky Farm Bureau Insurance Company, contacted Engineering and Fire Investigations, Inc. (EFI) and requested EFI's assistance in determining the origin and cause of the fire.

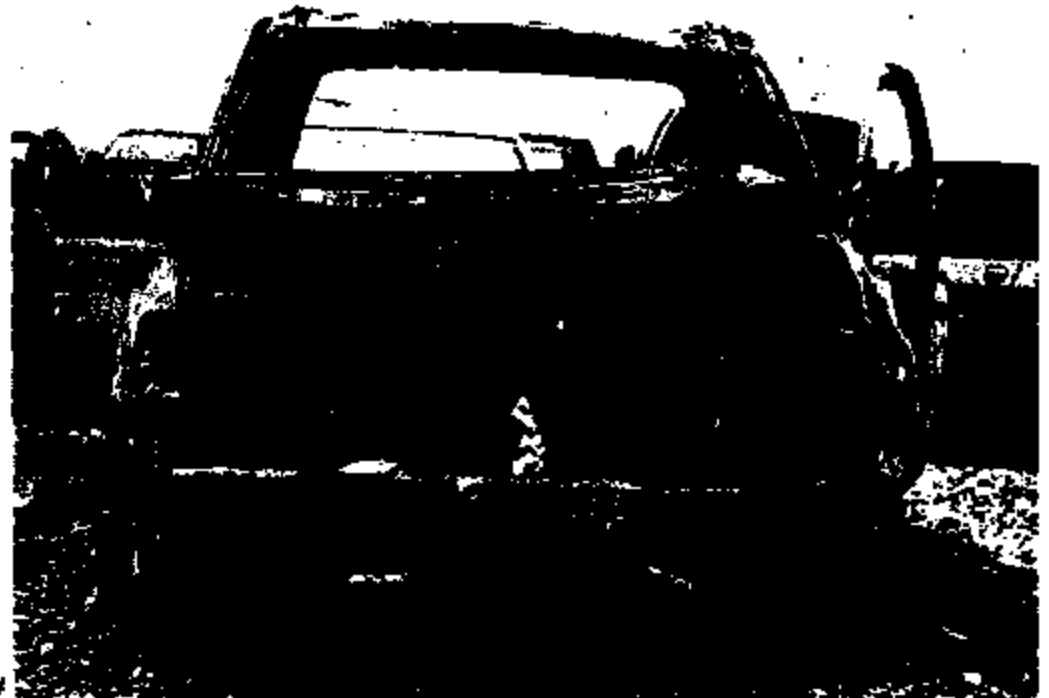
Photograph 4
Front view of the subject 2001 Ford Explorer Sport Trac.

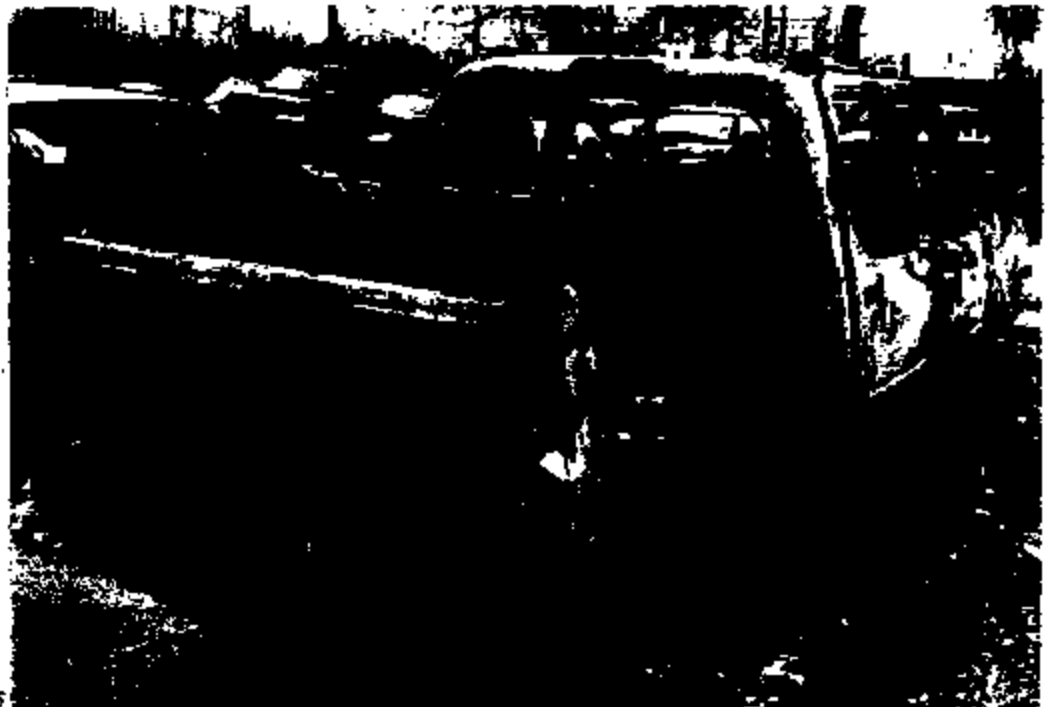
Photograph 5
Rear view of the subject 2001 Ford Explorer Sport Trac.

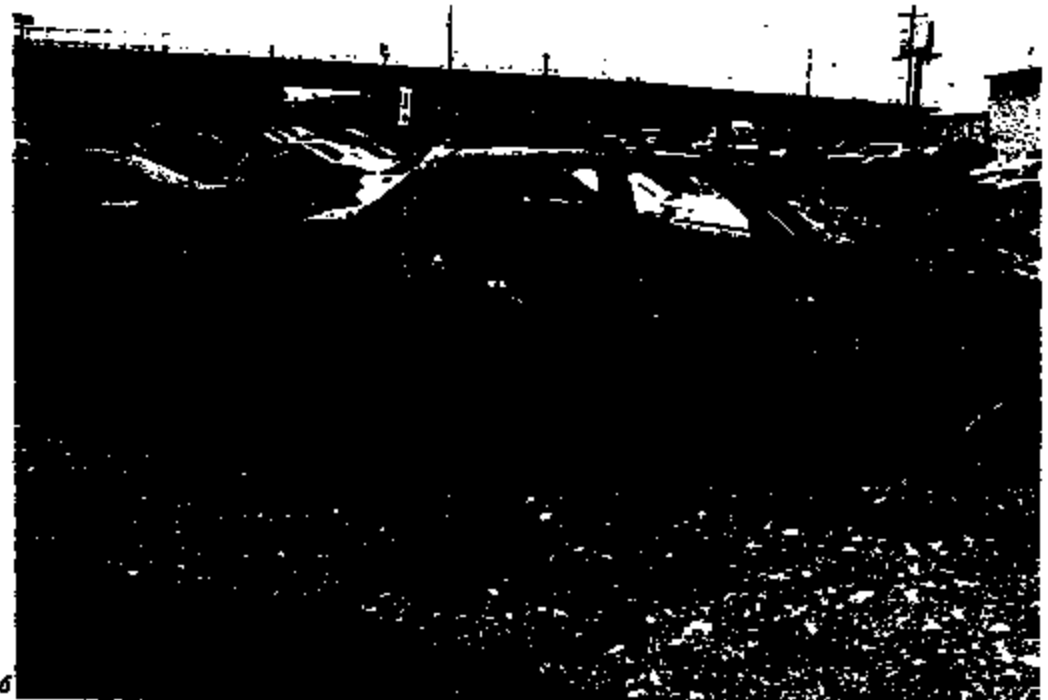
Photograph 6
View of the passenger's side of the subject vehicle.

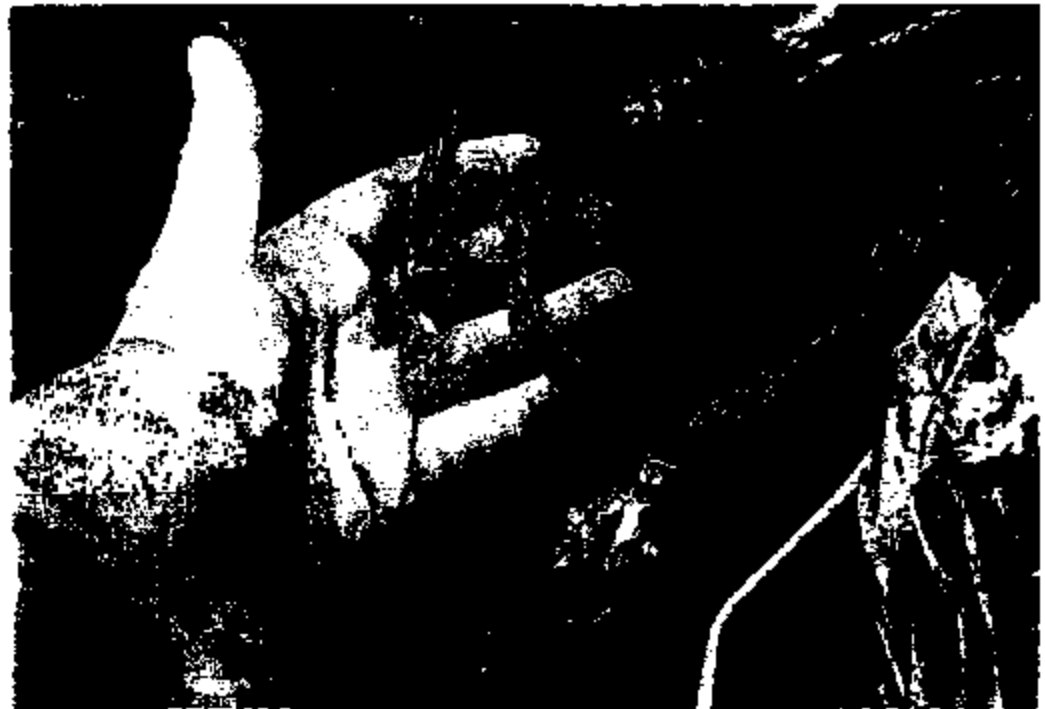
Photograph 18 shows a view of the extent of damage to the passenger's side of the engine. The remnants of the lug connections to the battery were discovered (*Photograph 19*). No battery remnants were discovered.

Photograph 19
View of large gage stranded conductors connected to battery.
