FILE # 430-281183
INSURED [REDACTED]
VEHICLE 1998 Ford F150
VIN 2FTZX1SW5WC [REDACTED]
ODOMETER Unknown - burned
DATE OF LOSS October 24, 2002

Examine the Ford F150 and determine the origin and cause of the fire. Determine the mechanical and cosmetic condition of the vehicle at the time of the loss.

IN RE: Allstate Claim No. [REDACTED]
H&A File No. 04-0883VF
Date Received: May 14, 2004
[REDACTED]

ORIGIN AND CAUSE INVESTIGATION:

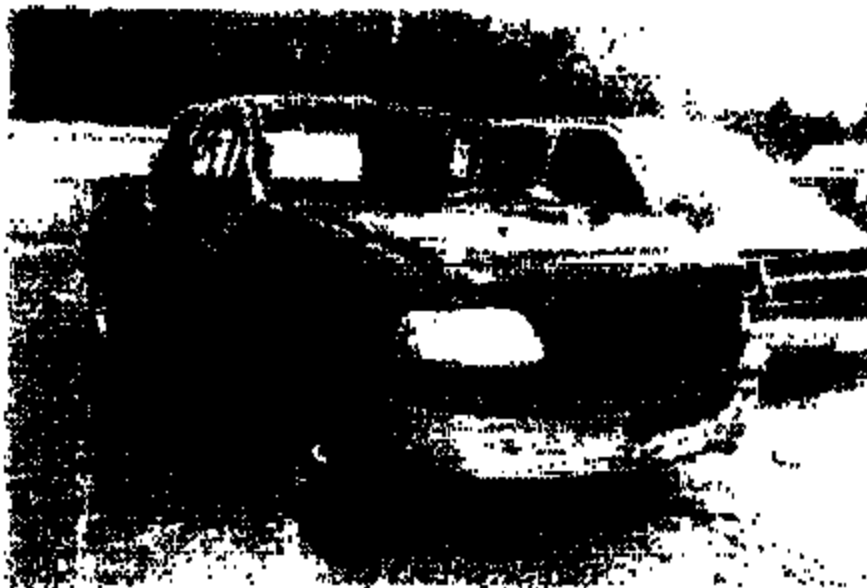
Photograph 1

Left front view of the 1965 Ford F-100 pickup. It appeared to have the original factory painted finish.

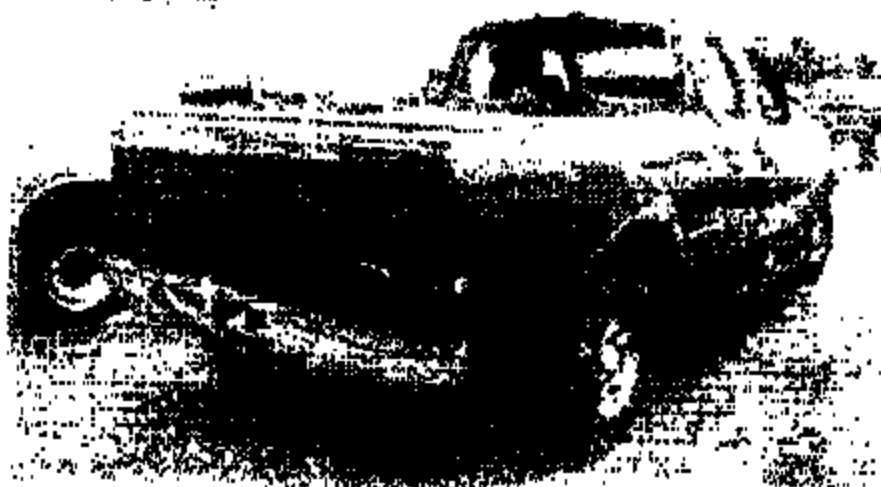
Photograph 2

Right front view of the 1965 Ford. The body was in good cosmetic condition prior to the fire.

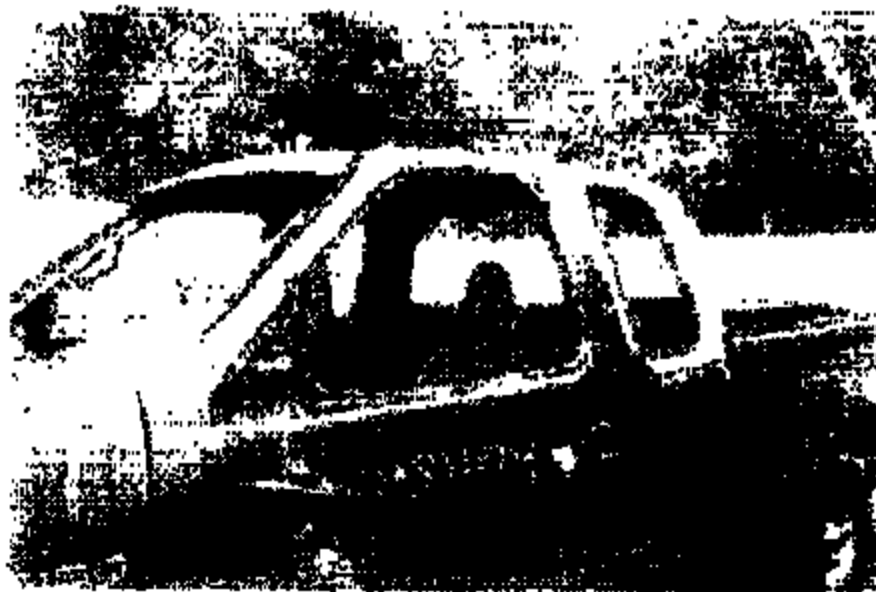
Photograph 5

The left side door showed scuffing only along the upper frame.

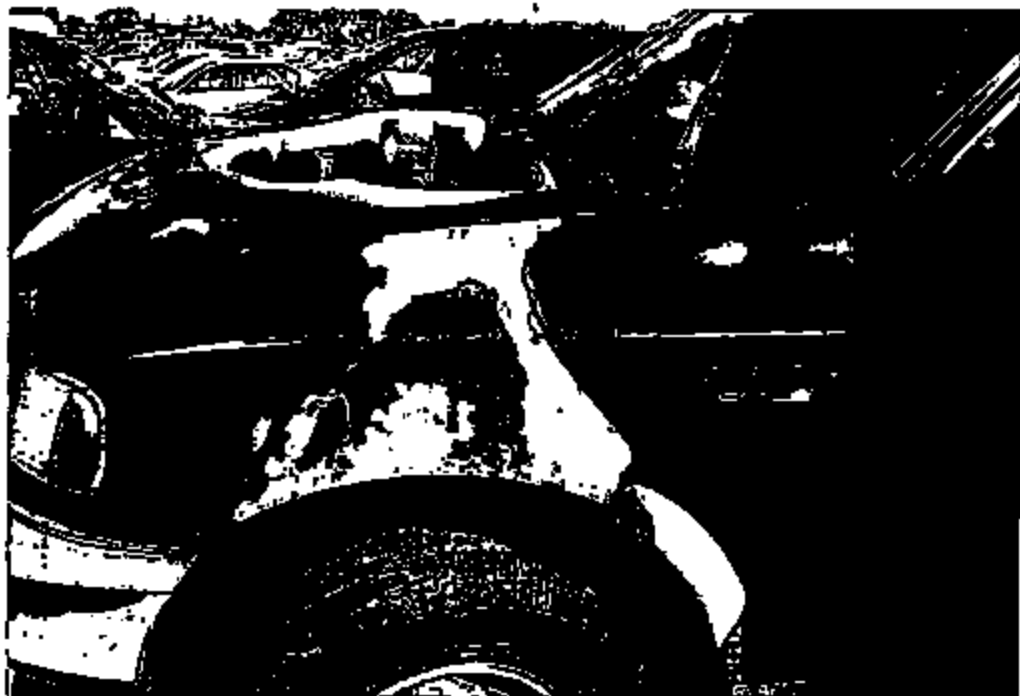
33. Fire damage to exterior front quarter panel on the driver's side.
