PROPERTY INVOLVED:

1995 Ford F150 pickup truck, color black, VIN# 1FTDF15Y05 [REDACTED] This vehicle was equipped with a 4.9 liter 6 cylinder engine, 5 speed manual transmission, and air conditioning. There was no impact damage noted regarding this vehicle. Mileage at the time of loss could not be verified, due to the fire damage and destruction of the dash and instrument panel. The owner insured indicated an estimated mileage of 73,000, and this may be verified through service records at Marshall Ford in Chattanooga, Tennessee. There was no indication that this vehicle had been altered from original factory manufactured specifications, and no installations of after market electrical items were noted. The steering column and the ignition cylinder had not been breached. Tires were Trail Blazer ATP235-75R15 and were in good condition. This vehicle displayed Tennessee tag [REDACTED] registered in Hamilton County.

VEHICLE EXAMINATION:

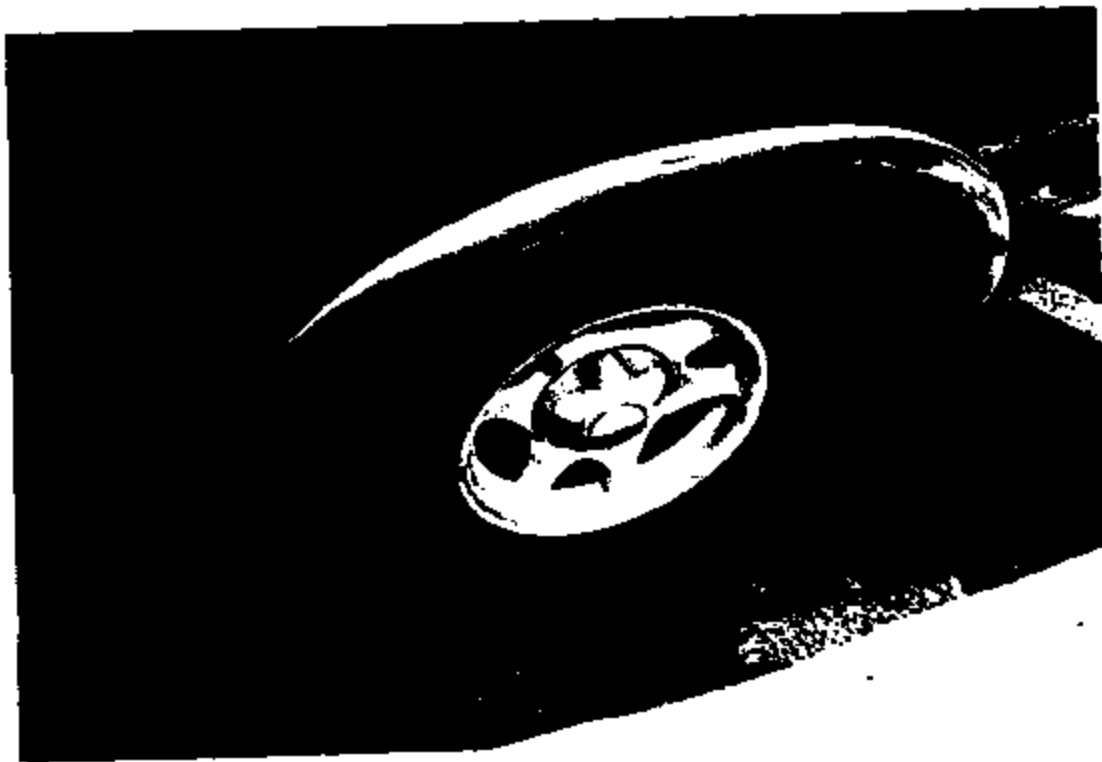
Photograph #7 Left front fender and tire are fire damaged
