FIRE CAUSE DETERMINATION

VEHICLE FIRE

**[REDACTED]
MACON, MS
1998 FORD EXPEDITION**

**CASE #4870
CLAIM # [REDACTED]
NOVEMBER 22, 1999**

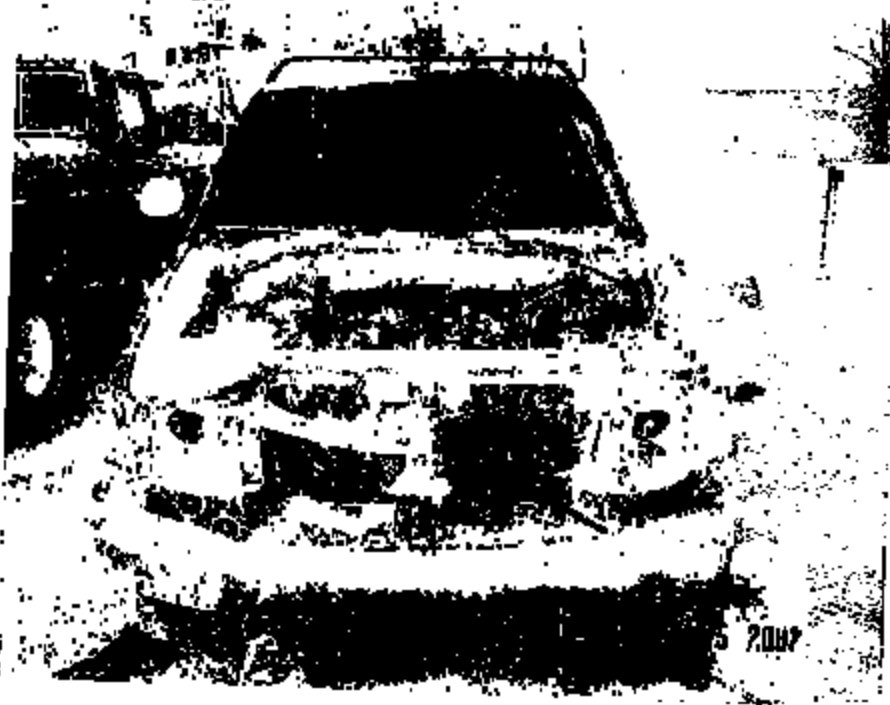
Photo 1
Photograph taken showing
the front of the vehicle.
The arrow shows the
heaviest area of fire
damage to the front grill
area.

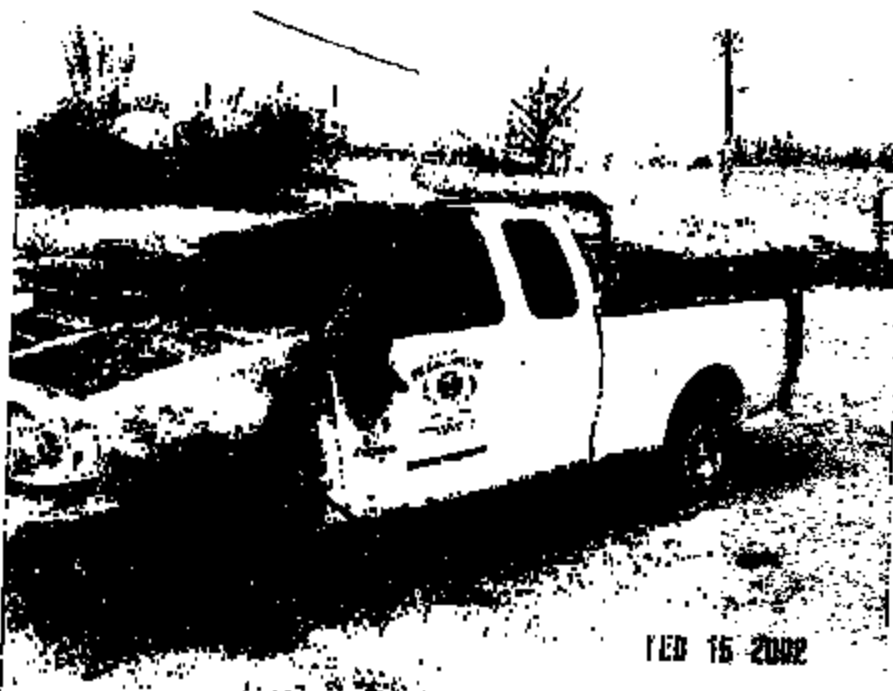
Photo 2
Photograph taken showing
the driver's side of the
truck the arrow shows the
fire damage to the front
fender, part caused by the
tire burning.

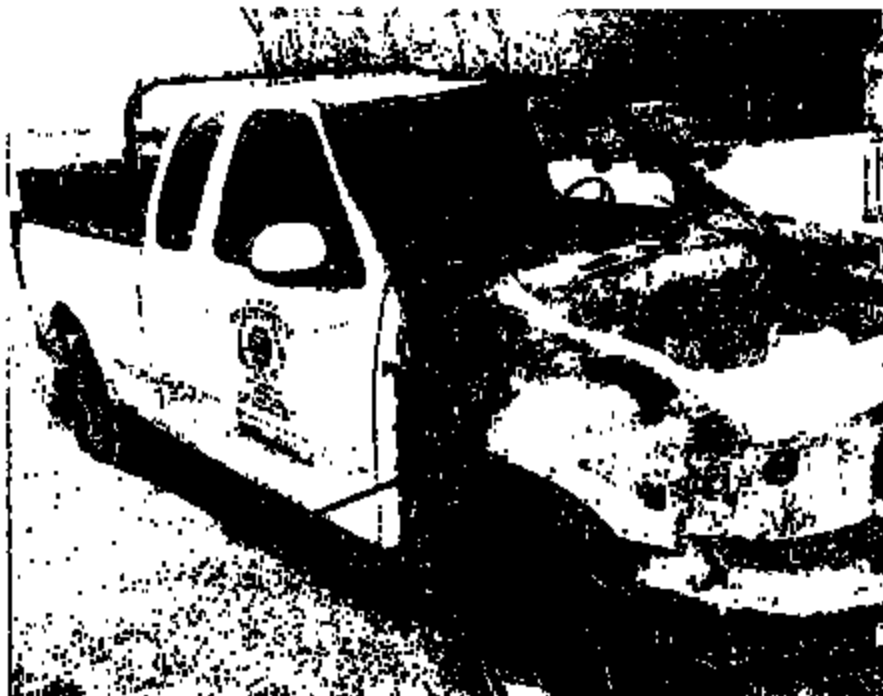
Photo 4
Photograph taken showing
the passenger side of the
truck, the arrow shows the
front fender not as
extensively burned as the
driver's side.

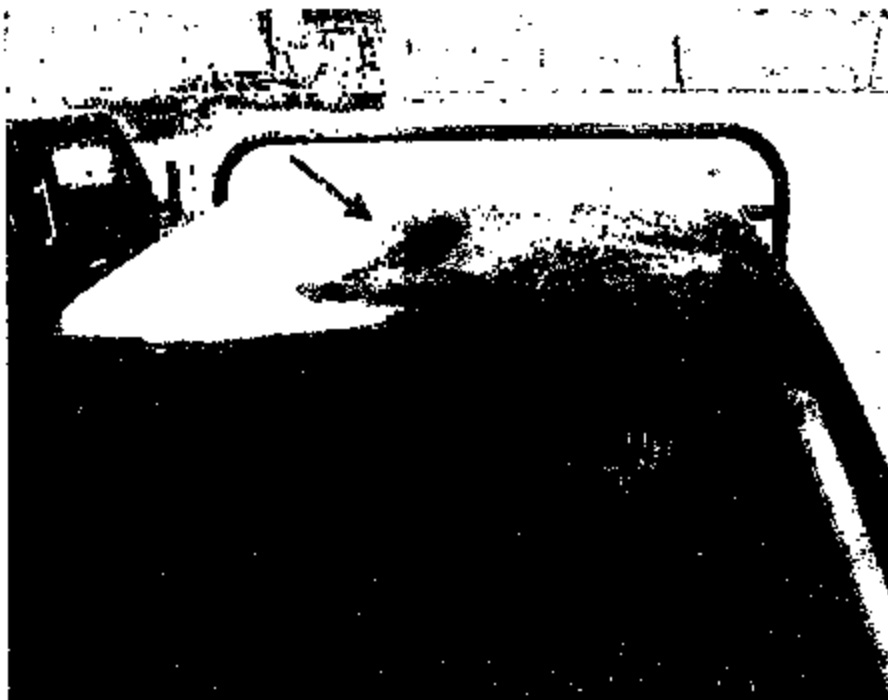
Photo 5
Photograph taken showing the top of the cab the arrow shows the heat damage being on the driver's side and extending from the windshield back across the cab roof.

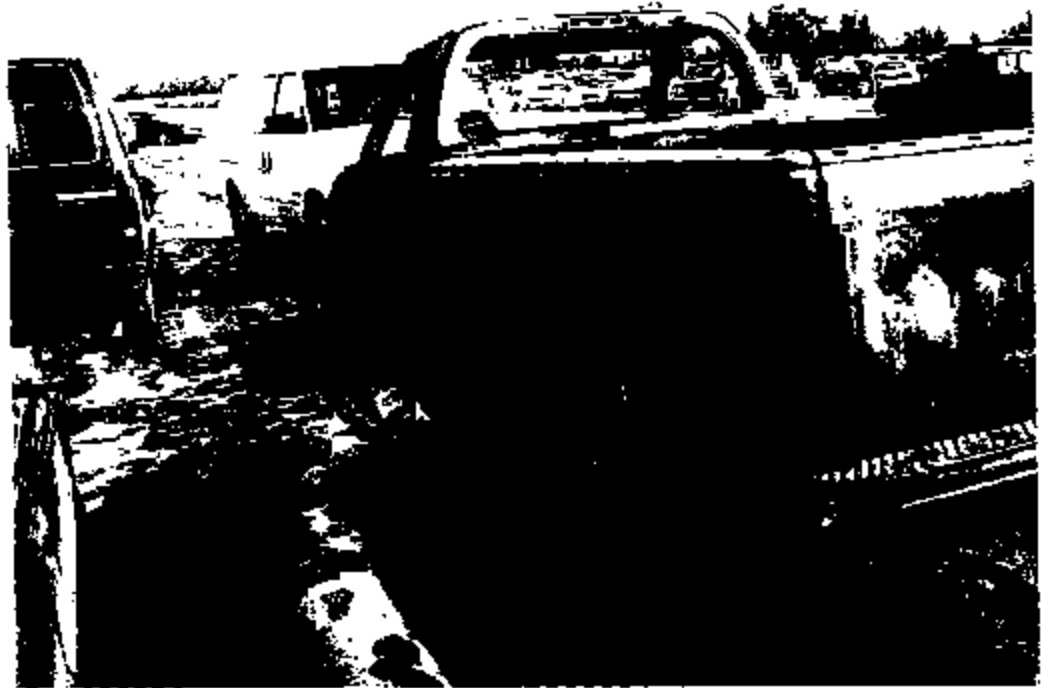
FIGURE #10

This is a view looking along the right side of the vehicle. The right front tire had been subjected to heat and was deflated, but it was not damaged as much as the left front tire. The condition of the right door of this vehicle indicates that it was open, or at least partially open, during the fire.

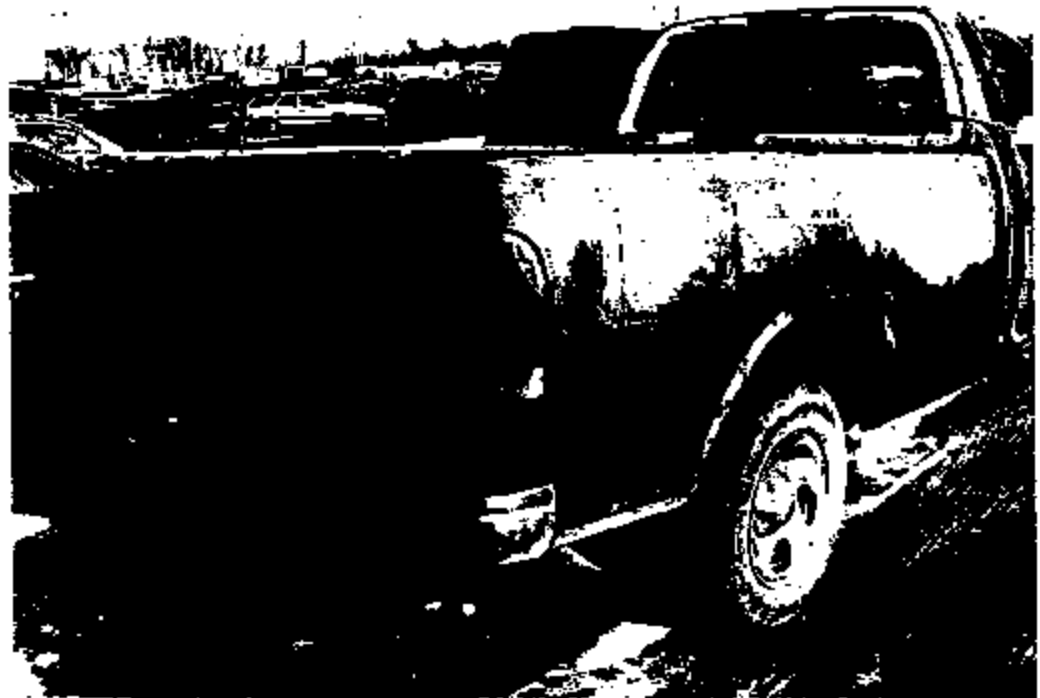
FIGURE #11

This is a view of the right front tire. Although deflated and partially burned, it was not damaged as extensively as the left front tire.
