**EA05-005**  
**STEPTOE & JOHNSON**  
**FOR TEXAS INSTRUMENTS**  
**2/23/2006**  
**ATTACHMENT PART 1 OF 3**

## REPORT OF ANALYSIS

**SUBJECT:** TSL # 148997: 77FS FORD/BOSCH TERMINAL PROBLEMS:  
- UPDATE TO MEMO 98-330

**DATE:** 7/1/98

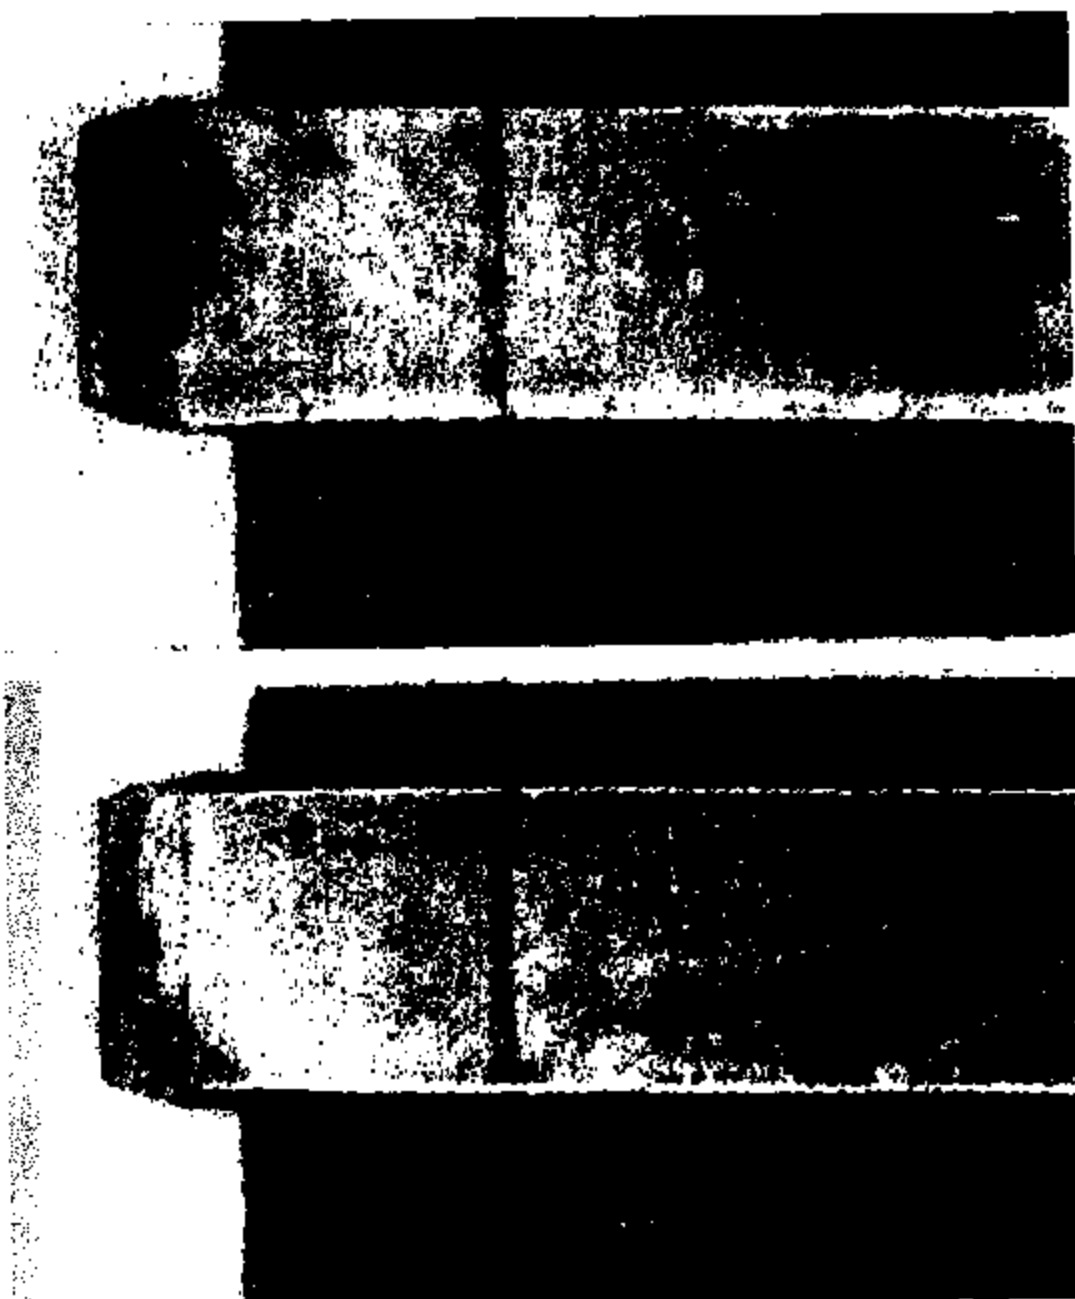
The other two devices had a much different pattern of corrosion. They are different from the typical Bosch/Ford problem and the Gallatin problem in the following ways:

- Both devices had one bad terminal and one pristine terminal.
- The bad terminal had a "Splash" type stain that extended up the leg and into the electronics cavity. This had to occur before the terminals were molded into the plastic. This defect is similar to the "splash" type stain found on the raw terminals.
- In addition to the splash stain there was a corrosion zone on the ultimate tip of the bad terminal of both these devices. We found the same elements in both these end type stains and the splash type of stains so they are probably were exposed to the same liquid although by a different mode.
- We found chlorine, potassium, calcium, iron, sulfur and silicon in addition to the bulk species of copper, zinc, carbon and oxygen.
- We didn't find the "dried riverbed" pattern on either sample.

Photos of terminals from these two devices are shown below:
