**EA05-005**  
**STEPTOE & JOHNSON**  
**FOR TEXAS INSTRUMENTS**  
**2/23/2006**  
**ATTACHMENT PART 2 OF 3**

Description	#1	#2	#3
Fed X #	8031 8189 5661	8031 8189 5661	8012 1766 1055
Date Code	8127	8127	8127
Found @	Gallatin, TN	Gallatin, TN	Ford - Louisville
Visual Inspection	<ul style="list-style-type: none"> <li>• Parts where installed</li> <li>• Base cavity clean</li> <li>• Stake looks shiny</li> <li>• Contamination looks green / waxy residue on both term.</li> <li>• Contam. Appears to only go half way down terminal</li> </ul>	<ul style="list-style-type: none"> <li>• "</li> <li>• "</li> <li>• "</li> <li>• "</li> </ul>	<ul style="list-style-type: none"> <li>• "</li> <li>• "</li> <li>• "</li> <li>• Contamination looks dark/olive brown.</li> <li>• Contam. Appears to end half way down terminals.</li> </ul>
Continuity Check	Pass	Fail / Intermittent	Pass
Function Test	Pass	Fail - ZPLF	Pass
Cut Open Parts	<ul style="list-style-type: none"> <li>• Yes</li> <li>• Clean inside device &amp; at entry of terminal.</li> </ul>	<ul style="list-style-type: none"> <li>• Yes</li> <li>• "</li> </ul>	<ul style="list-style-type: none"> <li>• Yes</li> <li>• "</li> </ul>

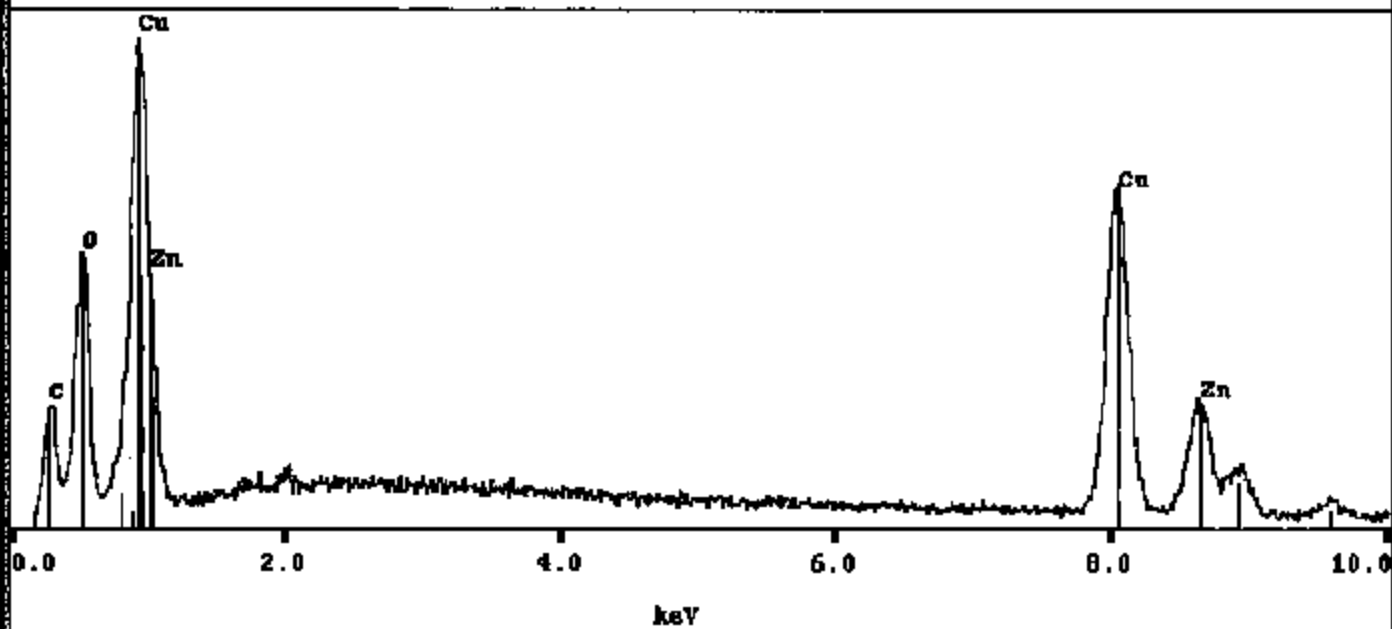
— ✓ proia\_149025\_020 Switch 1, post ipa/acetone

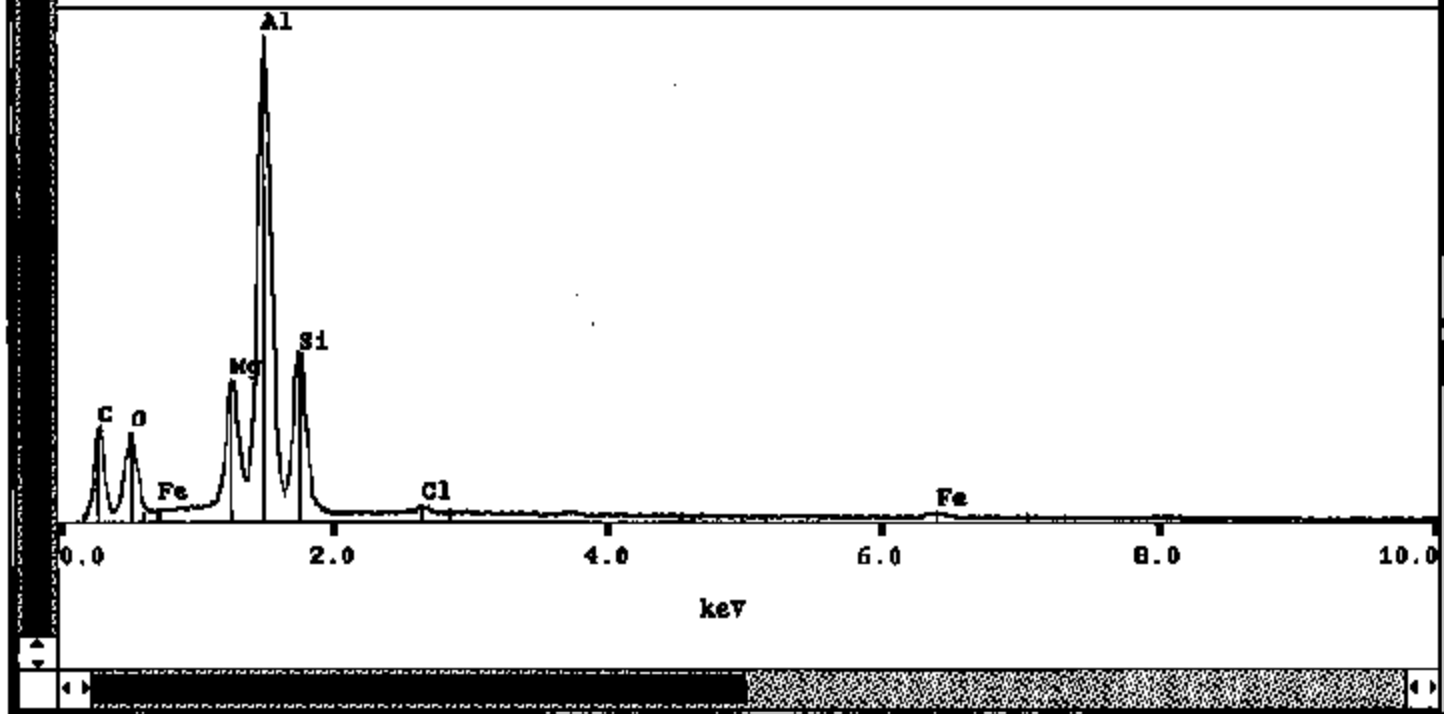
— ✓ proia\_149025\_030 spots at terminal base

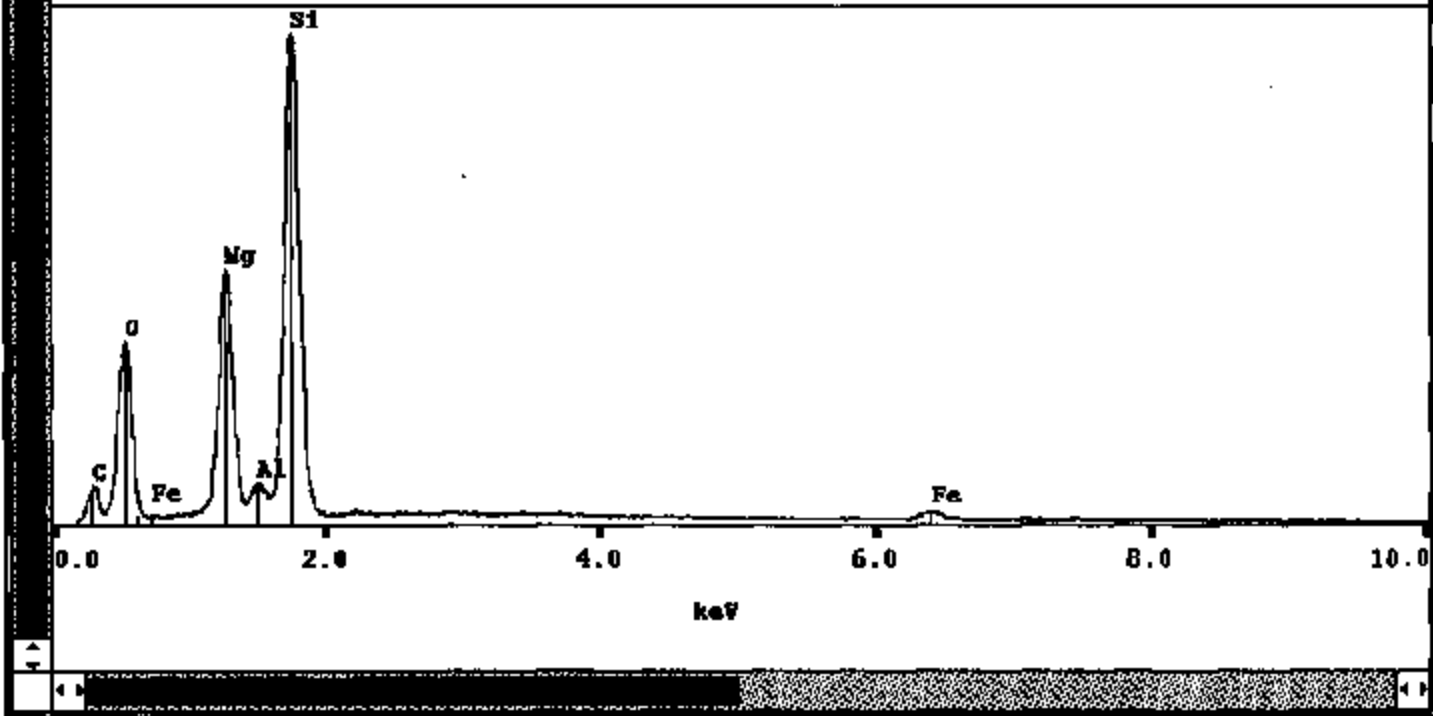
— ✓ proia\_149025\_031 spots at terminal base

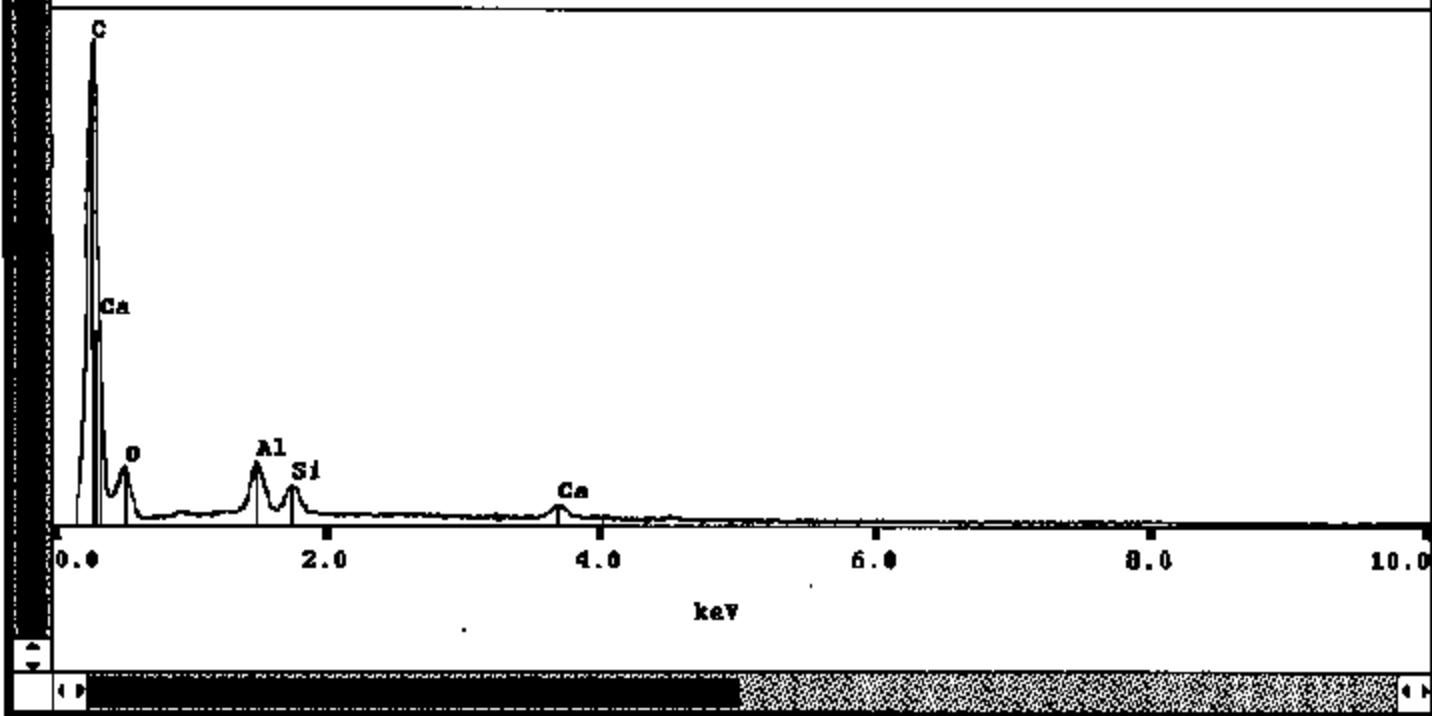
— ✓ proia\_149025\_032 spots at terminal base

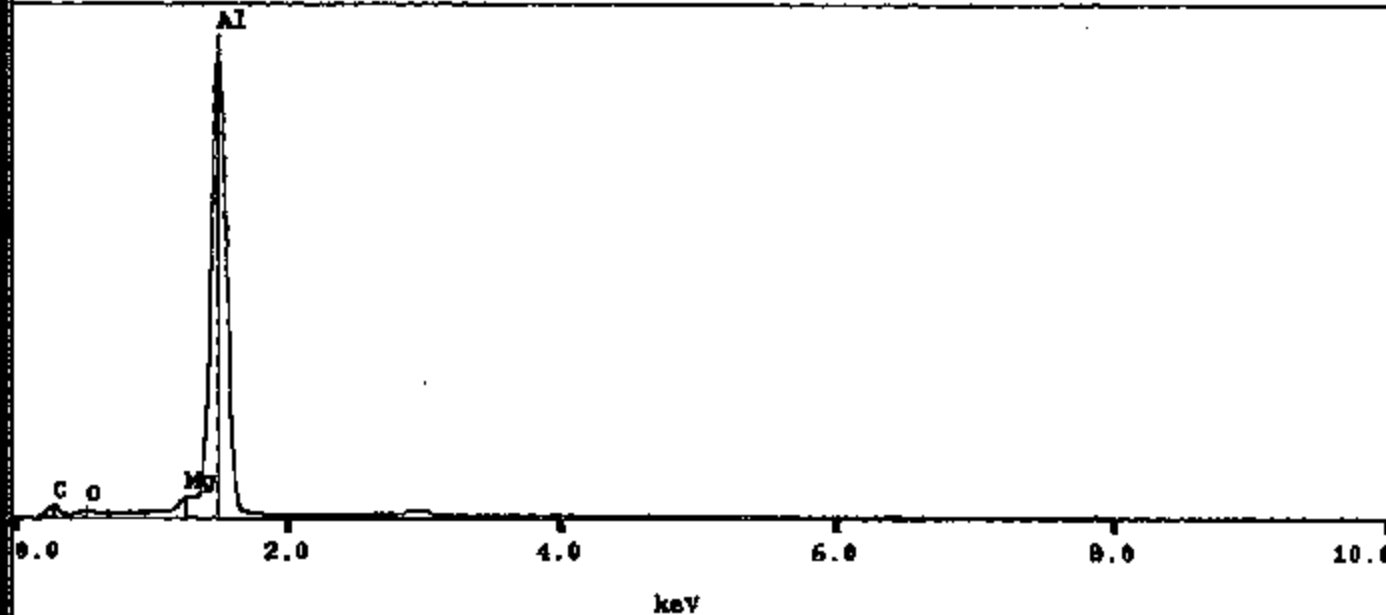
✓ proia\_149025\_033 spots at terminal base

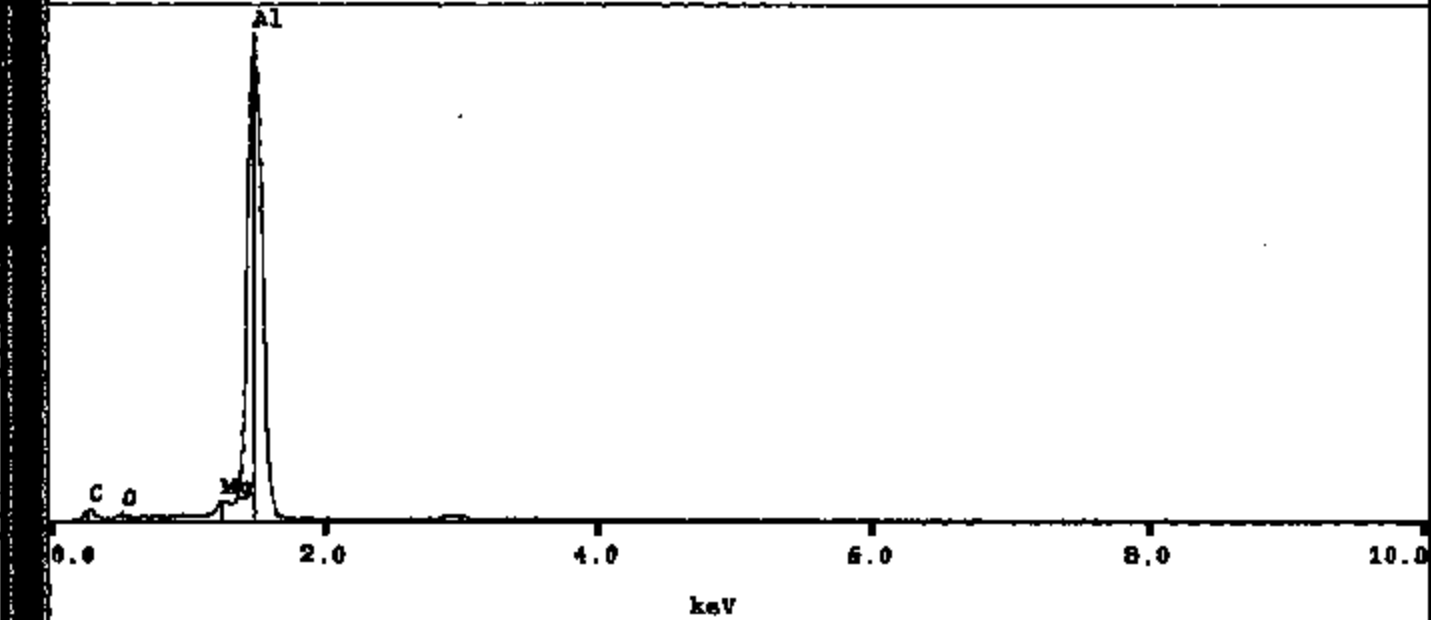
— ✓ proia\_149025\_034 spots at terminal base

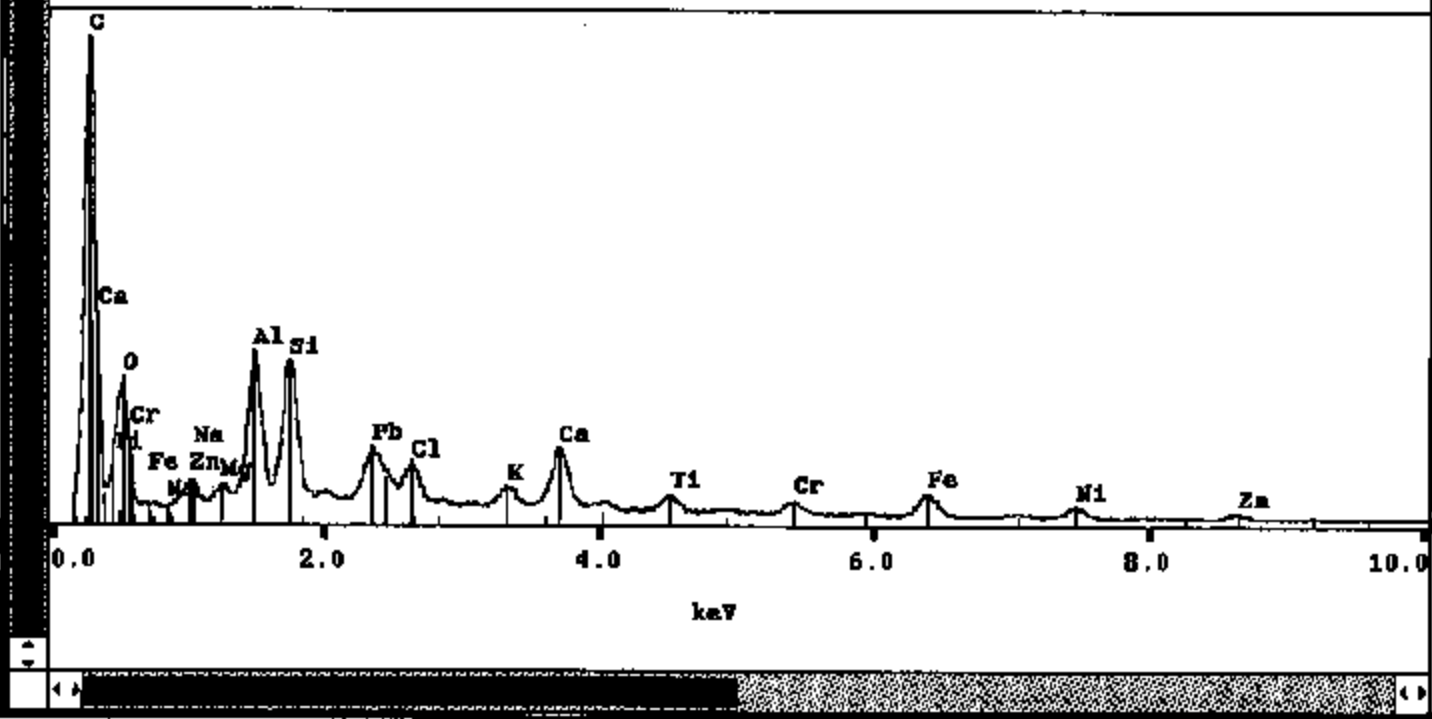
✓ proia\_149025\_036 spots at terminal base

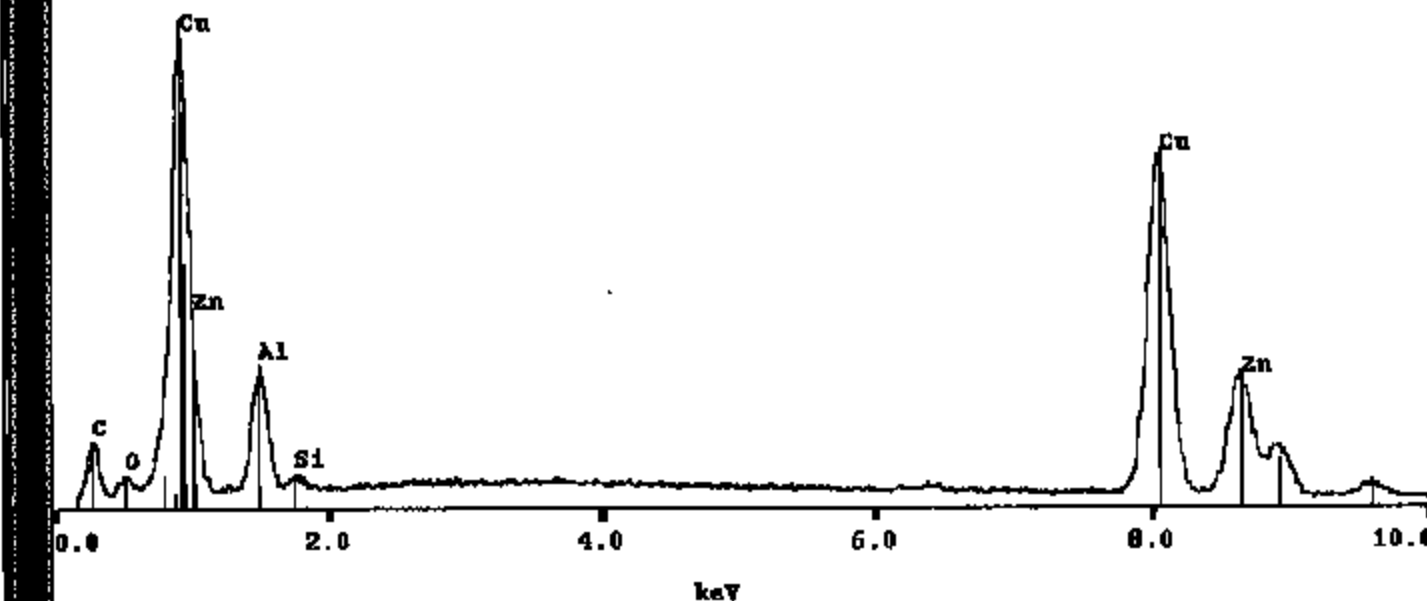
— ✓ proia\_149025\_030 spots at terminal base

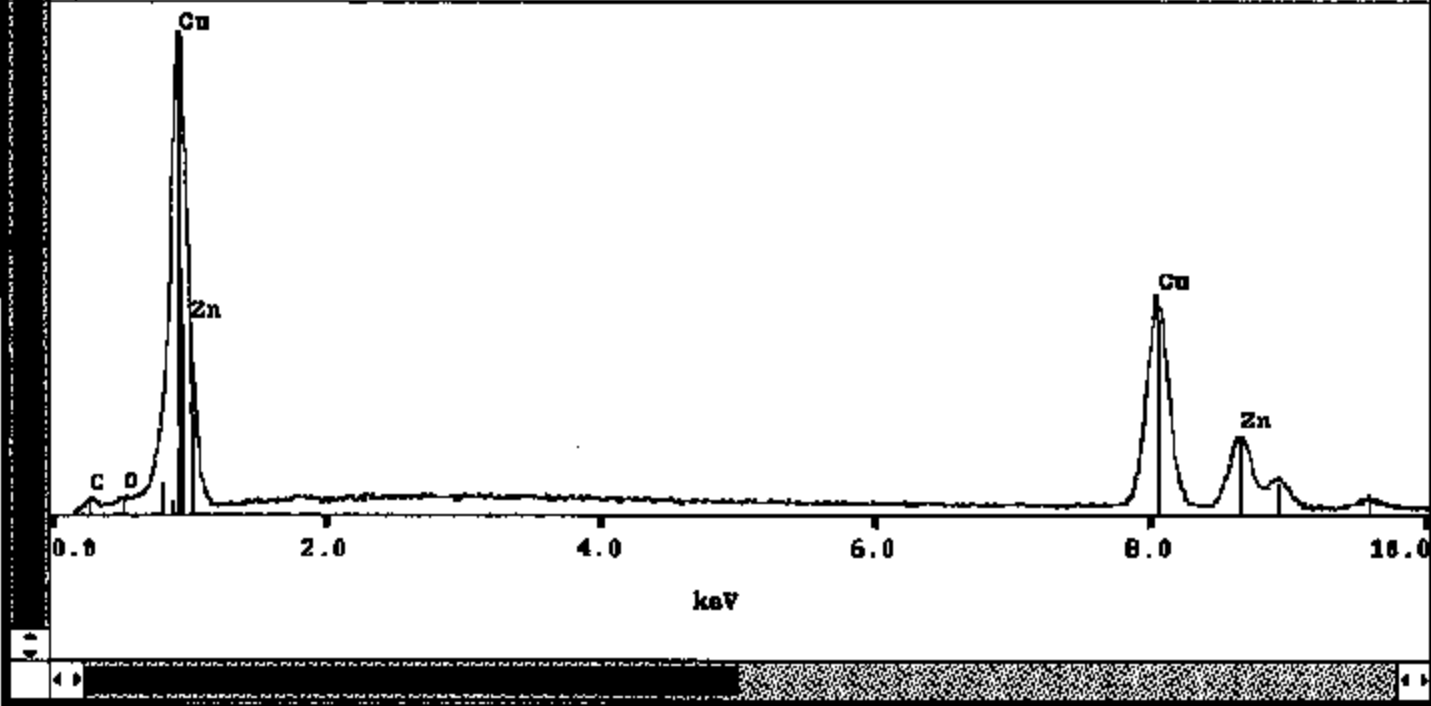
✓ proia\_149025\_044 Gallatin #5 terminal pin

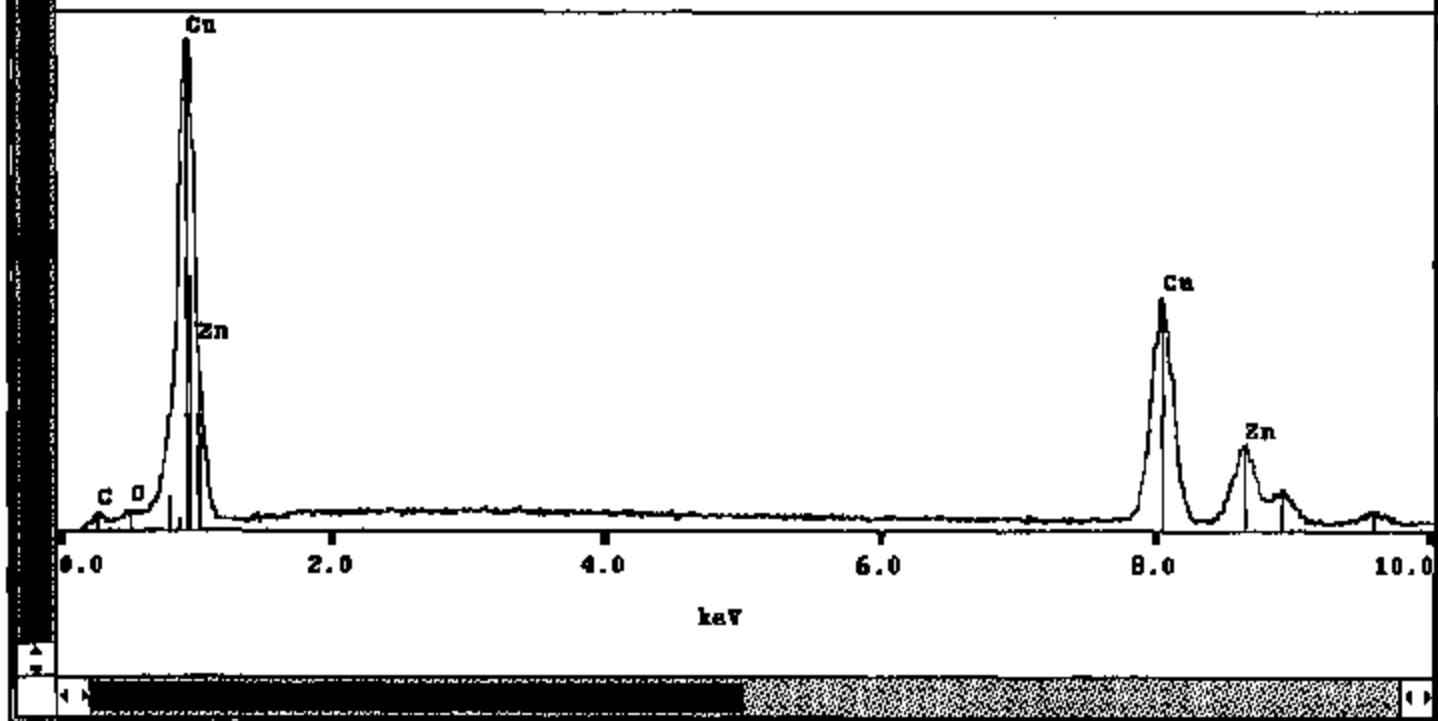
— ✓ proia\_149025\_045 Gallatin #5 terminal pin
